HISTORIC PROPERTIES INVENTORY FORM

1. NAME(S), historic/common: Blennerhassett Hotel
(Downtown Parkersburg, W.V.)
2. LOCATION, street/road: 316 Market St. (S corner of
TAX MAP-LOT# Market & 4th Sts.)
95-2 city/town: Parkersburg, WV 26101
(incorporated/unincorporated)

Blennerhassett Hotel

316 Market St. (S corner of Market & 4th Sts.)

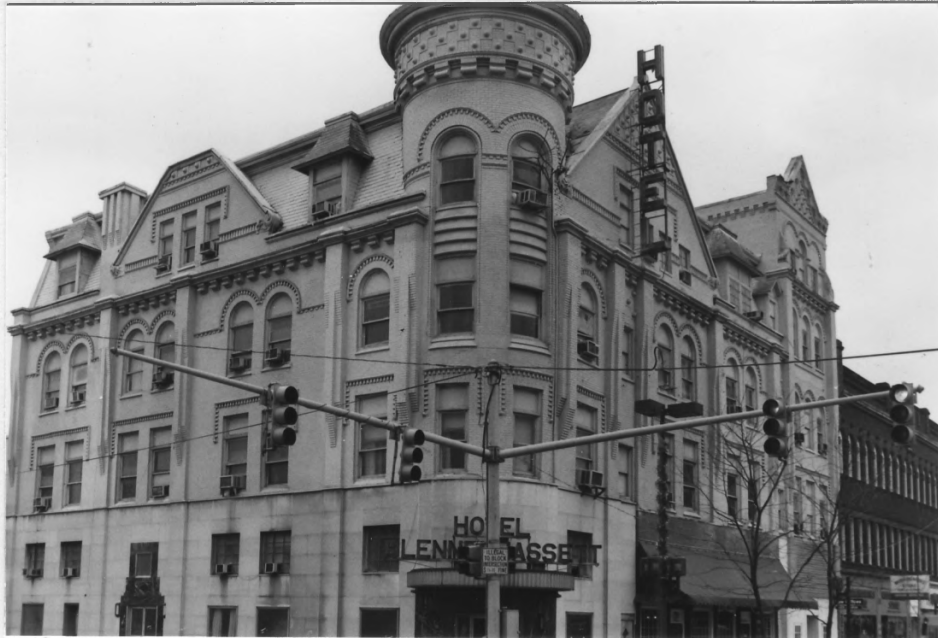
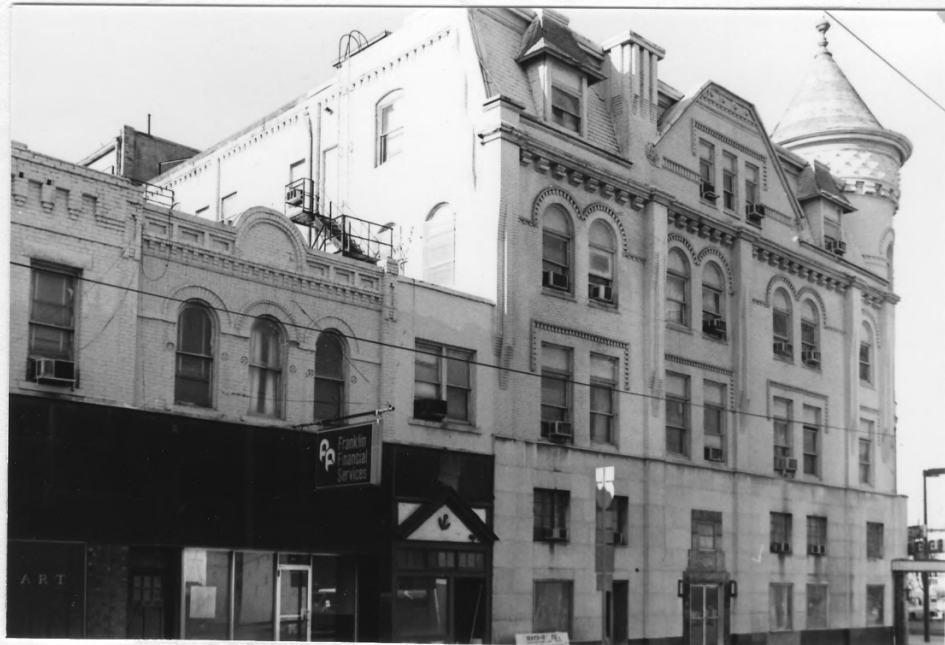
Sited on a prominent corner at the heart of downtown Parkersburg, this 4 story, attached structure presents a highly textured and picturesque silhouette to the streetscape; the southernmost bay on Market St. rises 5 stories. Its asymmetrical composition measures roughly 4 bays square; buttresses define the bays. The roof includes a mansard on the 2 street facades, pierced by Chateausque dormers, a chimney (NE), a flattened gable (NE), and a standard gable (NW); at the corner is a taller, round, conical roofed tower with a finial; ornament throughout the roofline includes a corbeled cornice and brick and terra cotta work. The 3rd and some of the 4th story windows, generally grouped 2 per bay, are d/s with arched lunettes; the raised brickwork of the arches continues as a springing course, interrupted only by the buttresses. The 2nd story windows are d/s with straight transoms; drip molding in a similar raised brickwork frames the pairs. The 1st story has been remodeled with various facing materials and an Art Deco corner entrance.

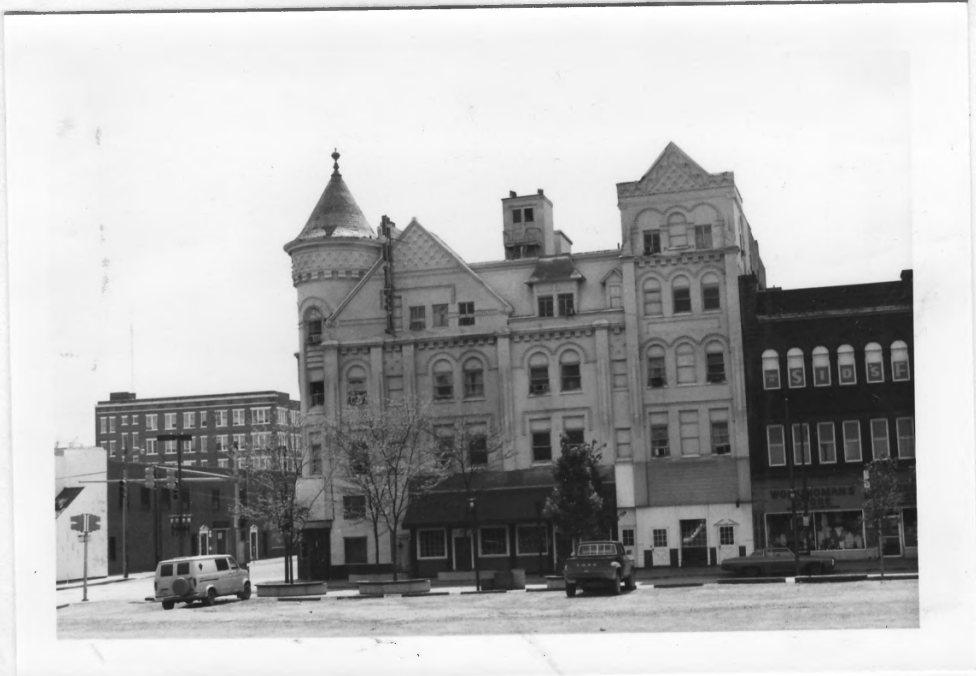
8201-R2-F35

Sited on a prominent corner at the heart of downtown Portland, this 4-story attached structure presents a highly textured and picturesque silhouette to the streetscape. The southernmost bay on Market St. rises 3 stories. Its asymmetrical composition features a row of 3 bays square; buttresses define the bays. The roof includes a mansard on the 2nd story facade, flanked by a chimney (NW), a chimney (NE), a flat roof (SE), and a standard gable (SW). At the corner is a taller round, conical roofed tower with a spiral ornament throughout the roofline including a corbelled cornice and brick and terra cotta work. The 3rd and some of the 4th story windows, generally grouped 2 per bay, are also with arched lintels. The raised brickwork of the 4th story continues as a swinging course, interrupted only by the buttresses. The 5th story windows are also with arched transoms; drip molding in a similar raised brickwork defines the eaves. The 1st story has been remodelled with various
