National Register of Historic Places Registration Form

Historic name: Charmco Building

Other names/site number: Charleston Milling and Produce Company

Street & number: 606 Morris Street

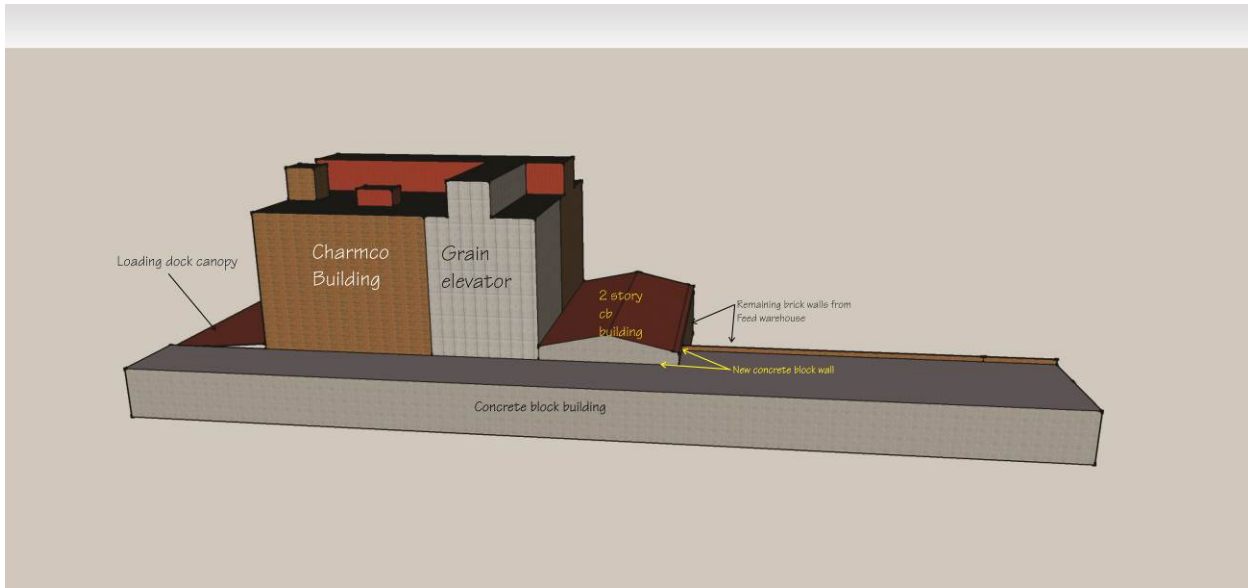
Figure# 05 - Birds eye view representation from south current.

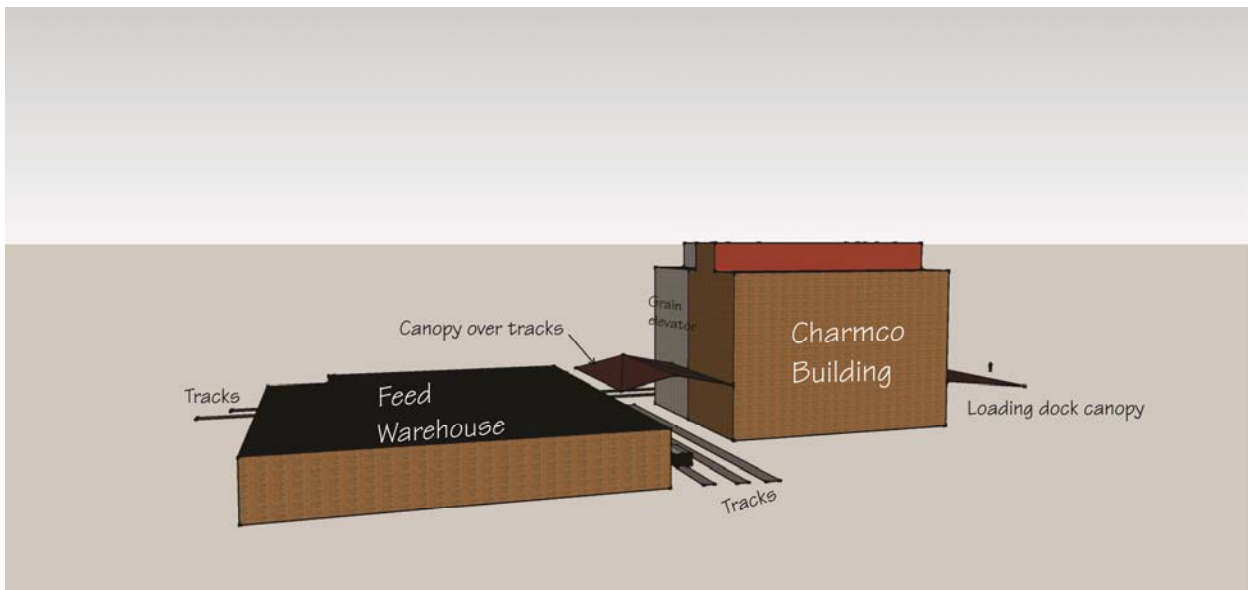
Figure# 06 -Birds eye view from north representation ca. 1950.

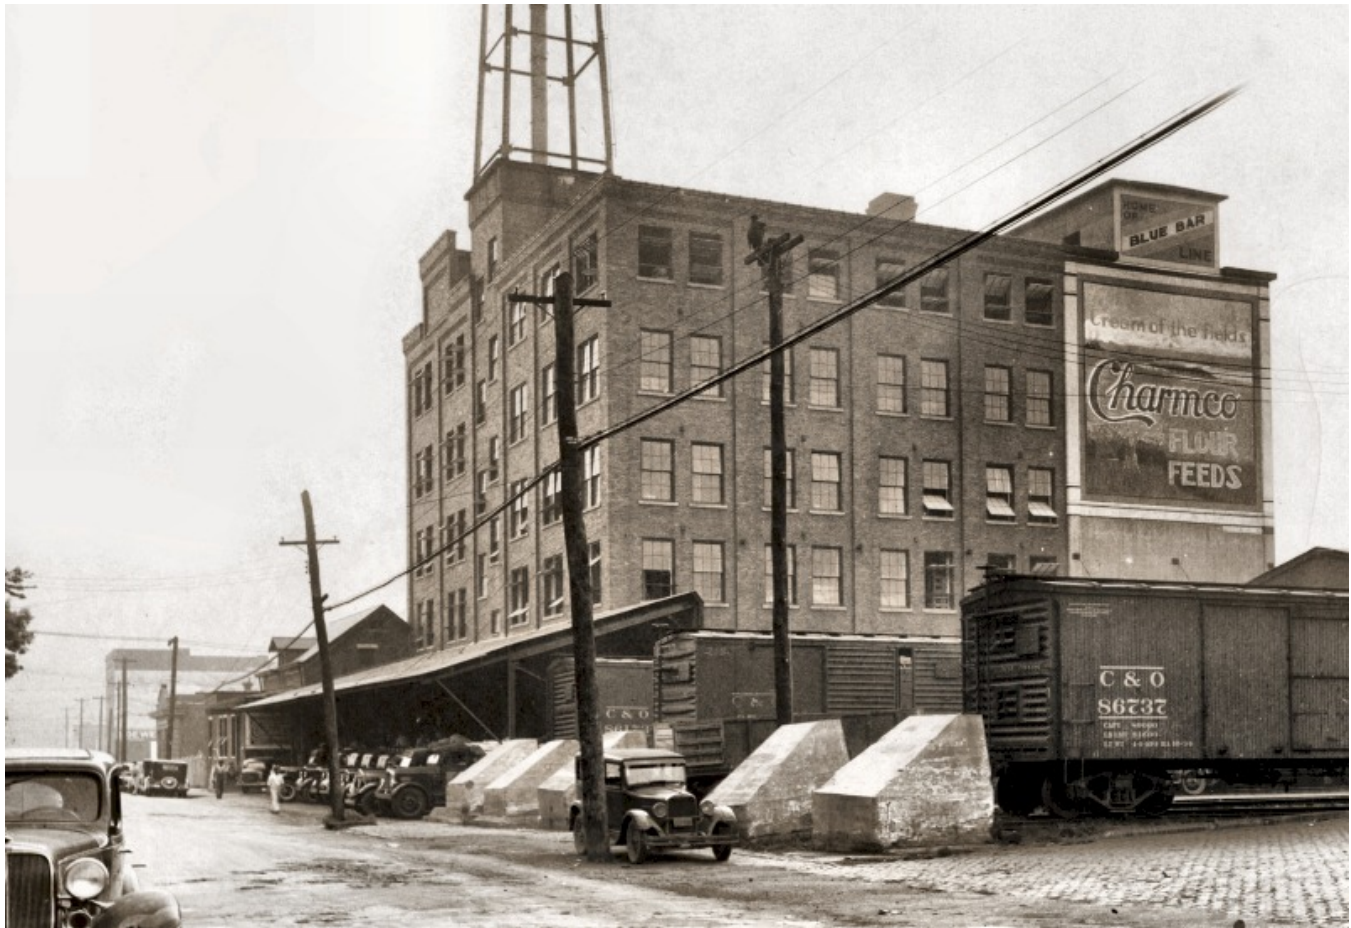
Figure# 26 - 1930s Historic Photo Facing North - Permission by Jerry Waters - mywvhome.com

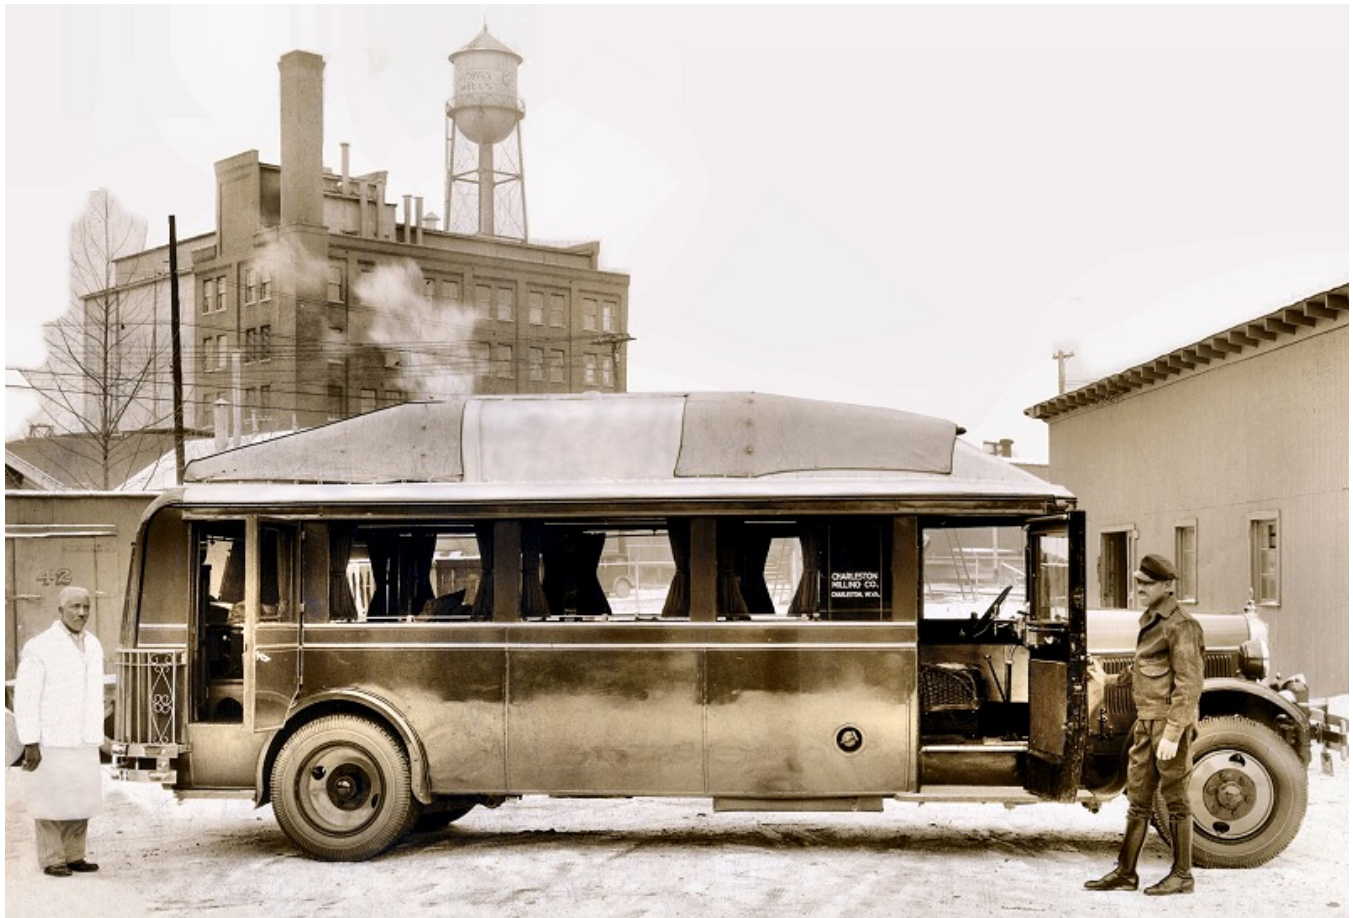
Figure# 27 – ca. 1934 Historic Photo Facing Southwest - Permission by Jerry Waters - mywvhome.com

There was a tall water tower above the stair tower that is no longer extant. The water tower, as seen in the ca. 1934 historic photograph (Figure 27), provided a source and head pressure for the sprinkler system, which protected the building in case of grain fires. This is not unusual in a mill building of this period. The tower is still visible in a photograph in a 1958 newspaper article about an adjacent building (Charleston Gazette 23).

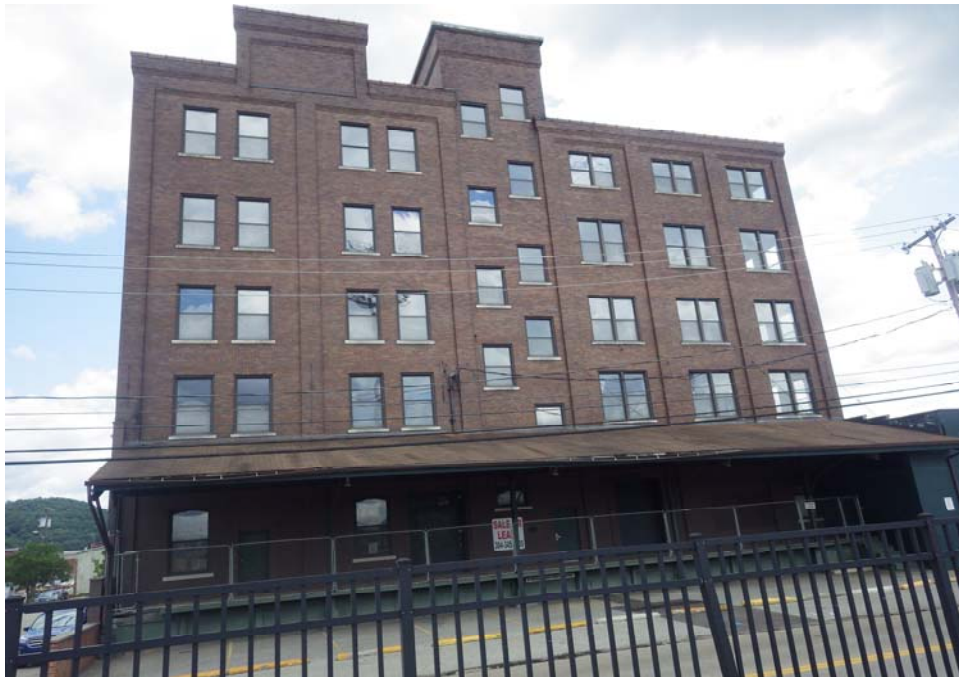
Photo# 01 - Front Façade Facing East

The building is five stories with a brick façade. There are six recessed bays in the front (west) elevation. Each bay has a pair of windows. The bays are separated by brick pilasters and the recesses are corbeled above the fifth floor to create a sort of entablature supported by the pilasters. This contains a corbeled molding forming the cornice, with the flat brick parapet above the cornice. The parapet is capped with terra cotta caps. The third bay from the north contains the stair tower which projects above the roof to form a sixth floor. There is also a sixth floor/penthouse above the pilaster separating the north first and second bays. The penthouse west wall contains a recessed brick panel with the corbeled cornice and parapet above. The parapet is flat, though the structure behind it has a gable roof. The gable structure, essentially a monitor, runs east west and steps up to a taller profile for two bays at the east end. Another gable structure intersects this section and runs north south along the top of the 1926 grain elevator. These structures contain storage rooms and hoisting equipment. There is a one story loading dock the full width of the front façade with a metal roof supported by steel I shaped columns with I beams supporting smaller C channel purlins. The purlins in turn support a wood structure. The primary façade contains four entrances, two large warehouse loading doors and two man doors. The north loading door is an original rolling door. It has a center mullion, creating the appearance of a pair of doors. Each leaf is divided into two horizontally by a wide center rail. The panels above and below the rail have cross bucks with vertical board infill. There is a segmented flat transom above the doors. The center loading door is a modern steel door. The two man doors are modern flat panel hollow metal steel doors. There is a bricked in former loading door in the south bay.

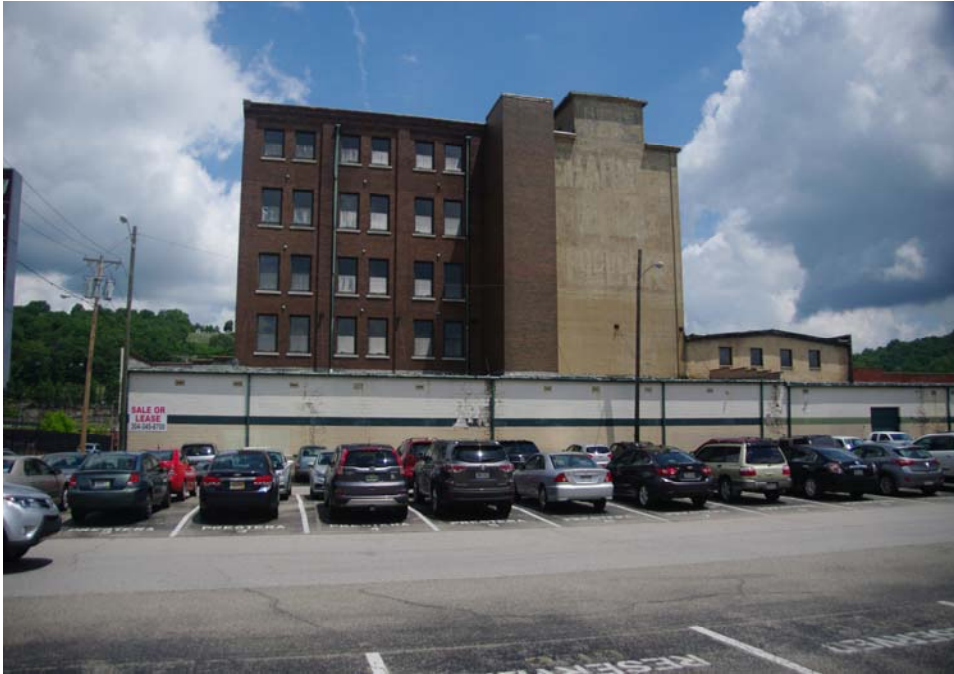
Photo# 03 - South Elevation Facing North

The south elevation consists of three recessed brick bays in the west side. The east end contains a concrete grain elevator which comprises approximately one third of the elevation. The grain elevator contains up to eight silos within its concrete structure. There is a modern elevator shaft, ca. 1970, addition in the center of the south elevation. The grain silo contains a penthouse as well with a shallow gable roof. There is a faint ghost sign on the concrete façade. A ca. 1930 historic photograph (“Charmco”) shows this sign (Figure 26). The portion on the monitor reads: “Home of Blue Bar Line”. The portion on the main concrete façade reads: “Cream of the fields; Charmco; FLOUR; FEEDS”.

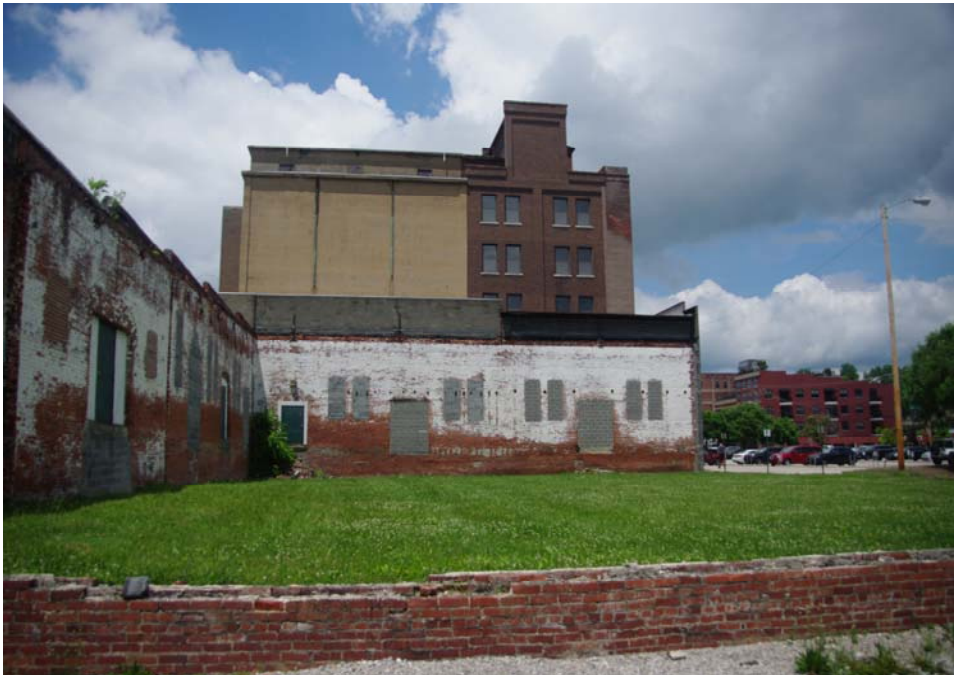
Photo# 04 - East Elevation Facing West

The east elevation contains three bays of the grain elevator, and two of the recessed brick facade with paired windows. There is also a brick chimney on the exterior of the northeast corner. The penthouse extends the depth of the building to this elevation face and has the same recessed brick panel.

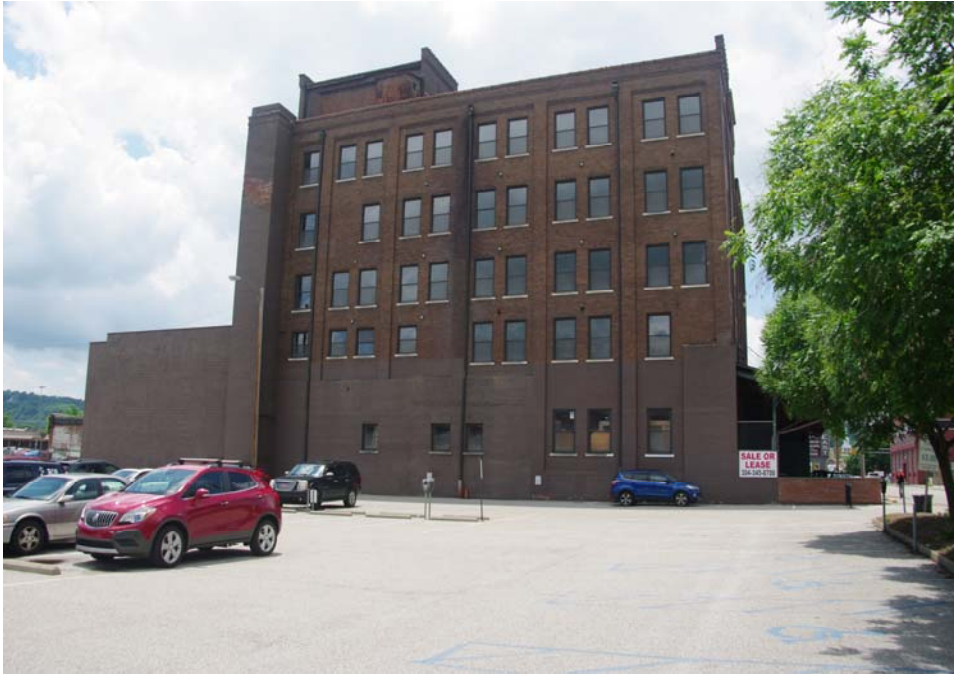
Photo# 05 - North Elevation Facing South

The north elevation contains six bays, each with paired windows, except for the east bay, which has a single window and the chimney. The first floor contains a different fenestration pattern than the upper floors. The historic photograph ("Charmco") (Figure 26) and a 1933 Sanborn map show a one story building abutting this elevation. The first two bays from the west corner contain windows aligned with the upper floors, except for the first window. The remainder of the elevation contains three smaller windows that do not align with any of the upper floor windows. They are irregularly spaced. In addition to this change in fenestration, the lower portion of the wall does not contain the recessed panels. The brick wall is flat. This portion of the wall is also painted brown.

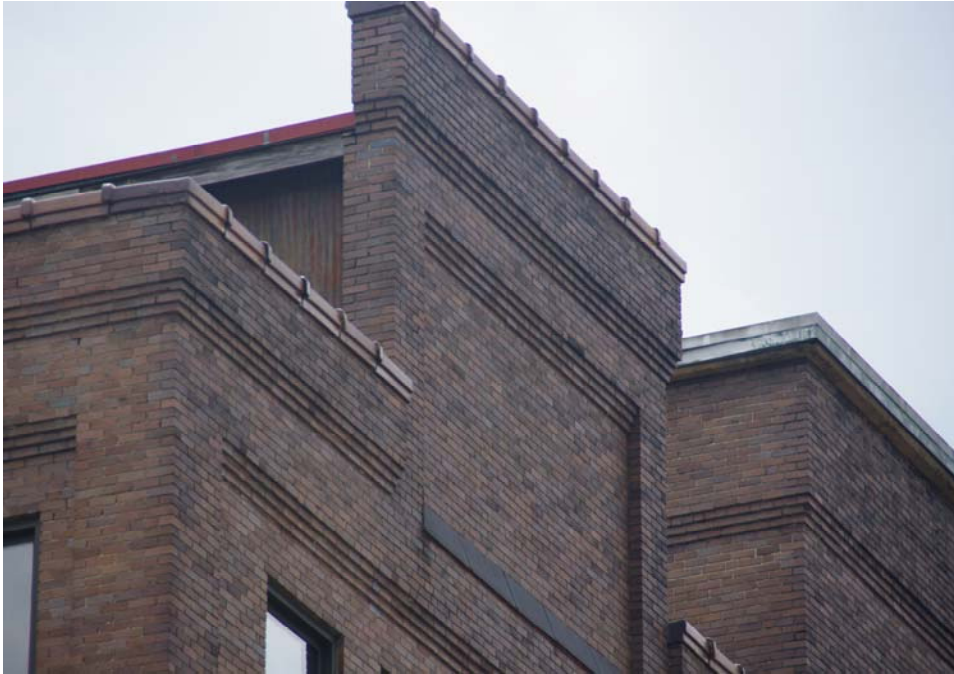
Photo# 07 - Detail of Cornice and Parapet at Northwest Corner of Building

The building exhibits some Romanesque influence, notably the corbeled façade panels, corbeled projections at the parapets, and irregular massing and heights of the stair tower and monitor parapet on the front elevation.

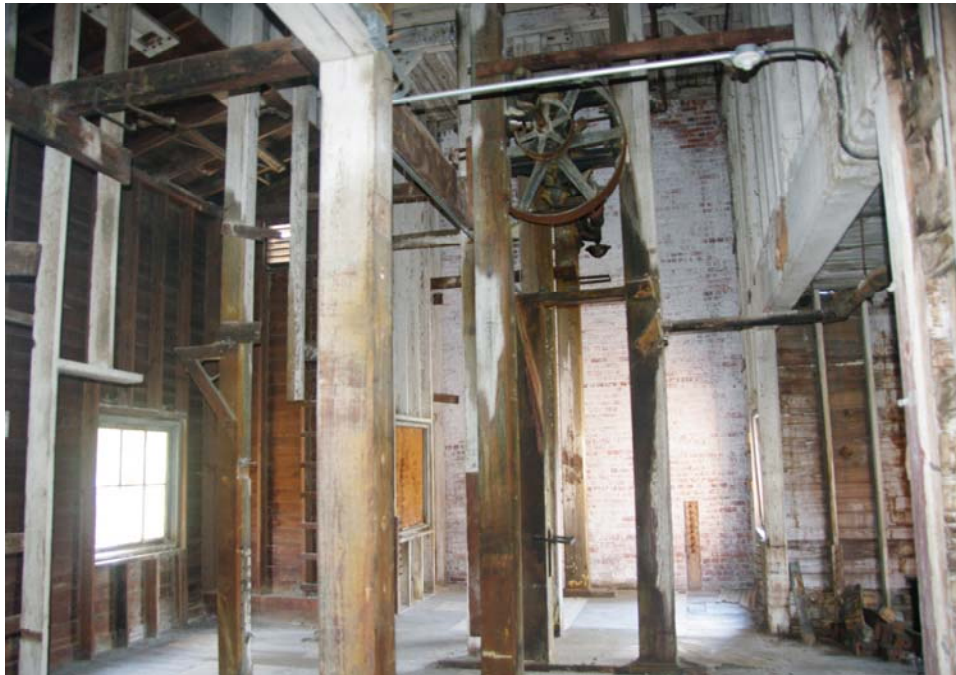
Photo# 14 - Penthouse Fl North Side Interior Facing East

The penthouse is an "L" shaped plan. The intersection of the legs is taller than the legs and contains timber framing that supports pulleys and hoisting equipment. The east and west walls are painted or exposed brick. The others are wood studs and the back side of the exterior wood tongue and groove sheathing. There are pulleys, rails, a small cart and other equipment in the penthouse above the silos. There is no other remaining equipment in the building associated with the mill.

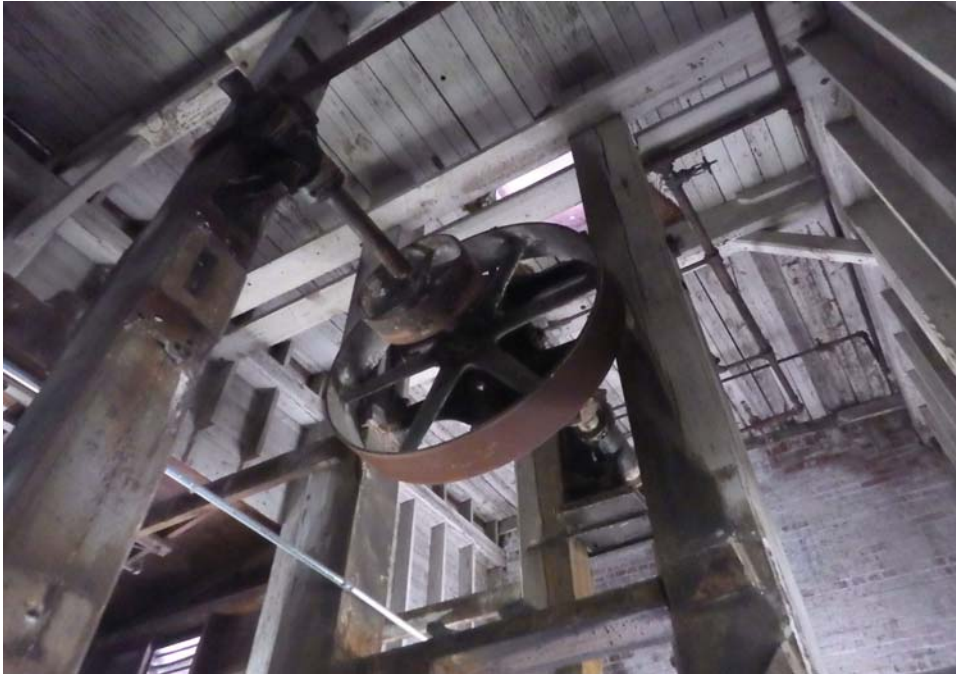
Photo# 15 - Penthouse Fl Original Pulley Wheel
