NATIONAL REGISTER OF HISTORIC PLACES  
INVENTORY -- NOMINATION FORMSEE INSTRUCTIONS IN HOW TO COMPLETE NATIONAL REGISTER FORMS  
TYPE ALL ENTRIES -- COMPLETE APPLICABLE SECTIONS**1 NAME**

Rock Valley Farm

Rock Valley Farm, Dallas vicinity, Ohio County, West Virginia

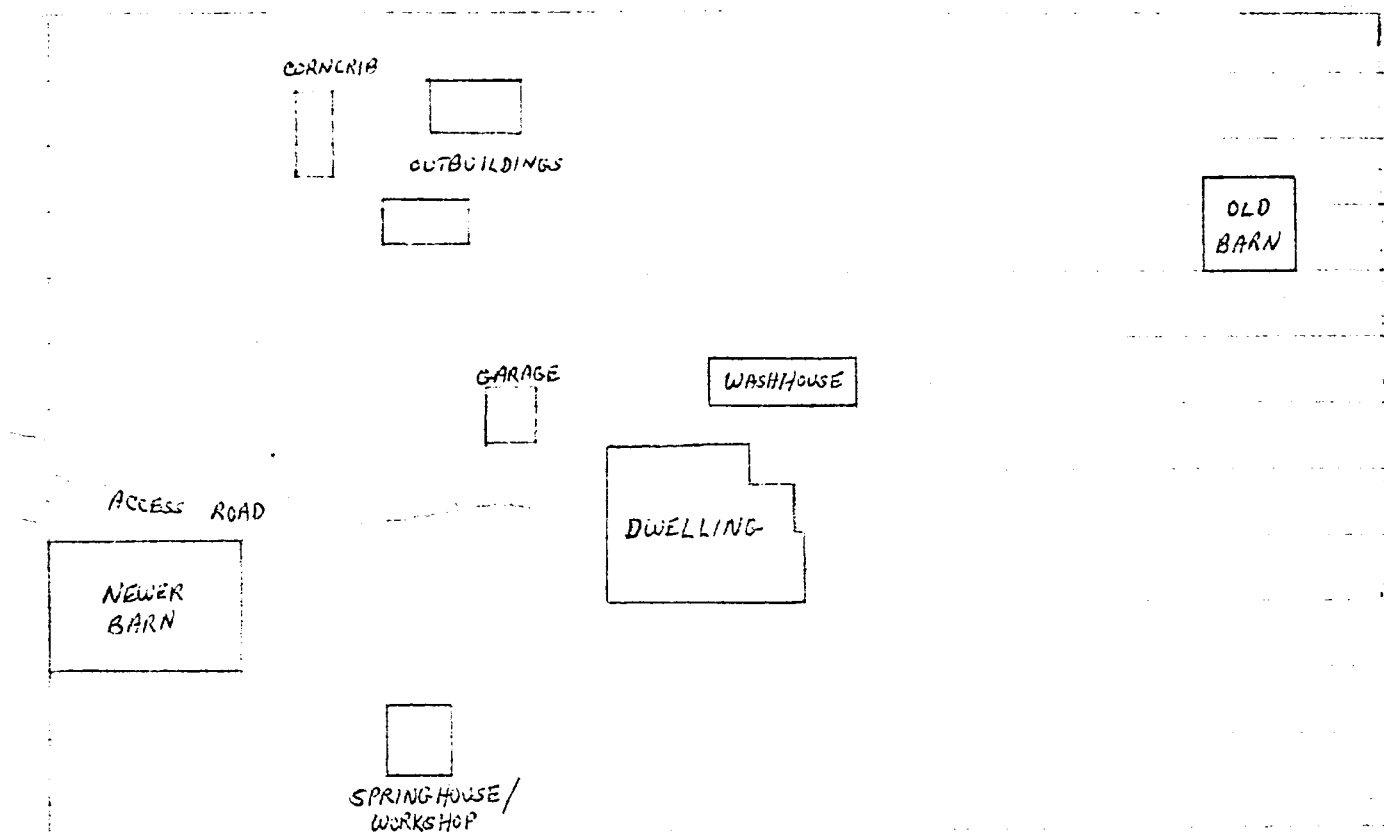
ROCK VALLEY FARM  
DALLAS VICINITY, OHIO COUNTY, WEST VIRGINIA

Approximate relationship of outbuildings to dwelling. Red line represents rough estimation of boundary of nominated area.

direction to a fenceline approximately 150 feet east of the house, northward along that line about 100 feet to a point north of the old barn, then westward along the ridge line behind the corncrib to an area approximately 50 feet west of that structure, and then southward to a point about 20 feet west of the newer barn near the springhouse (see accompanying map). Also included is the access road that runs from the house about  $\frac{1}{4}$  mile to the Dallas Pike (County Route 43).
