United States Department of the Interior National Park Service
NATIONAL REGISTER OF HISTORIC PLACES REGISTRATION FORM

historic name: Gap View Farm

state: WV county: Jefferson code: 037 zip code: 25414

Gap View Farm Jefferson Co, WV
Section number 7 Page 1

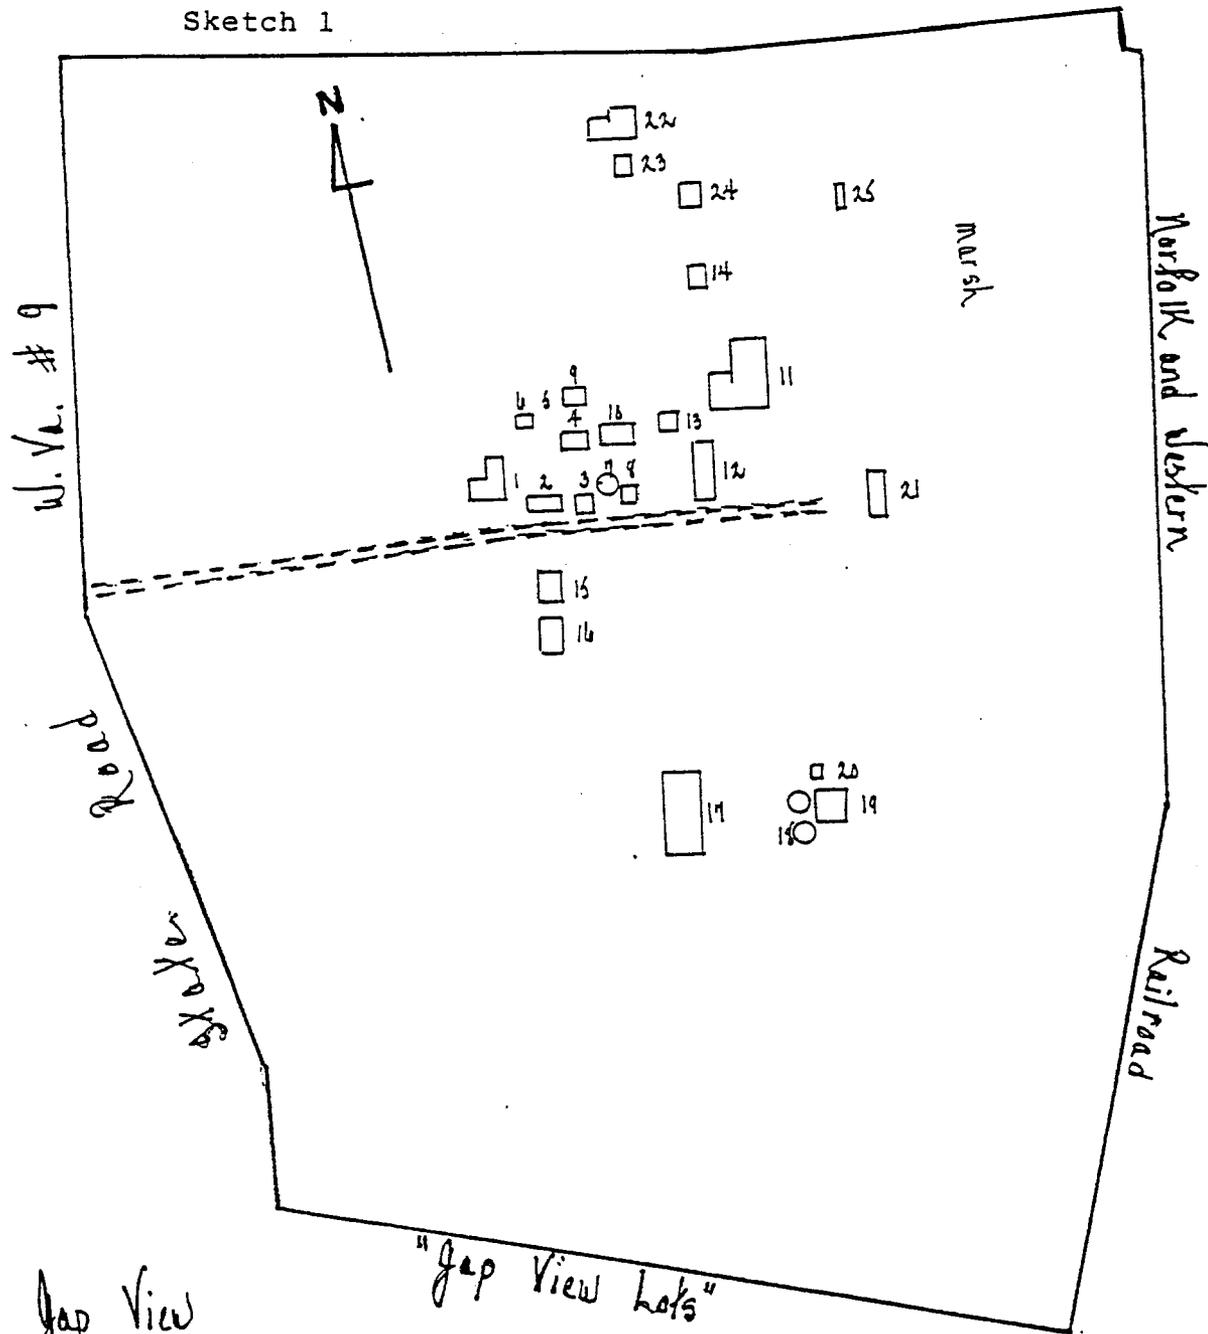
Sketch 1

Index to sketches #1 and #2

Gap View
152.1 acres

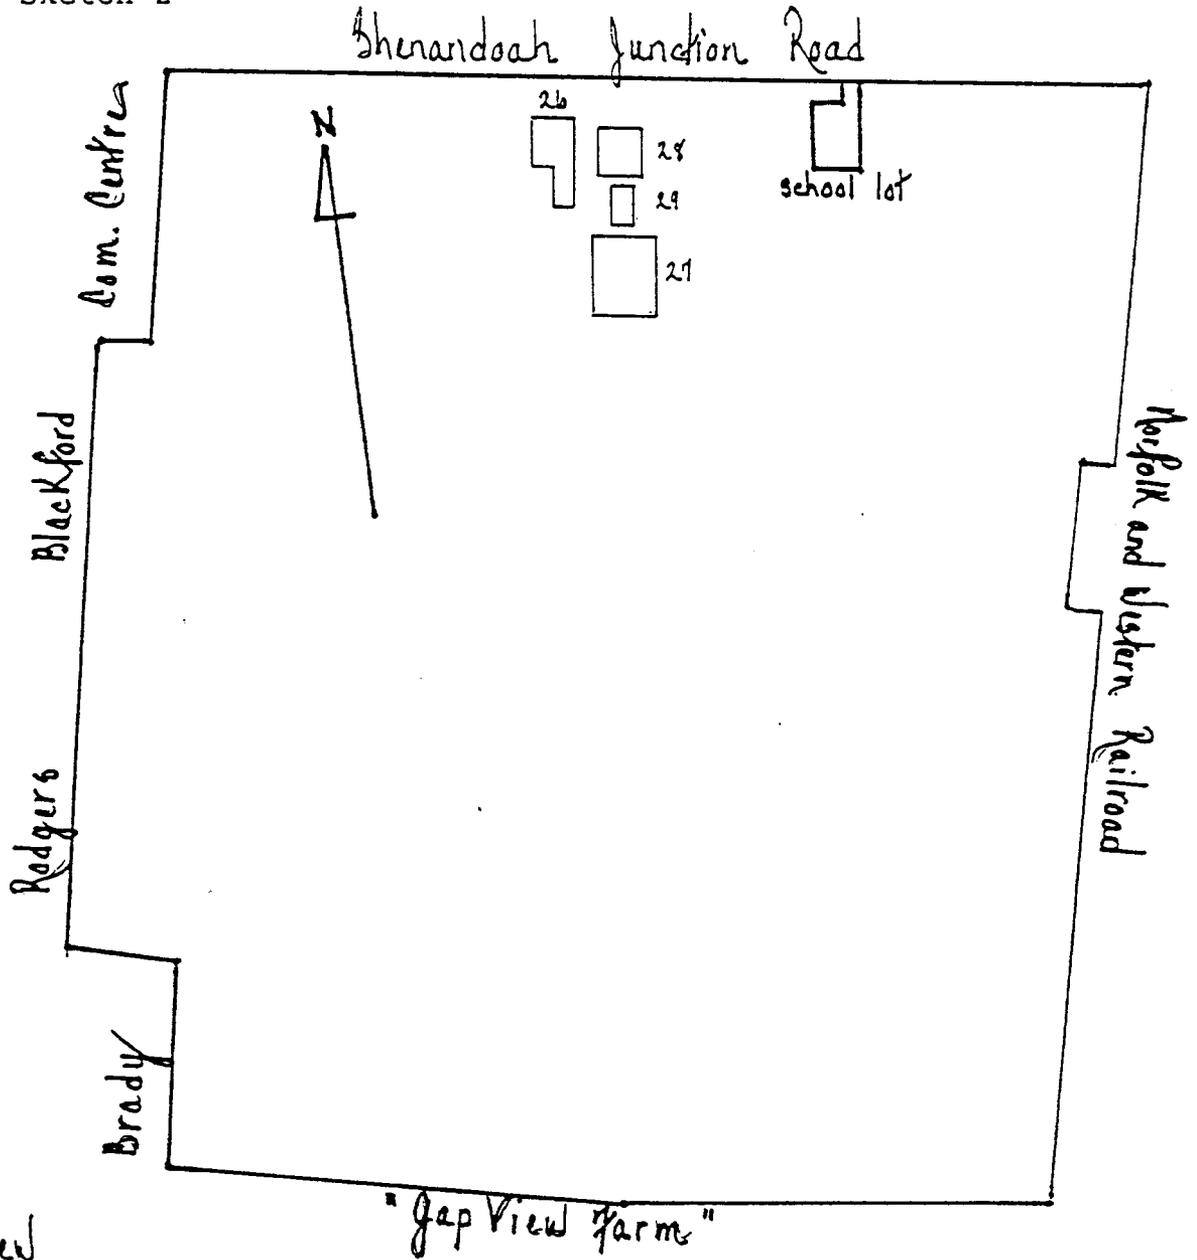
Sketch 2

26 Tenant House Contributing Bldg, c. 1776 Photo #37/Sketch #2, 8

27 Red Barn Contributing Bldg, C. 1931 Photo #39/ Sketch #2

Gap View
132.6 acres

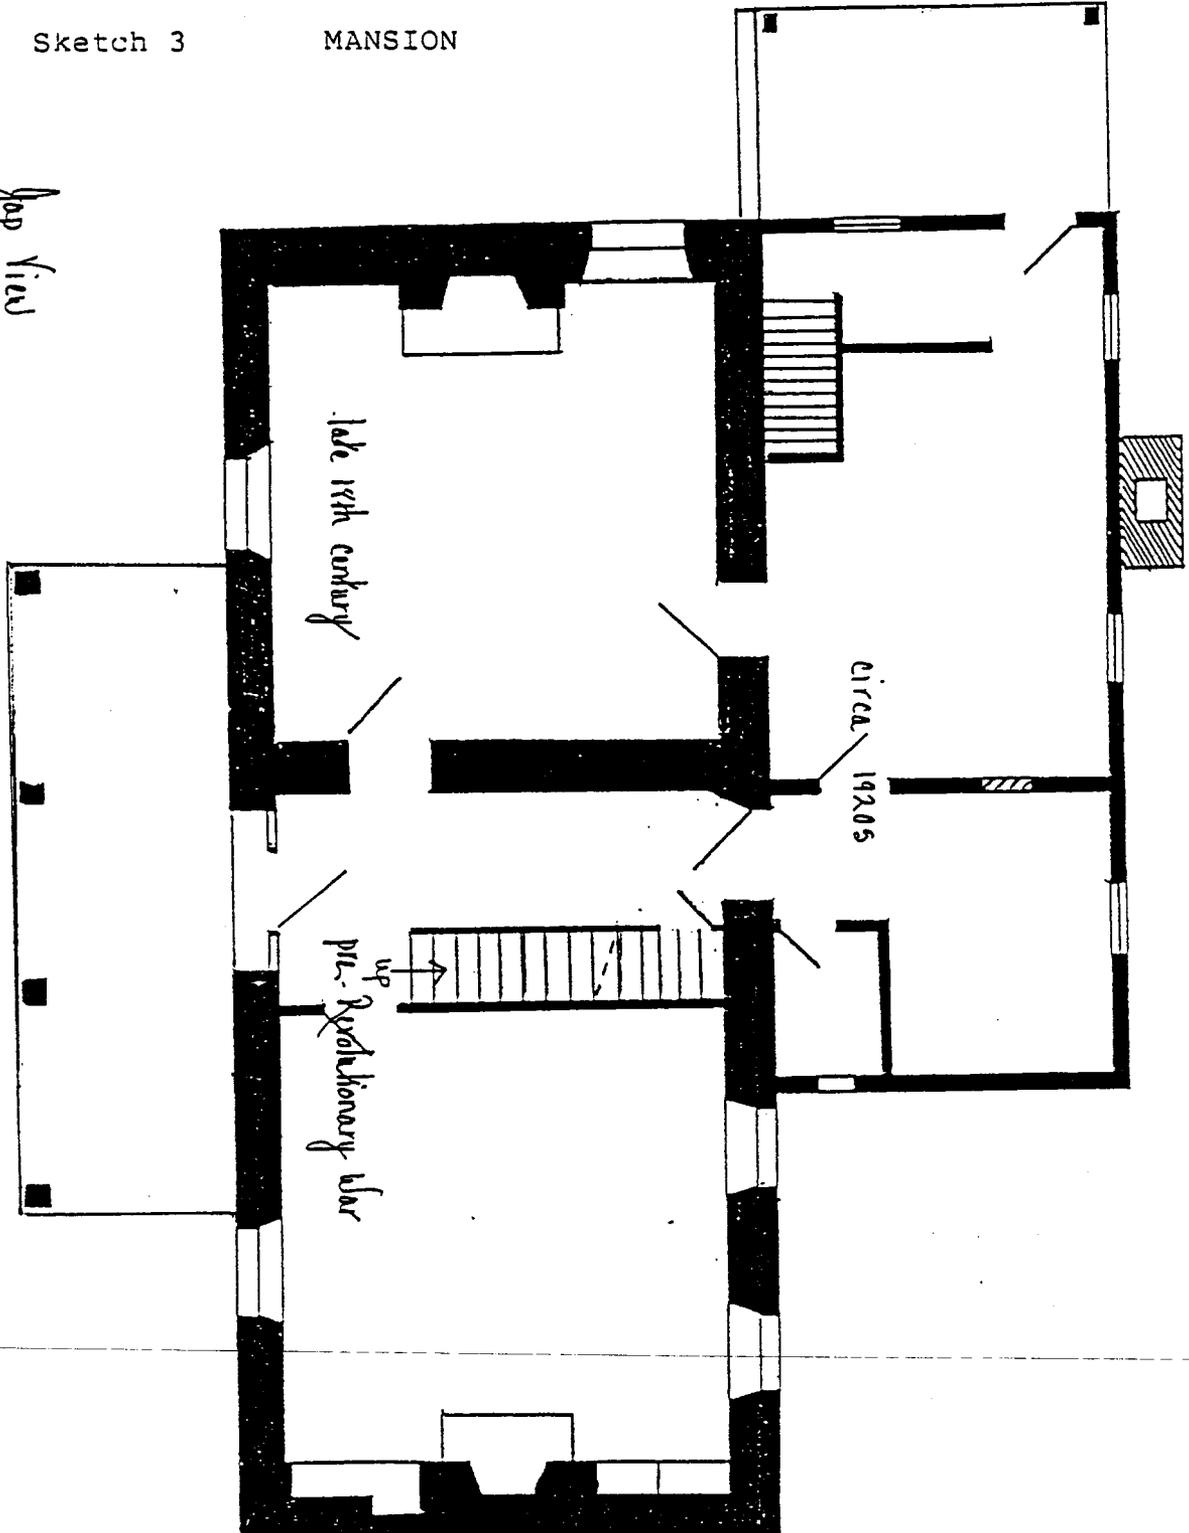
Sketch 3

The center entrance hall ends at the rear addition. On the inside of the original front door is a brass box lock and key. The original stairway on the north wall doubles back to the second floor at a landing. The mahogany balustrade has simple square newell posts, flat handrails and white painted square section balusters. The entrance hall ends at the rear addition. White painted simple panelling is beneath the stairway. The south wall is the original exterior wall of the oldest part of the house. The entrance to the dining room on the south wall has panelled reveals and a heavy fielded panel door. The door to the living room on the north curtain wall is lighter plain panelled door reflecting the earlier period of the house. The baseboards are flat boards with a beaded cap and surround six inch pine floor boards.

The living room also has the six inch pine floor boards that is surrounded by the same baseboard as the hall. On its north wall is centered a fireplace flanked by bookcases with cupboards underneath, a 1955 alteration. The fireplace surrounds and hearth have been rebuilt with brick. The fireplace is capped with the original 18th century wood mantel beneath a large fielded panel flanked by two narrower fielded panels. The chair rail, a mid-20th century alteration, wraps around the room. A center bead cornice was also built at the same time. The windows on the west wall are original with this section. However, the one on the east wall was replaced during the mid-20th century renovation. They all have wide plain wood reveals and the radiator on the east wall is set in the wall directly beneath the window.

The dining room mirrors the living room except the fireplace is flanked by a window and a built-in china cabinet; a mid-20th century alteration. The floor has had a layer of 3 inch oak placed over a 6 inch pine floor. A fireplace has a single fielded panel with dog-ear corners above the mantel. A swinging door on the west wall leads into the kitchen. Both these rooms have 9 foot ceilings.

*Gap View
first floor*

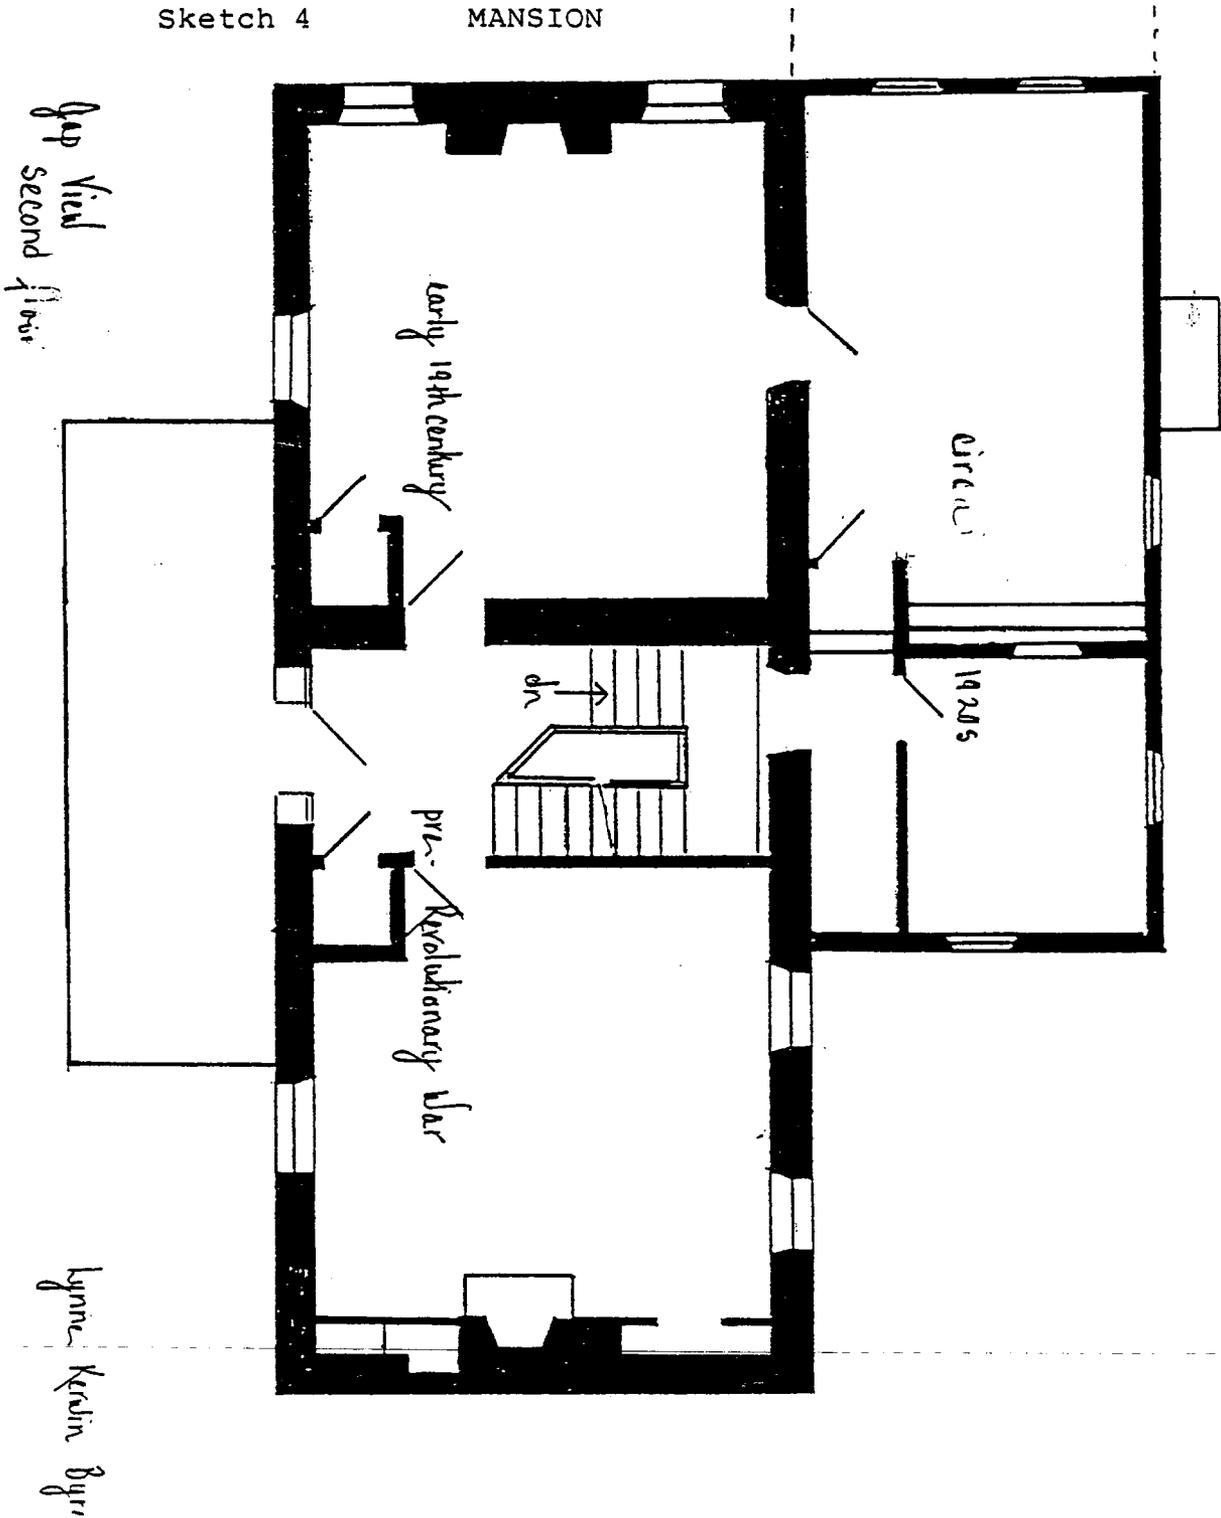
Sketch 4 MANSION

The configuration of the rooms on the second floor are the same as first floor. Ceilings in the older section are lower than those on the first floor. The bedrooms on the second floor of the stone section of the house mirror the placement of doors, fireplaces and windows of the first floor and in turn the bedrooms mirror each other.

However, the north bedroom has shallow closets flanking the fireplace on its north wall. The original one at the east end has its hand carved wooden pegs for hanging clothes. The fireplace has a simple mantel and surrounds are wood supported by engaged square columns capped by a deep cornice. The chair rail's lower edge is beaded and is capped with a beaded edge moulding. Both rooms have 6 inch pine floors surrounded by the same baseboards as the first floor. closets have been added to the north wall of the south bedroom; during the late 20 century.

The center hall at the second floor mirrors the first floor hall. At the landing between the first and second floors is an entrance into a small hall of the rear addition. A closet has been added at the east end and against the north wall. The entrance to the second story porch is at the east end also.

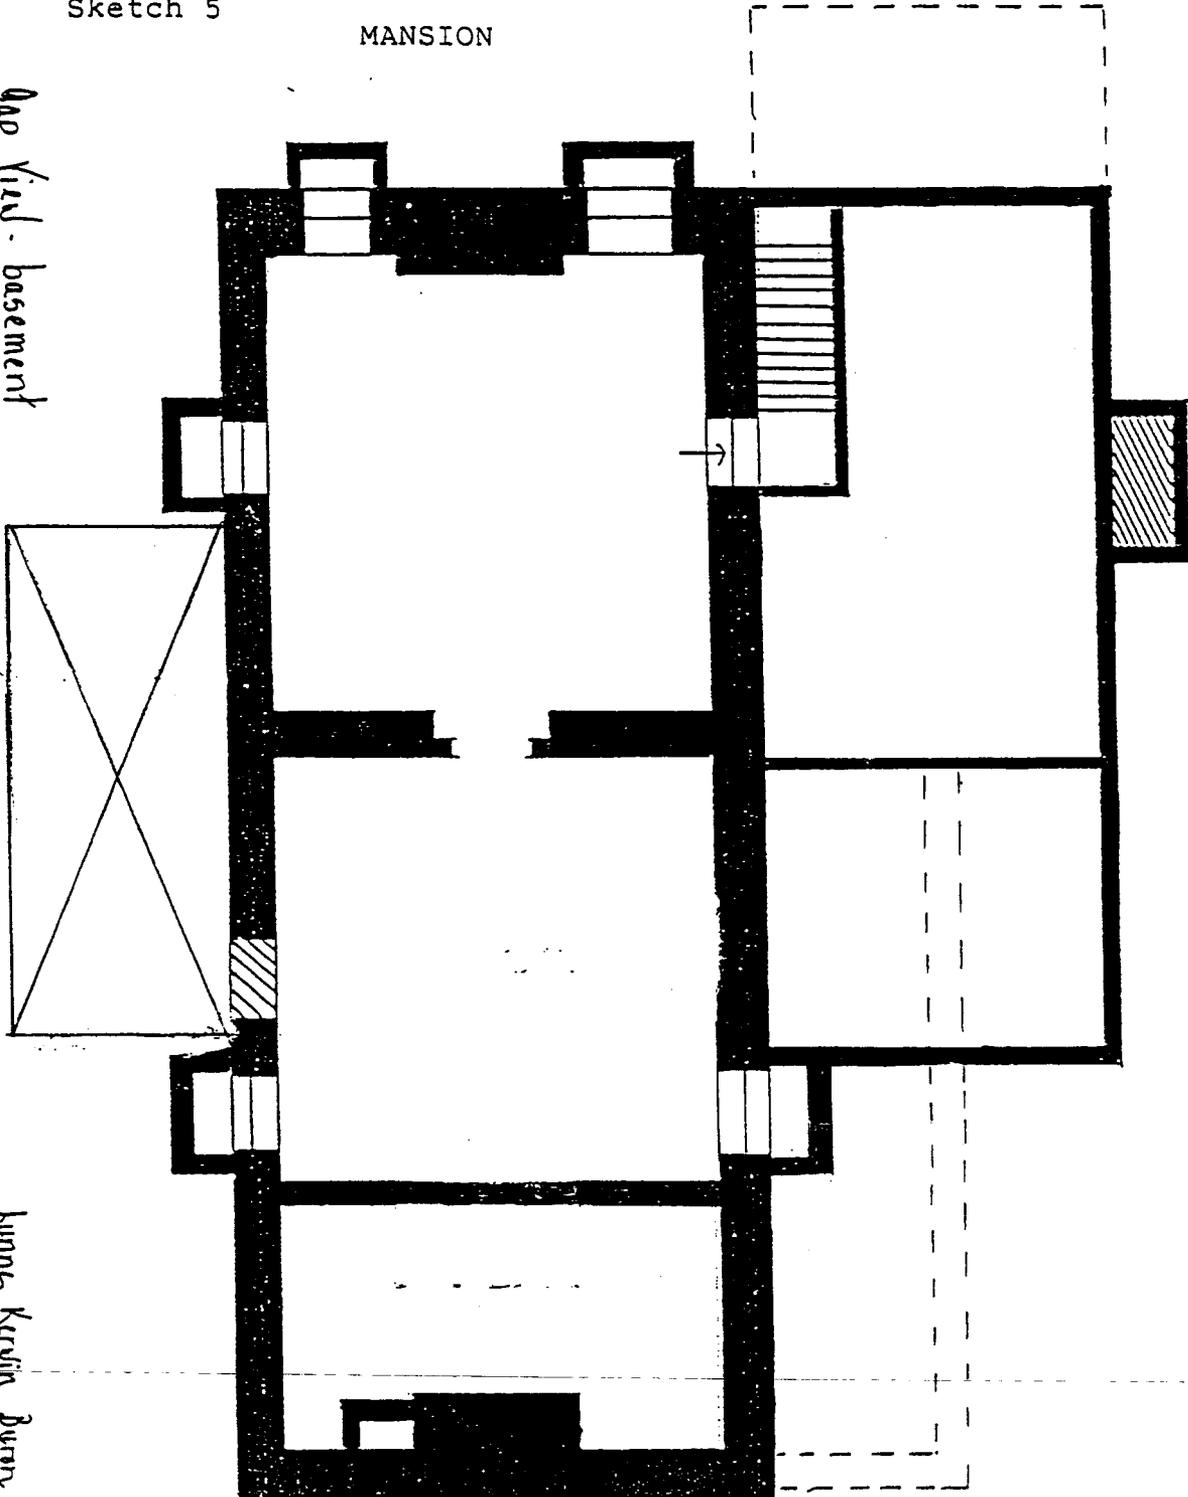
gap view - basement

The house does not have a full basement. The first floor addition, mid-19th century, is evident in the basement as it was extended toward the east beyond the outside wall of the original house. The west end of the basement is a crawl space and was partitioned off with a brick wall. Handhewn logs and beams are joined with wooden pegs.

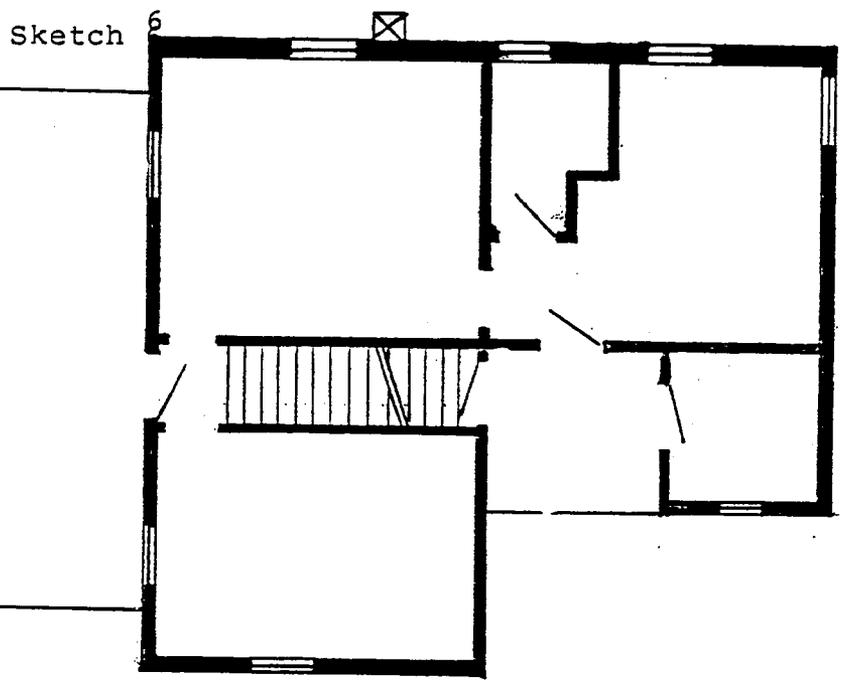
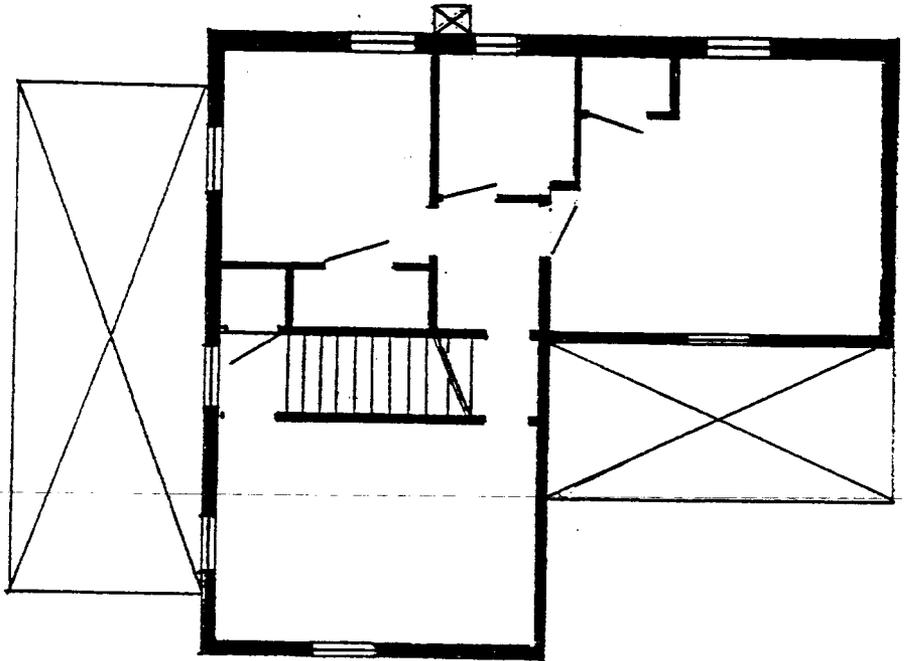
1 tenant house

- 1 Tenant House Contributing Bldg - c. 1937 Photo #3, 4, 26/Sketch #1, 6
Exterior: The L-shaped Colonial Revival style house is situated along the drive leading to the mansion house. It faces south and has an excellent view of the Blue Ridge mountains. It is a three bay wood clapboard gable-end two-story house with a standing seam tin roof and snowbirds at the south elevation only. The foundation is poured concrete. A porch stretches across the front elevation and has a concrete floor and a glass wind-break similar to the one at the main house. The windows are all double-hung 6/6 and are framed with simple flat boards. The exception is the window on the first floor west elevation north of the concrete block chimney. It is a single horizontal light double-hung window.
The two-story ell at the rear or north elevation has an enclosed porch on the east side with doors to the kitchen, a work room and the basement.

Interior: The interior of this tenant house has plaster walls and ceilings with 4 inch yellow pine floors. The surrounds of the doors and windows are simple flat boards. It has no distinctive architectural features which is typical of a farmhand's house of the period.

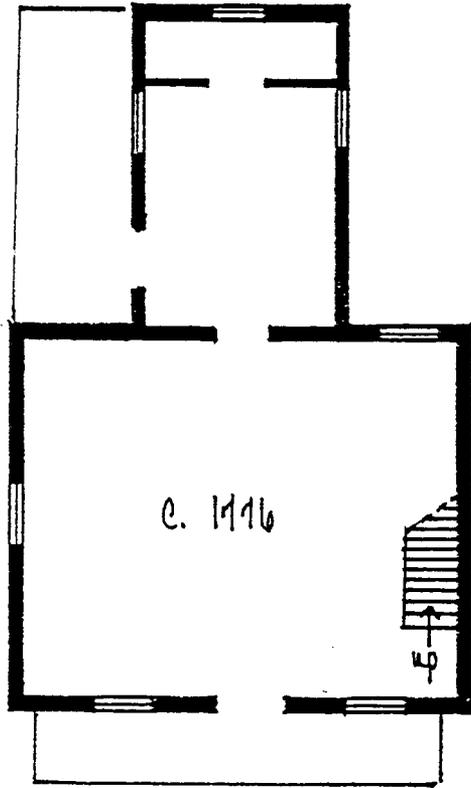
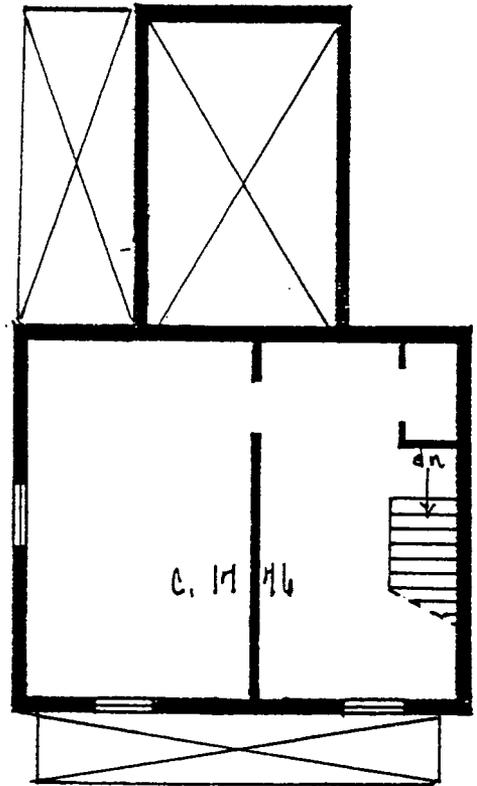
Sketch 7

- 22 Tenant House Contributing Bldg, c. 1776 Photo #30, 31/Sketch #1
Exterior: This two-story three bay stucco covered gable-end log house was originally a two-story single pen and at a later date (unknown) a one-story framed ell was added at its west side. The whole house has a standing seam metal roof. Snowbirds are on the north elevation of the ell roof. A porch stretches the length of the ell on the south side. The building is on a patched stone foundation.
Interior: The living room has an enclosed stairway of simple boards to the second story on its west wall. The single board stair treads are worn with age. At the rear in the ell are the kitchen and a bath. The second floor has two bedrooms over the living room. Random width flooring is visible here. There is a tongue and groove corner closet over the stairway. The rooms were originally heated by stoves. Their chimneys are still in place. All the windows are 6/6 double-hung. The door and window surrounds are simple flat boards.

first floor

#2 tenant house

second floor

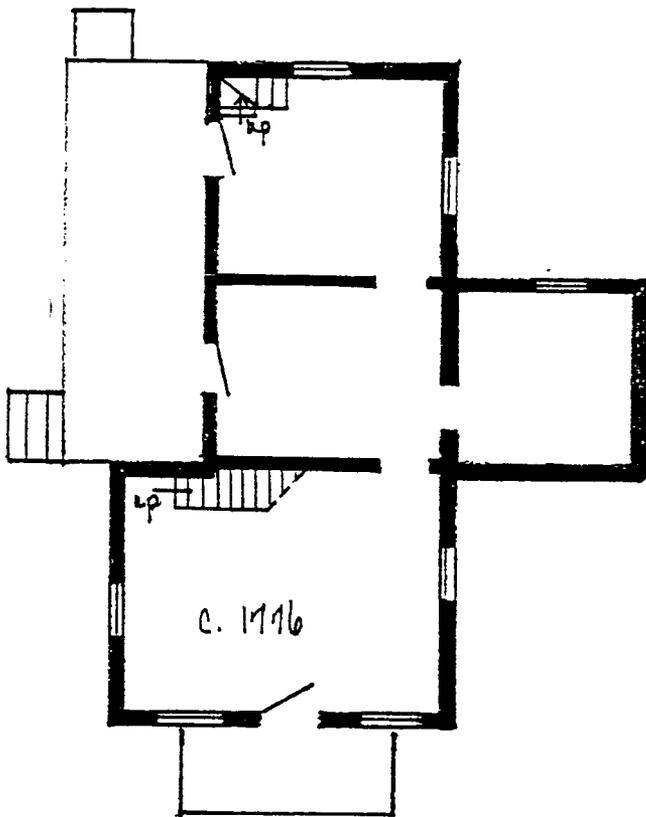
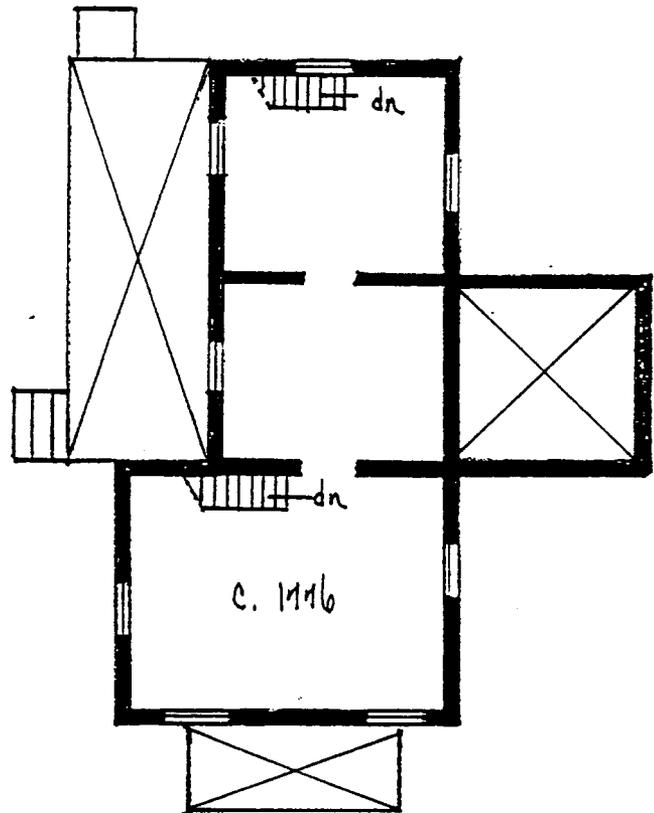
Sketch 8

Exterior: This three bay gable-end two-story log house has German siding and a metal roof. It was built on a stone foundation that has been reinforced with poured concrete. The two-story ell at the south side is of frame construction added at a later date (unknown). The entrance door is of four fielded vertical panels.

Interior: The rooms still have chimneys for heat stoves. The front room on the first floor is the original log house. The dining room and kitchen are in the ell. At the west wall of the middle or dining room is a recent addition for a bath. A curved stairway at the northeast corner of the front living room leads to the original second floor where there are two bedrooms. Above the middle dining room and kitchenware two more rooms. An enclosed stairway at the kitchen south wall leads to the back bedroom. All the window and door surrounds are of simple flat boards.

first floor

second floor
