National Register of Historic Places  
Inventory—Nomination Form

historic Marshall, James, House; "Marshall Hall"; Marshall-Myers-Byron House

and or common "Windward"

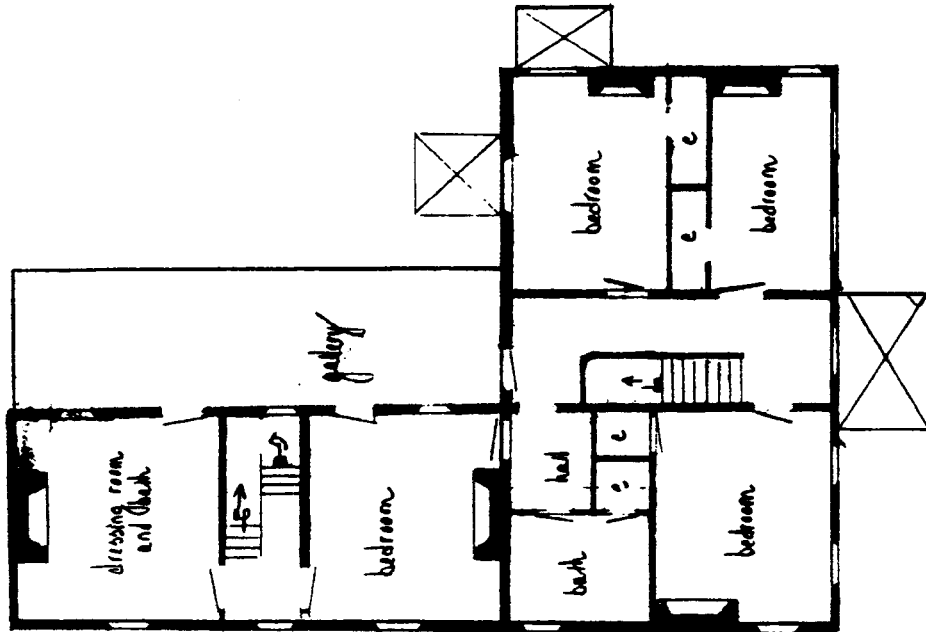
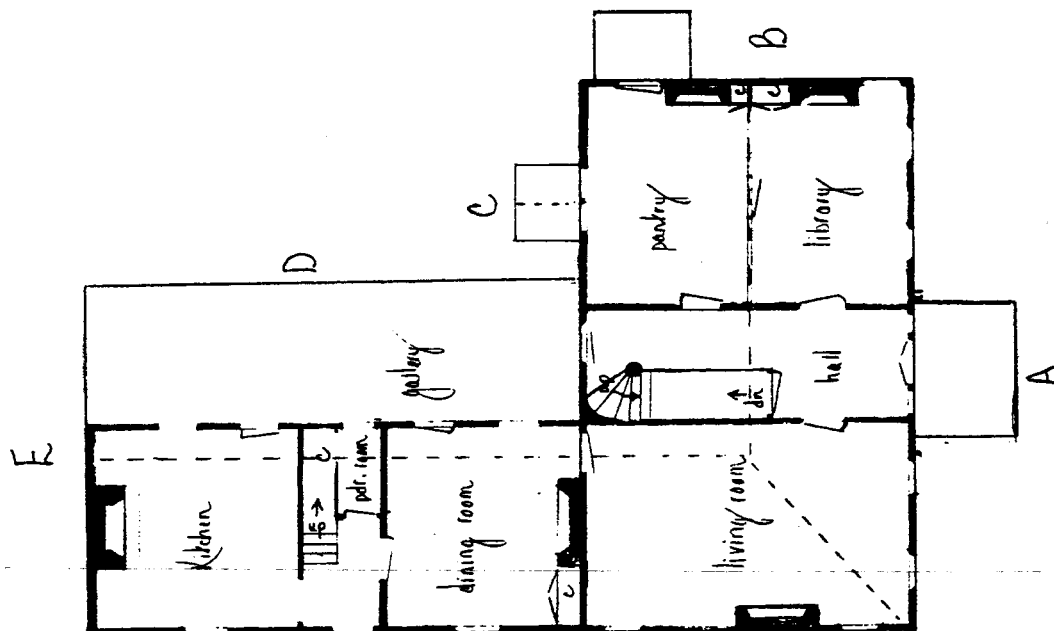
Continuation sheet Description Item number 7 Page 4 of 4

The five bay front facade (A) features a simple one-story Greek Revival-style porch with six squared, splayed wooden columns supporting a pedimented roof covered in slate. A trabeated entrance, a Greek-Revival feature, with double doors opens into the center hall. The doorway's mullions are embellished at the top with acanthus leaves, while the transom and sidelights are of lead and glass. There are four windows of six over six double-hung sash on the first floor, all with formal flat brick arches. Originally there were four small windows in the stone foundation. The two windows to the east of the porch have been filled in with stone that matches the foundation.

In the east elevation of the main section (B) there are one window and a door (formerly a window) on the first floor, two windows on the second floor and two small casement windows in the gable end at the attic level. A chimney rises within the brick wall between the windows. There is neither a brick cornice nor a wooden bargeboard at the junction of the wall and slate roof.

At the first floor level on the north side of the main section (C), the original window has been altered to make a smaller "over the sink" window. On the second floor there is a window resembling those on the east elevation and, within the stone foundation, there are stone steps leading to the basement.

The north end of the wing (E) contains a massive interior chimney rising from the stone foundation. Part of this foundation was removed at ground level to allow for the installation of a wooden and glass-paned double garage door. There are two wooden-framed casement windows located under the roof at the attic level flanking the chimney in the gable end.

Also located under the roof are double-tiered galleries (D) open to the east and north and supported by five squared and splayed wooden columns. These galleries originally rested on stone piers. However, when the galleries were rebuilt during the 1960's, the areas between the piers were filled in with concrete block. The columns and gallery railings were extensively repaired and screens were installed within the last twenty years. Two-tiered galleries are a common, though rapidly disappearing, feature of early West Virginia eastern panhandle houses. The galleries are usually located at the rear elevations within the angle between the main house block and rear ell. Such galleries are found in early 19th-century houses in northern Virginia and western Maryland.

The western elevation, encompassing both the main house and the wing (F), has five windows on both the first and second floors. Those windows in the main block are identical to the windows in the front facade. The remaining windows are nine over six double-hung sash on the first floor and six over six on the second floor. There are five small windows in the stone foundation at the basement level. These windows have contemporary cement sills and the wooden window frames have been replaced with metal frames. All other window sills in the house are walnut and many have recently been repaired with an epoxy resin.

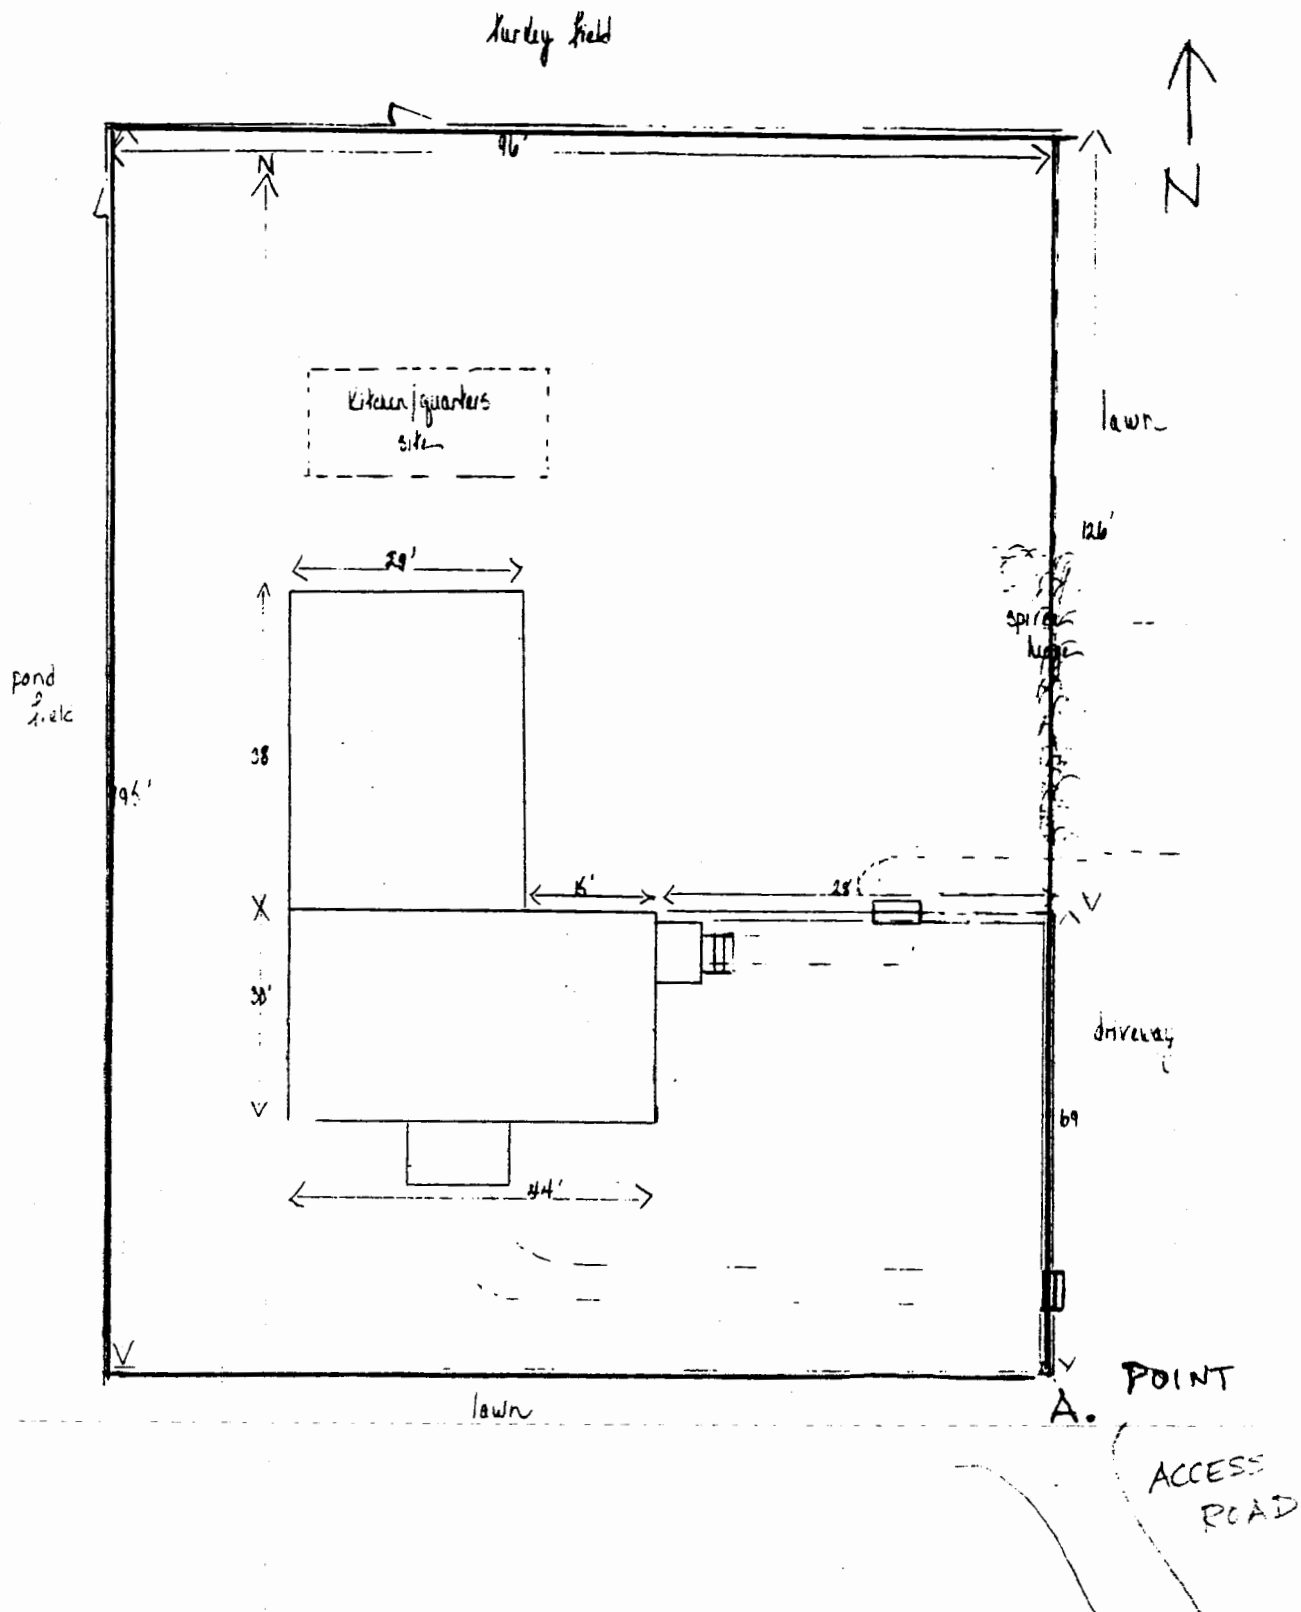
Continuation sheet Geographical Data

The point of beginning is at the terminus of the access road as shown on topo map for the Shepherdstown Quad, W.Va., Point A. The boundary runs northward 195 feet in a straight line, 96 feet westward in a straight line, 195 feet southward in a straight line, thence 96 feet eastward in a straight line to point A, beginning, to form a rectangle. (See red line on sketch map.)

Verbal boundary description and justification Beginning at southeast corner of stone wall, north 195 feet to turkey field fence, west 91 feet to pond field fence, south 195 feet, east 91 feet to point of beginning, approximately one-half acre, encompassing the main house and including kitchen/quarters - possible future archaeological site.
