United States Department of the Interior National Park Service
NATIONAL REGISTER OF HISTORIC PLACES REGISTRATION FORM

historic name: Reeves, John C., House
other name/site number: _____

street & number: 100 Reeves Drive not for publication: N/A
City/town: Wellsburg vicinity: X
state: West Virginia code: WV county: Brooke code: 009 zip code: 26070

Summary

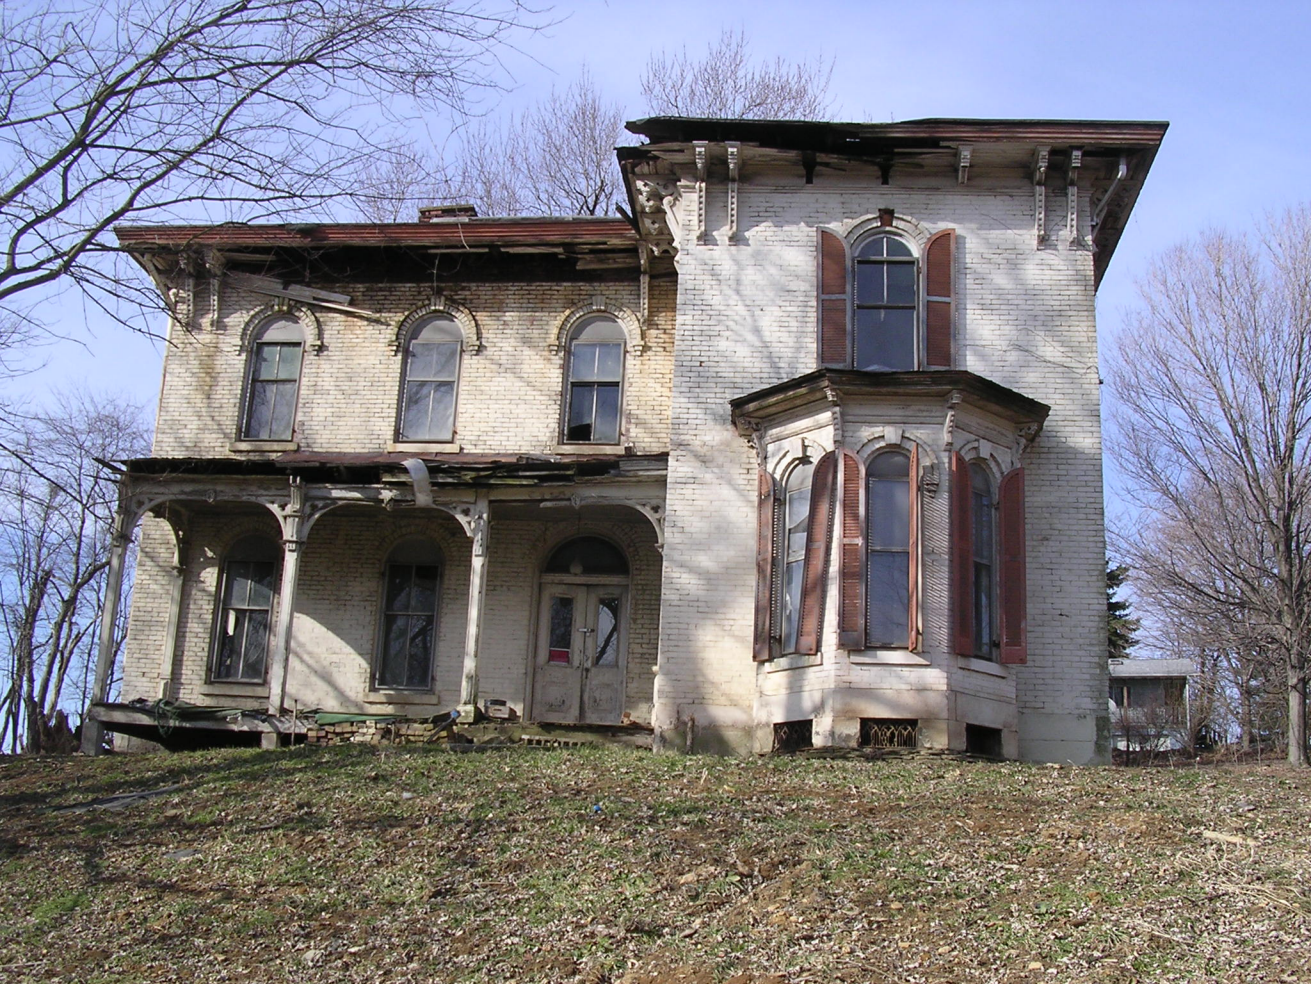
Photo 1 of 8: Main Façade, Camera facing West.

The main façade of the house faces east. The façade is broken into two main divisions, with a one-bay section on the northern half of the façade joined to a three-bay section to the south. The first story of the northern section extends outward from the wall plane of the southern section by about six feet. The most obvious feature of the northern section is a large, three-sided bay window. Each segment of the bay window features a tall and narrow 1/1 double-hung window sash with matching wooden louvered shutters. Each window displays a semi-circular lintel crested with an elaborate corbelled brick hood and

keystone. The sills are plain rectangular limestone blocks. Above the window lintels, the bay terminates in a deep wooden cornice. A wooden bracket is present along the cornice at each angle of the of the bay. Directly above the bay window on the second story there is a wide and tall 1/1 double-hung sash window centered in the façade. Immediately above the second story window is a wooden cornice broken into sections by a series of carved wooden brackets. The brackets are arranged in pairs at the far ends of the façade wall, with three smaller single brackets spaced evenly between the pairs. Two of the single brackets are missing. The first story of the southern section is sheltered beneath a shed-roofed porch that runs from the south wall of the northern section to the south-east corner of the house. Five elaborate porch posts support the roof. Each post displays chamfered corners and large brackets pierced with trefoil openings. The porch roof surface is covered with metal sheets. The main entrance to the house is located in the northern-most bay of the southern section. The entrance is composed of double doors set beneath a semicircular Vaseline glass transom window. The entry is deeply recessed with beautifully paneled reveals. The double doors have windows that extend nearly half the length of the door. To the south of the main entry are located two window bays. Each window is a large, wooden 2/2 double-hung sash that extends almost to the floor of the porch. The second story of the southern section is broken by three evenly spaced window bays. Each of the three windows is a wooden 4/4 double-hung sash with a semi-circular lintel and plain rectangular limestone sills. Each window is crested with a corbelled brick hood and keystone. A wooden cornice and brackets progresses from the south side of the northern section to the north wall of the southern section. The cornice and brackets of the southern section have sustained heavy loss from water damage, with several brackets now missing and large holes evident in the fascia.

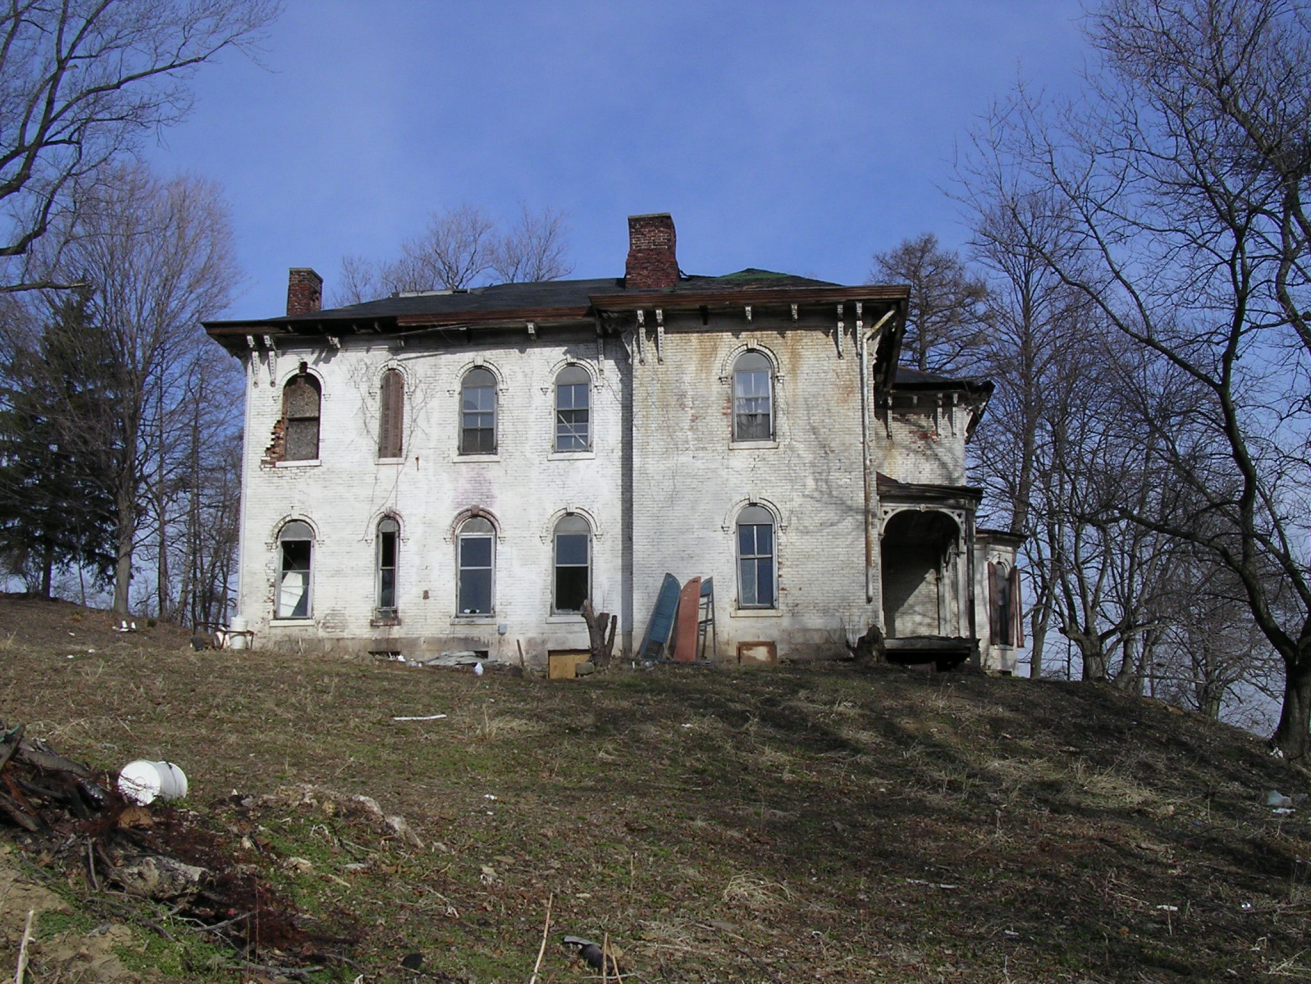
Photo 2 of 8: South Elevation, Camera facing North.

The south side elevation is broken into two major divisions, with a one-bay section located on the eastern half of the elevation joined to a four-bay section to the west. The eastern one-bay section extends outward from the wall plane of the western section by about two feet. Fenestration of the eastern section is limited to two wooden 2/2 double-hung sash centered on the façade and present on the first and second story. Both windows display semi-circular lintels crested by corbelled brick hoods with keystones. Matching wooden louvered shutters exist for these window casements, but are not attached at the

moment. Cornice details match the main elevation. Two sets of paired brackets are present at the outer ends of the cornice, with three smaller single brackets spaced evenly between the paired sets. One of the single brackets is missing from this location. The western four-bay section displays large window openings consistent with the other elevations of the house. Six of the first and second story windows are the standard tall and narrow opening with a semi-circular lintel crested by a corbelled brick hood with keystones. The survival of original window casements in this elevation is limited, with several replacement windows evident, and the window casement in the upper left corner missing entirely. Notable in the western section is a bay of a very narrow, almost slit-like, bay of windows third in line from the edge of the eastern section. The window in this set on the second story retains its original matching wooden louvered shutters. A large and plain brick chimney is visible from this elevation, located roughly in the middle of the house and toward the eastern side.

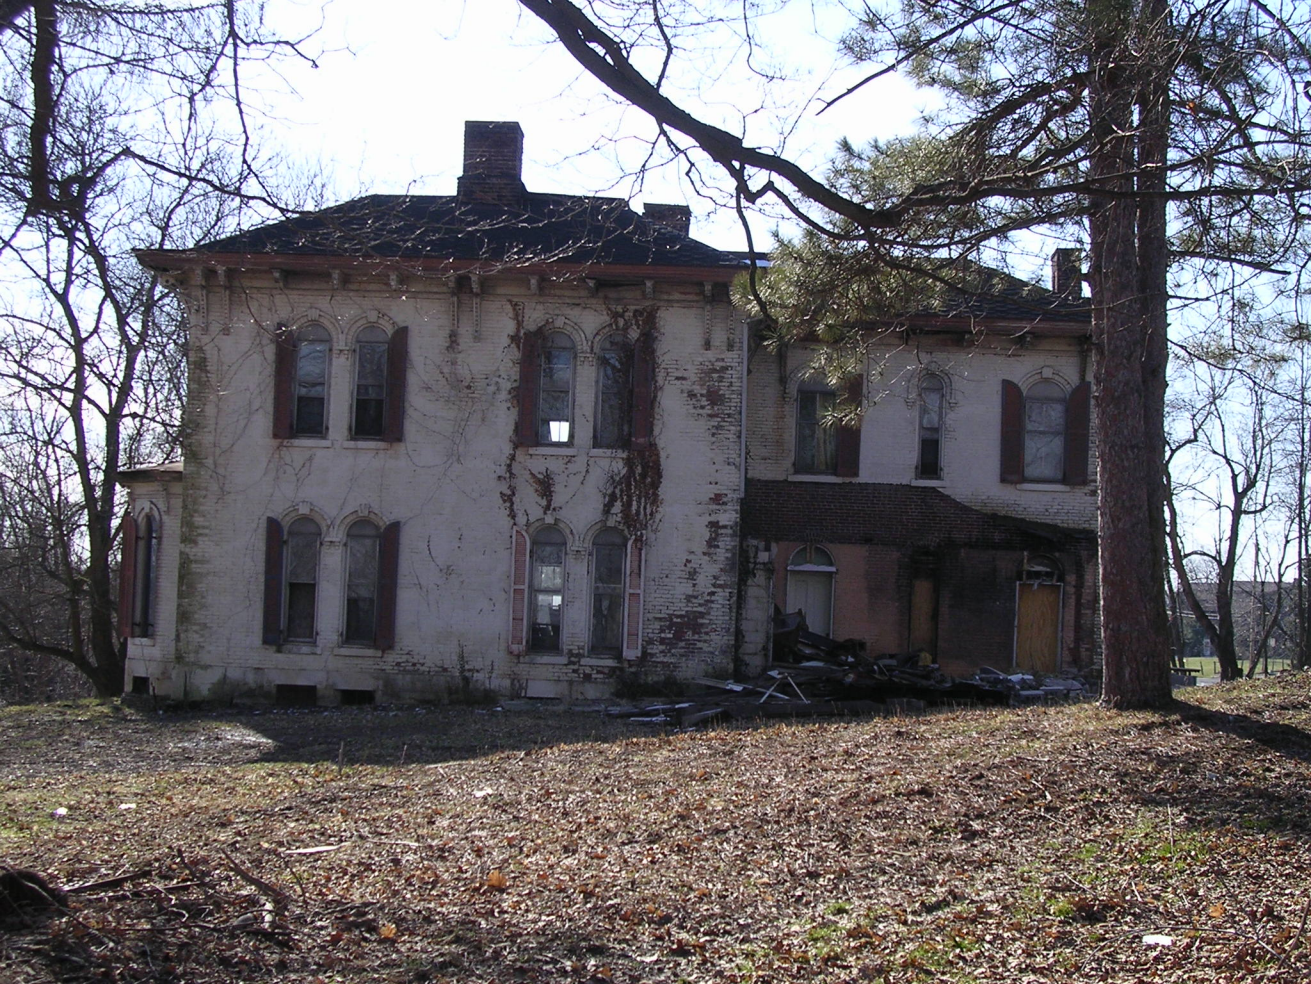
Photo 3 of 8: North Elevation, Camera facing South.

The north side elevation matches the elaborate decorative architectural treatments visible on the main façade, and the south elevation. This elevation is broken into two major divisions, with a large two-bay section to the east, and a smaller, rear three-bay section to the west. The western section once contained a porch within the 90° angle formed at the join of the eastern and western sections (see above). The first story level of the western section displays the now-demolished remains of the porch, including an outline of the original porch roof on the surface of the north wall. The brick in this section shows its natural red color. Three openings are present at the first story level, consisting of two large window openings with a narrow, slit-like window opening between them (identical to the windows of this configuration on the south elevation). The casements are no longer original, and have been temporarily in-filled with plywood. An identical fenestration pattern exists on the second story, with two wooden 2/2 double-hung sash windows with semi-circular lintels flanking a much narrower version between them. Corbelled brick hoods with keystones crest the top of each window opening. The cornice details carry the same appearance and arrangement here as in the rest of the house. Large paired brackets define the outer ends of the cornice with smaller single brackets spaced evenly between them. The eastern section presents a unique fenestration arrangement not found elsewhere on the house. The bays in this section consist of picturesque paired units of tall, narrow wooden 1/1 double-hung sash windows, totaling four pairs. Each window opening is crested with a semi-circular corbelled brick hood with a keystone. Matching wooden louvered shutters exist on the outer edges of each set of paired windows, but the inner shutter leaf is missing on each set. At the cornice level, there are three sets of paired, large brackets. Two define the far ends of the cornice, and a third is spaced evenly between them. Six small single brackets complete the installation. A large brick chimney is visible at the crest of the roofline.

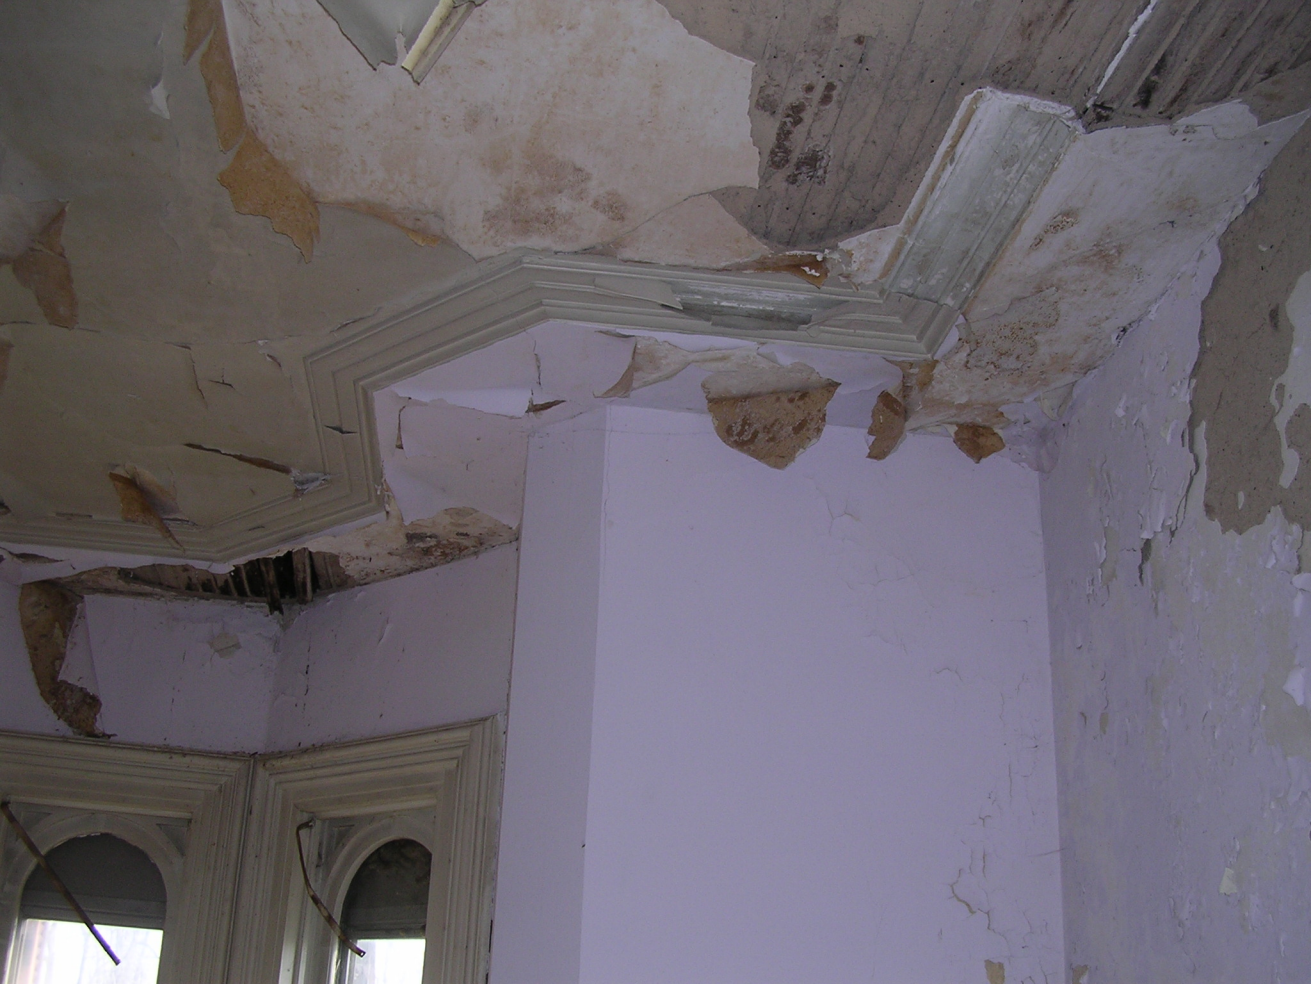
Photo 8 of 8: Main Parlor Ceiling, Showing Water Damage and Remaining Plaster Work.
