United States Department of the Interior National Park Service
NATIONAL REGISTER OF HISTORIC PLACES REGISTRATION
FORM

historic name: Rees, Morris III House

other name/site number: George McKown House; Springvale

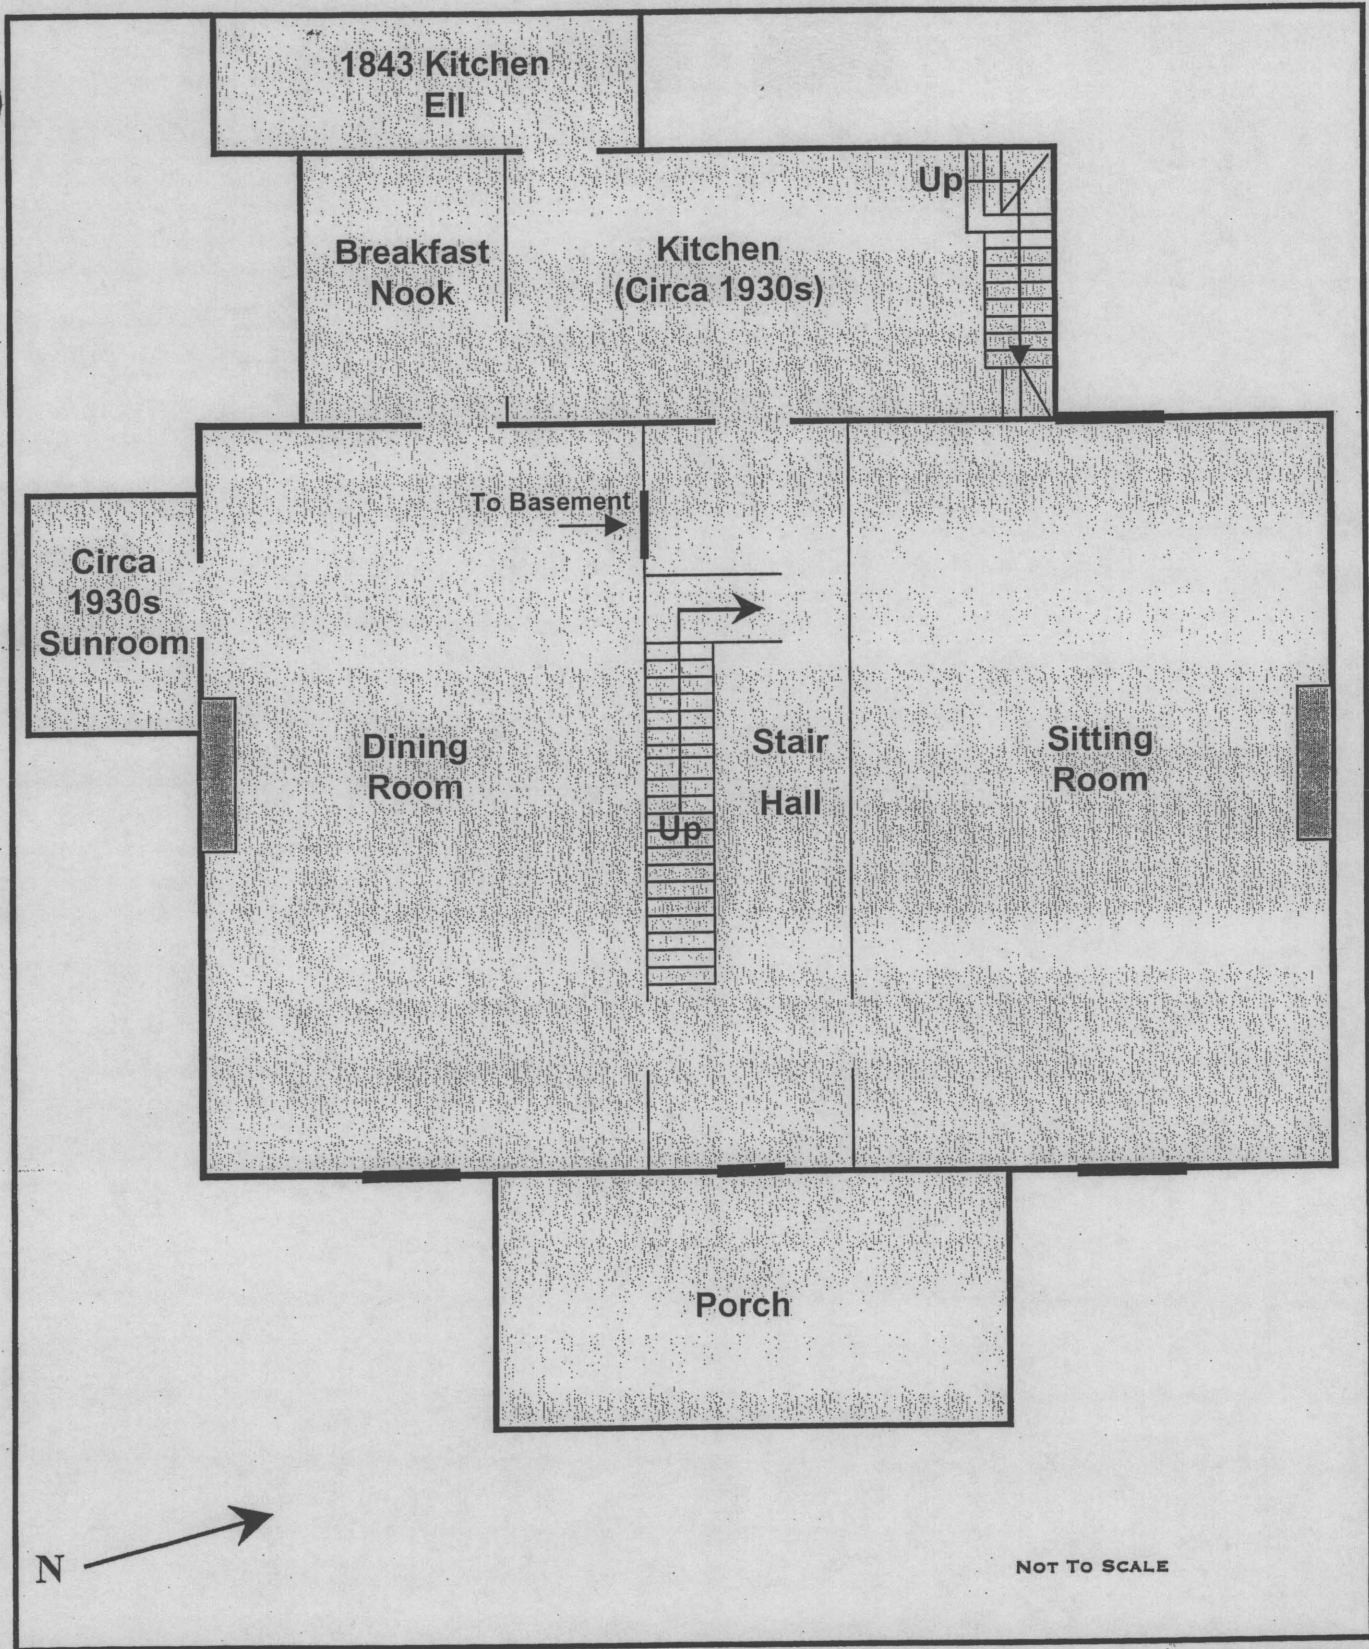
FIGURE

**1ST FLOOR PLAN, MORRIS REES III HOUSE,
GERRARDSTOWN VICINITY, BERKELEY
COUNTY, WEST VIRGINIA**

The Morris Rees III House interior consists of finished living space on the first and second floors, along with an unfinished cellar and an unfinished attic. The first and second floor plans of the main block feature a center-hall, single-pile plan, with a single room on either side of the center stair hall. The 2-story frame hyphen features two rooms on each floor, separated by an enclosed staircase. The 1-story brick kitchen contains two rooms, with an exterior entrance on the south end.

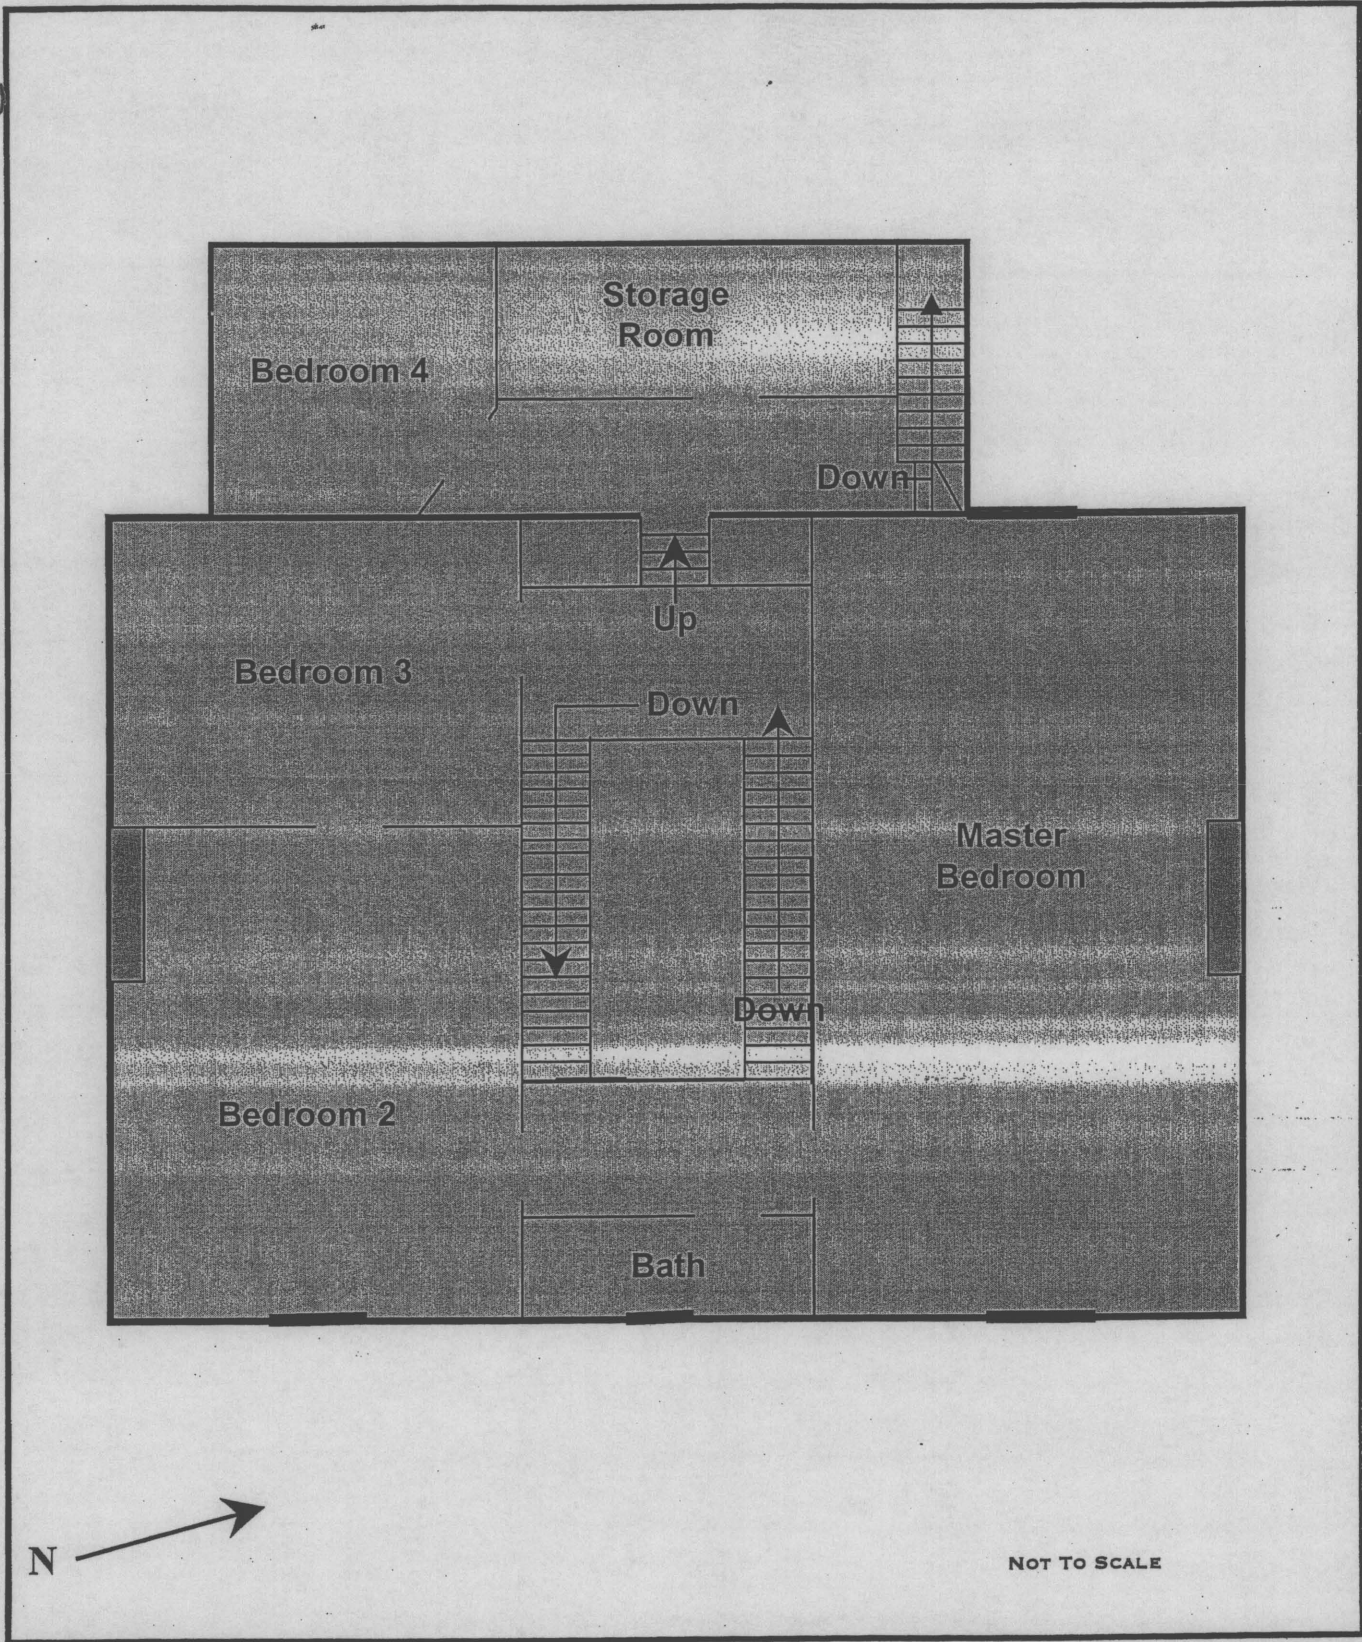
FIGURE
2ND FLOOR PLAN, MORRIS REES III
HOUSE, GERRARDSTOWN VICINITY,
BERKELEY COUNTY, WEST VIRGINIA

The second bedroom, which has a dividing wall, is on the south end of the second floor, and has a grained door as found elsewhere. The moldings and chair rail in this room are Federal style, and the splayed window reveals are paneled. The mantelpiece of this room is located on the south wall, and has fluted pilasters and a plain frieze, as well as a molded mantel shelf. The hearth has a plain molding strip. There are two built-in closets in this room. These have 6-panel doors.

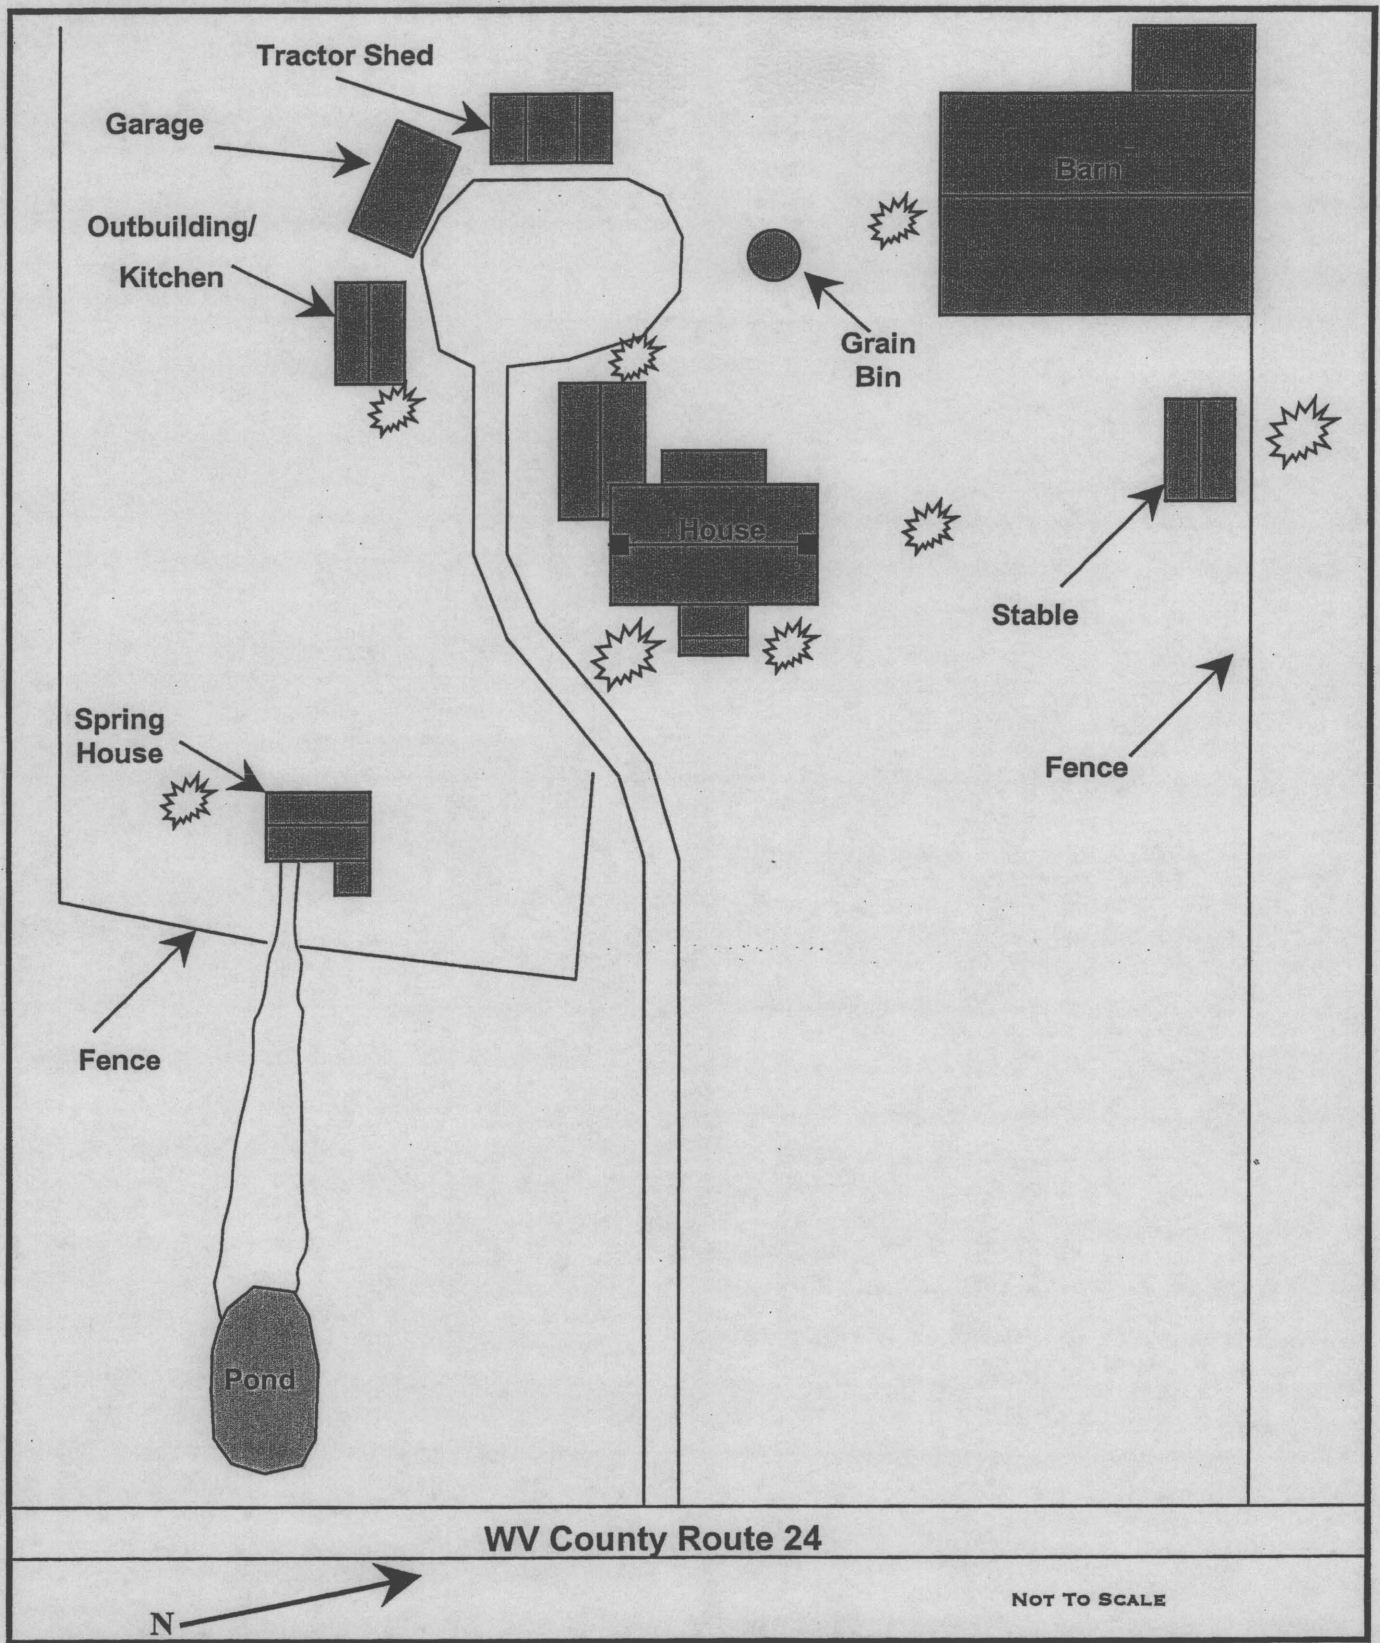
FIGURE

**SKETCH PLAN, MORRIS REES III HOUSE,
GERRARDSTOWN VICINITY, BERKELEY
COUNTY, WEST VIRGINIA**

The Morris Rees III House property contains seven contributing buildings: the main house, a frame tractor shed, a frame kitchen/living quarters, a frame stable, a barn, a stone spring house and a cinder block garage; and one contributing structure: a metal grain bin.
