# National Register of Historic Places Registration Form

historic name National Bank of Davis

street & number 417 William Avenue

The National Bank of Davis is a nine-bay Richardsonian Romanesque building with wood bracketed eaves and decorative frieze set beneath a hipped roof (Photo 1). Constructed in two phases - in 1892 and 1915 - the building maintains a generally consistent exterior appearance, however, differences in construction techniques and materials typical of these construction periods are evident from the interior and rear of the building. Exterior walls are largely finished in random ashlar sandstone, with some secondary elevations finished with exposed or parged brick masonry. Double-hung wood windows, set in half-round arches at the first and third stories, are present throughout the building, along with stone headers and sills. The east and west wings are set beneath hipped roofs bridged by a side-gabled hyphen. This A combination hipped and side-gabled roof, recently sheathed with copper-painted standing seam metal, rests on bracketed wood eaves with a decorative frieze. The first-story storefront facing William Avenue maintains much of its historic fabric desp

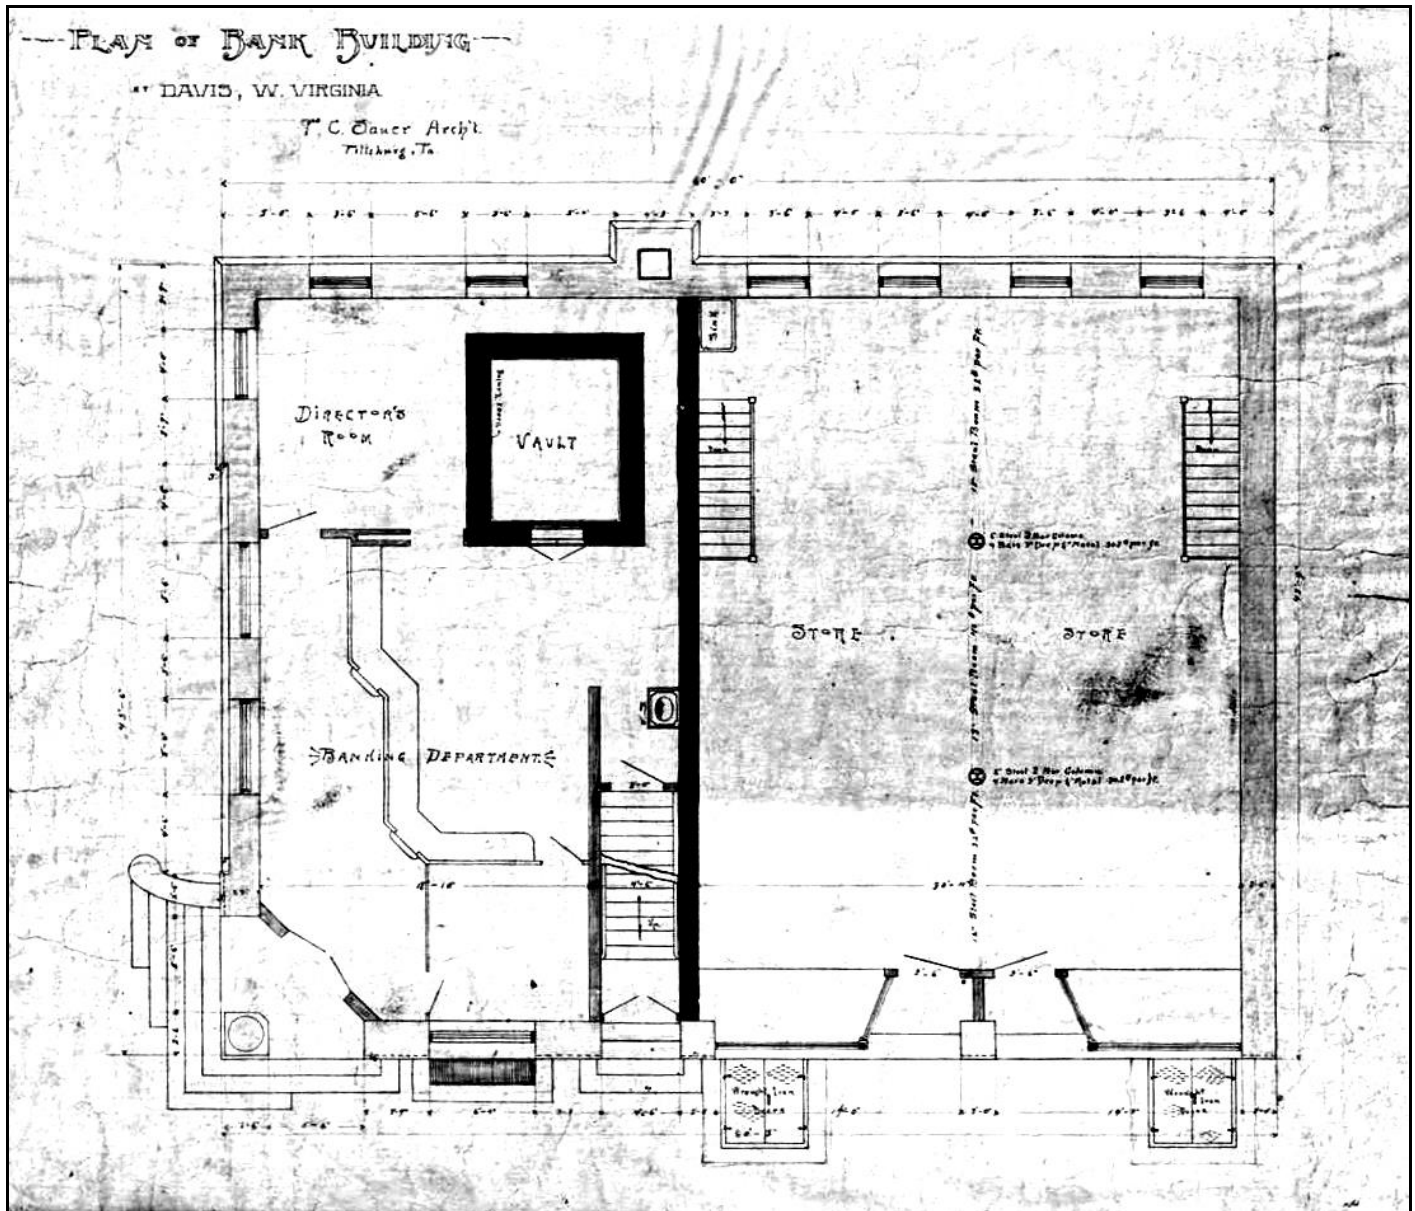
Figure 1. National Bank of Davis, 1892, First floor plan, inverted from original scan. Courtesy William Peterson (owner)

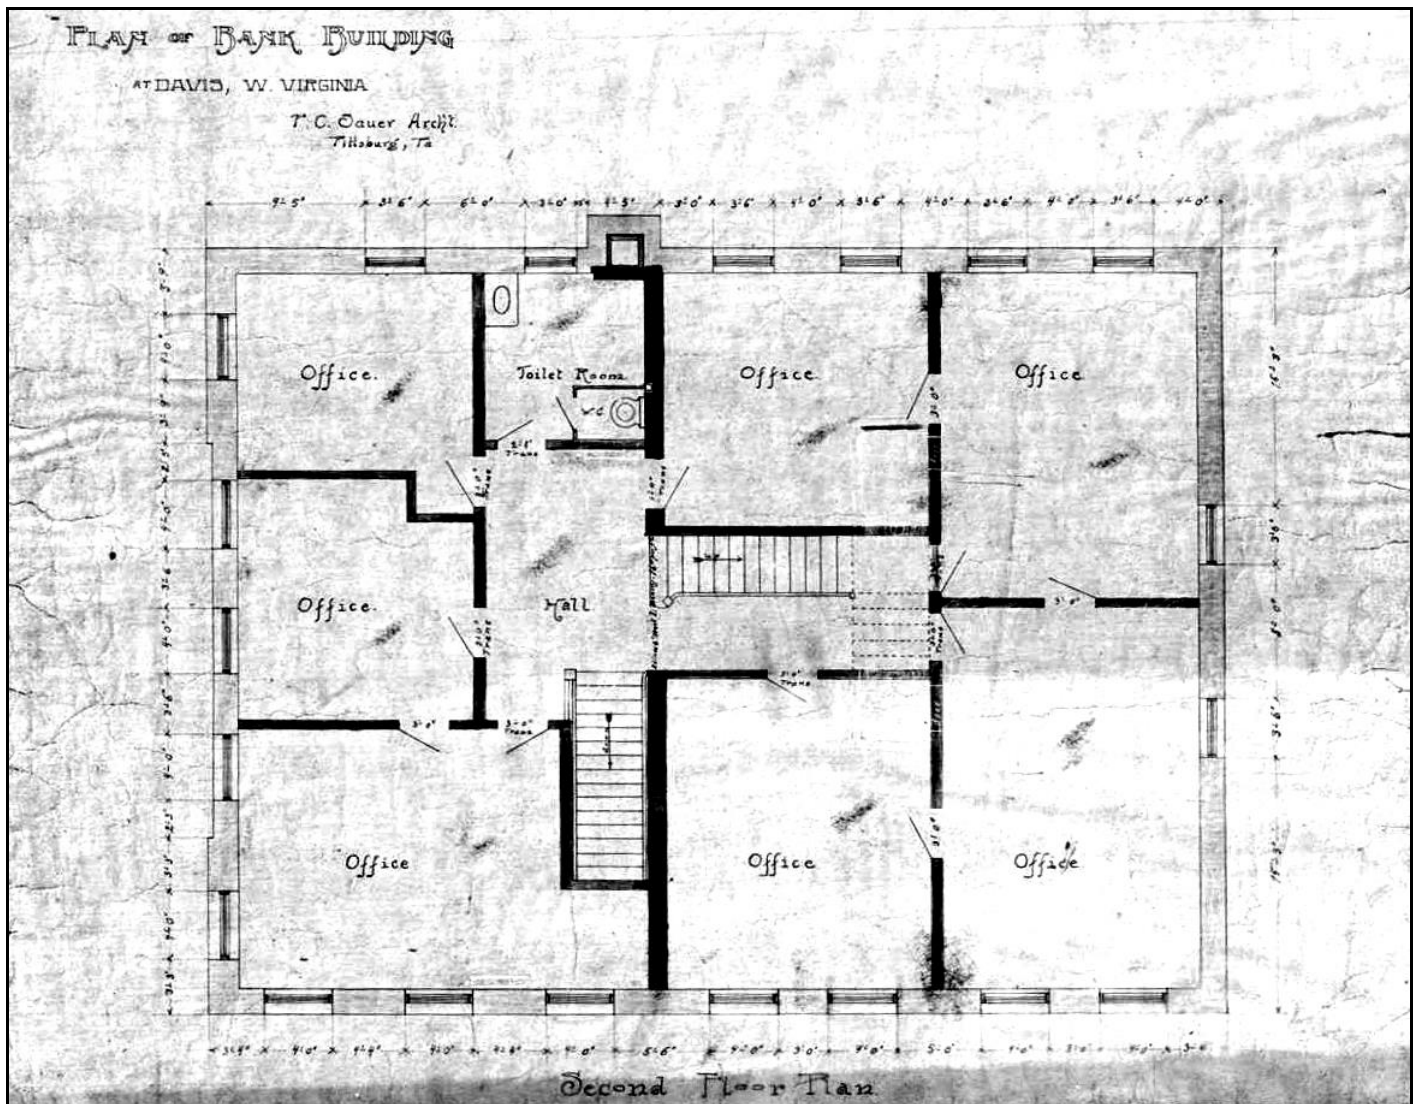
Figure 2. National Bank of Davis, 1892, Second floor plan, inverted from original scan. Courtesy William Peterson (owner)

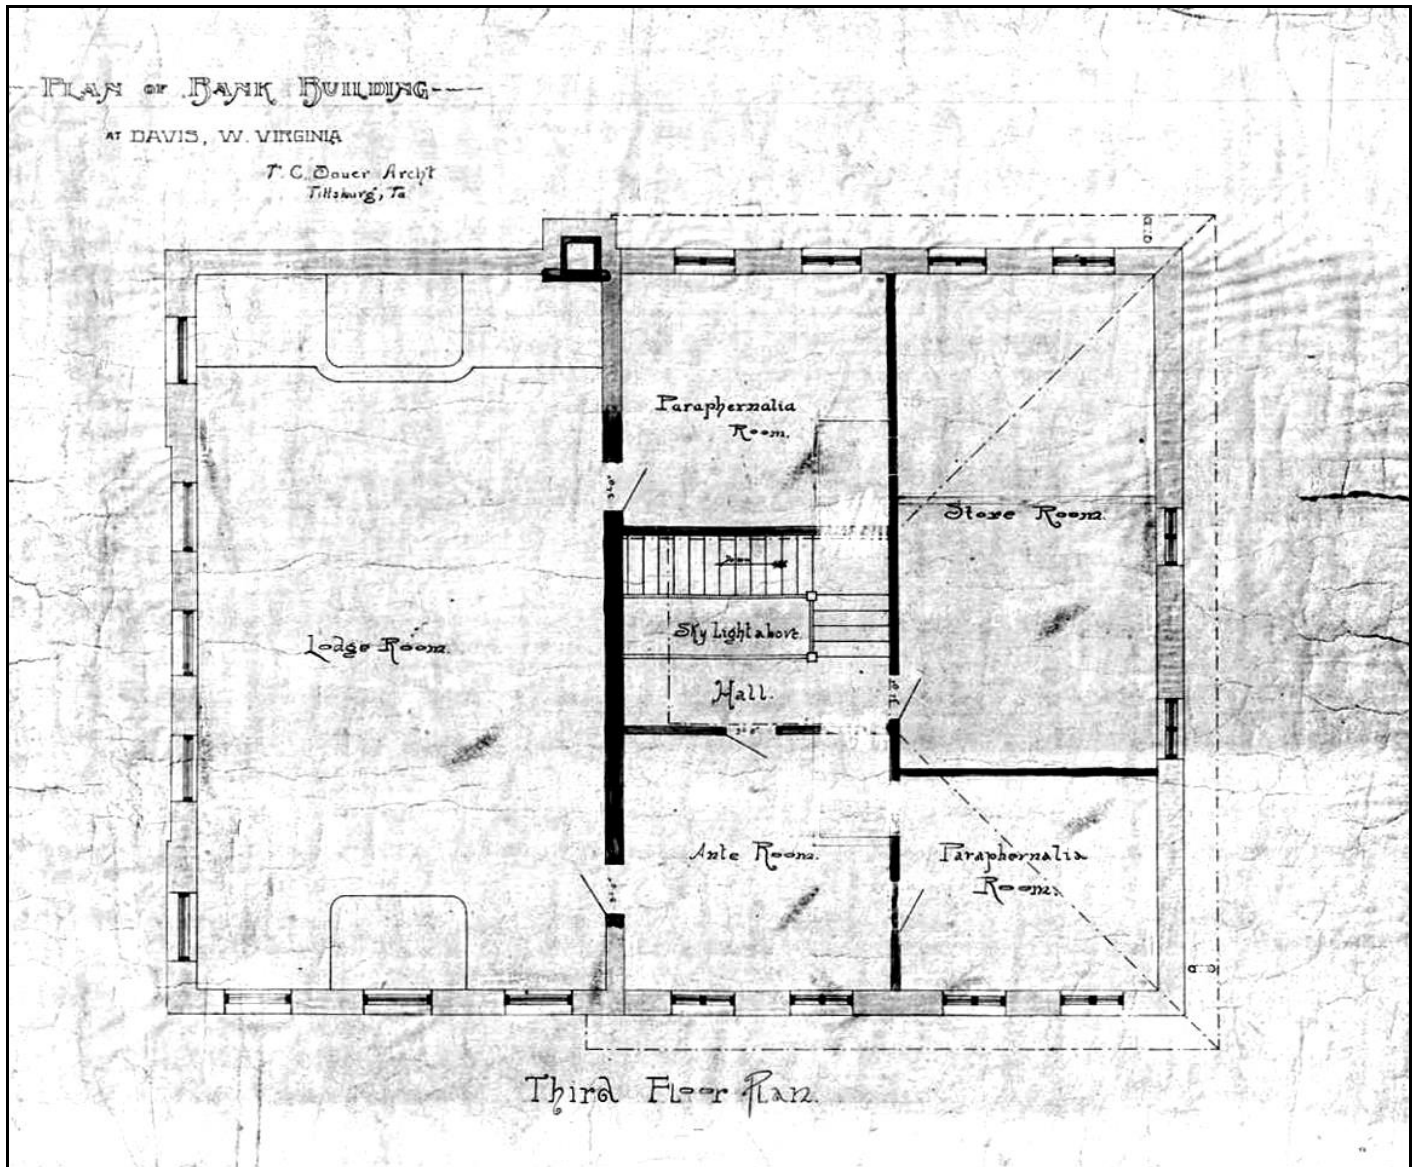
Figure 3. National Bank of Davis, 1892, Third floor plan, inverted from original scan. Courtesy William Peterson (owner)

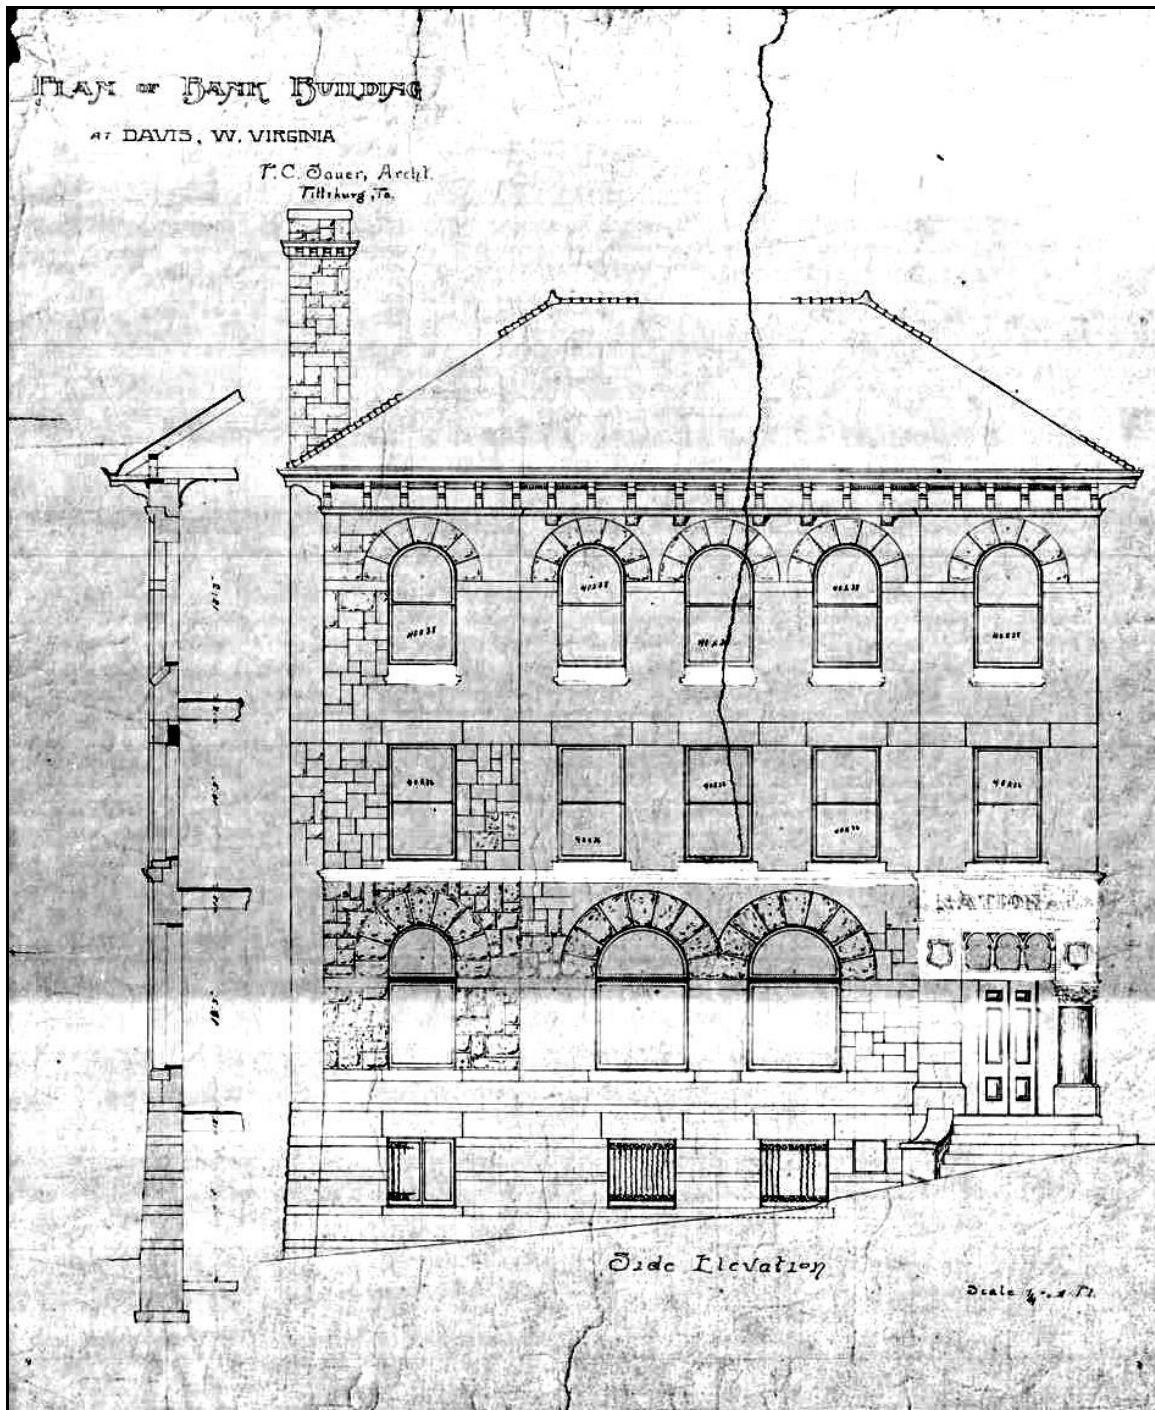
Figure 4. National Bank of Davis, 1892, East elevation drawing, inverted from original scan. Courtesy William Peterson (owner)

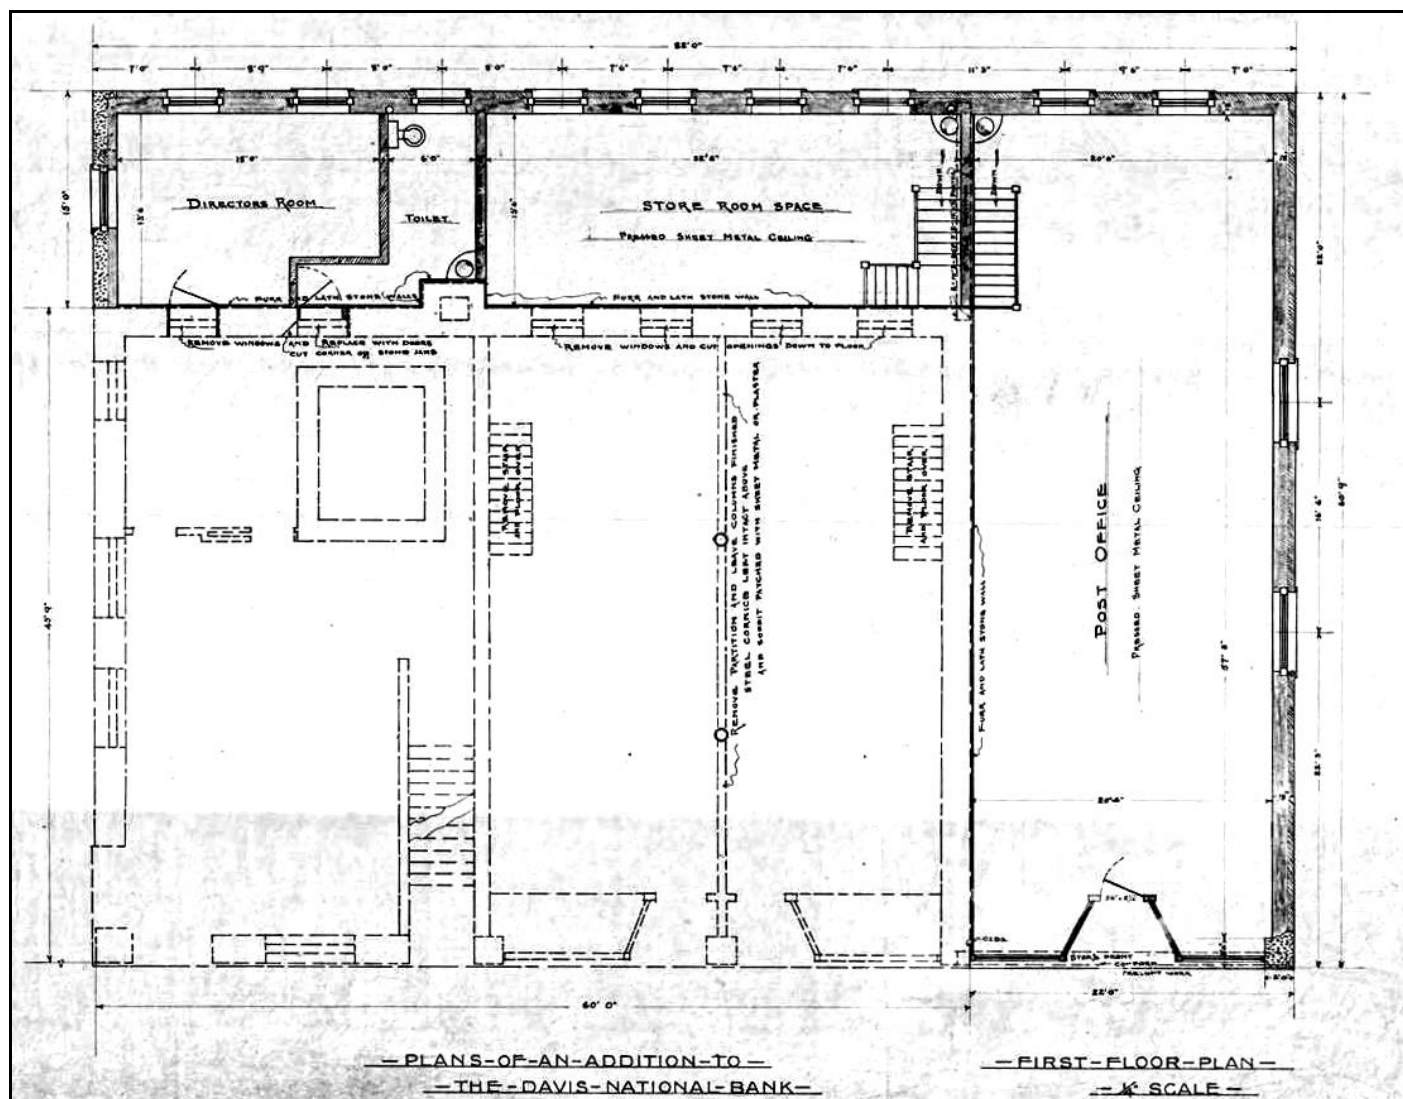
Figure 5. National Bank of Davis, 1915, First floor plan, inverted from original scan. Courtesy William Peterson (owner)

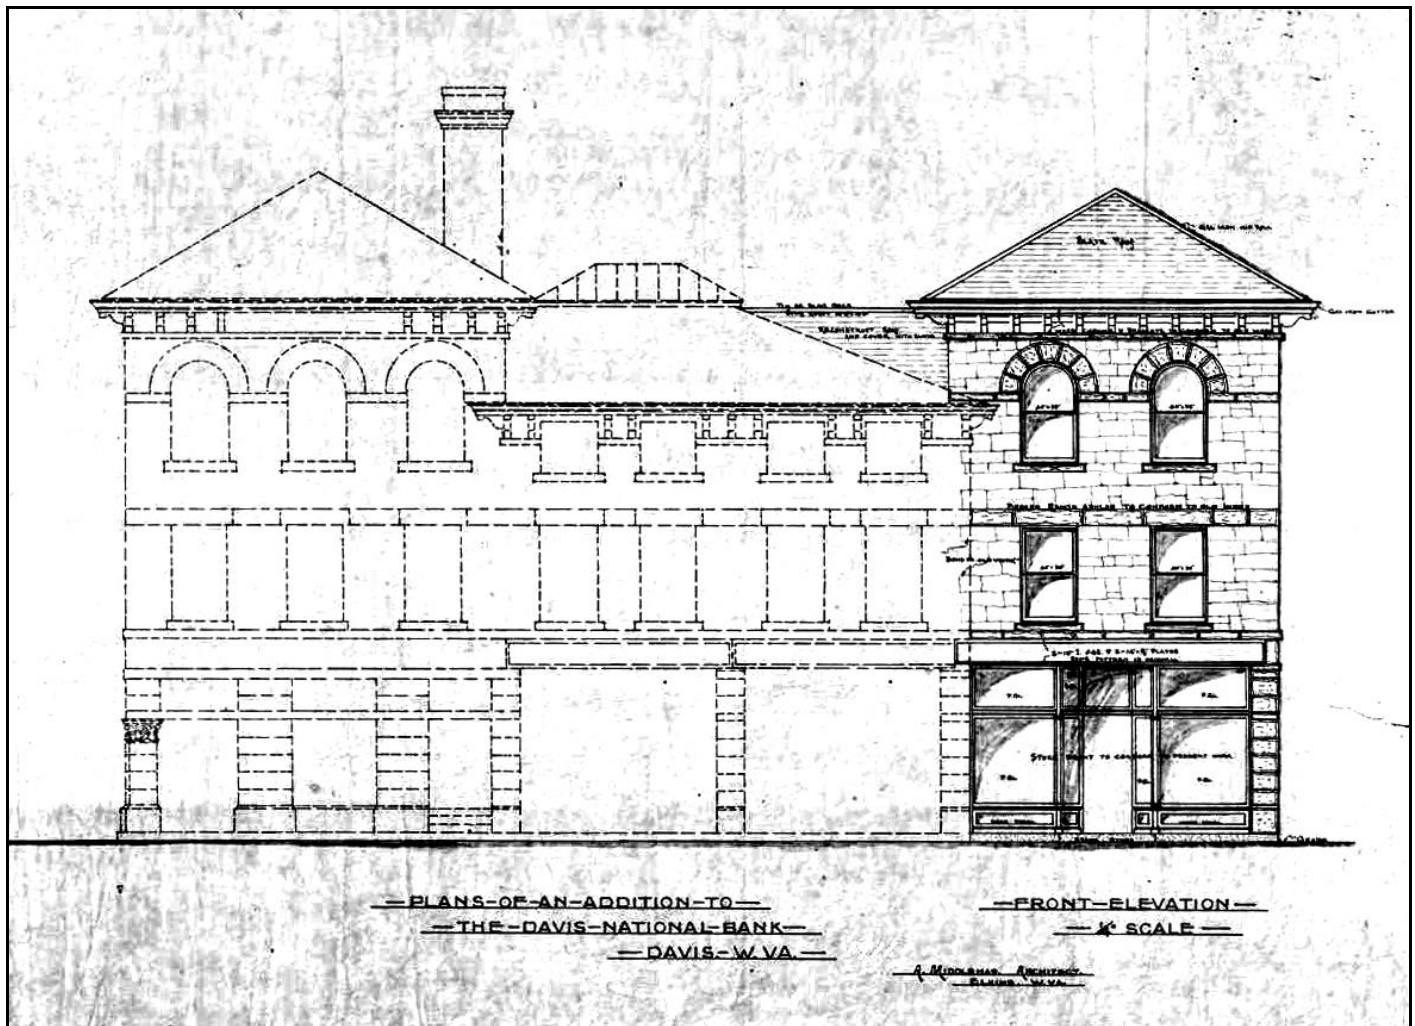
Figure 6. National Bank of Davis, 1915, North elevation drawing, inverted from original scan. Courtesy William Peterson (owner)

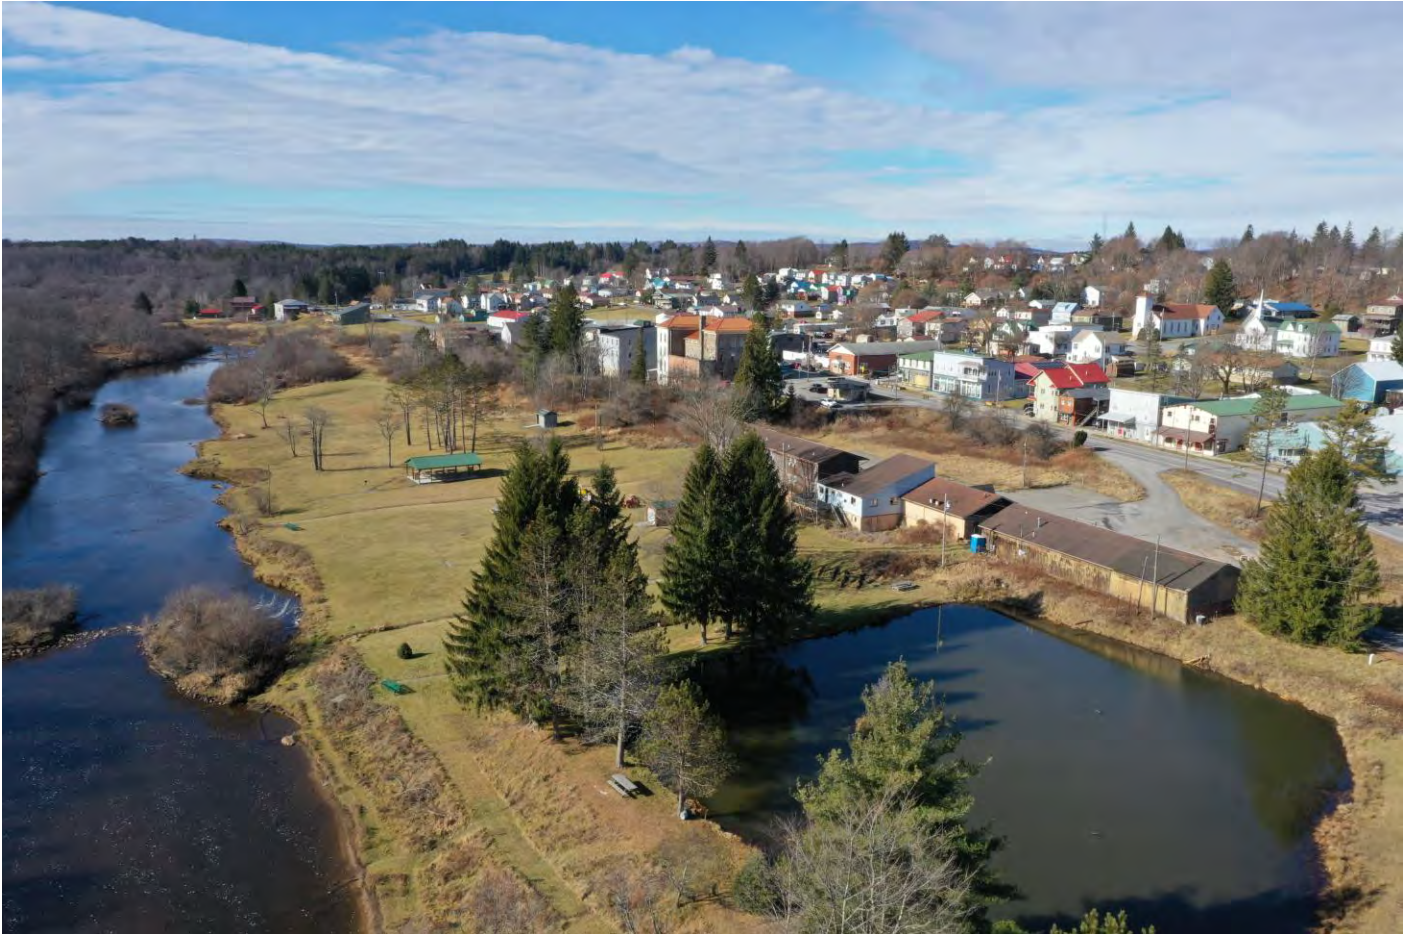
*Photo 1. Town of Davis with National Bank of Davis at center, facing northwest.*

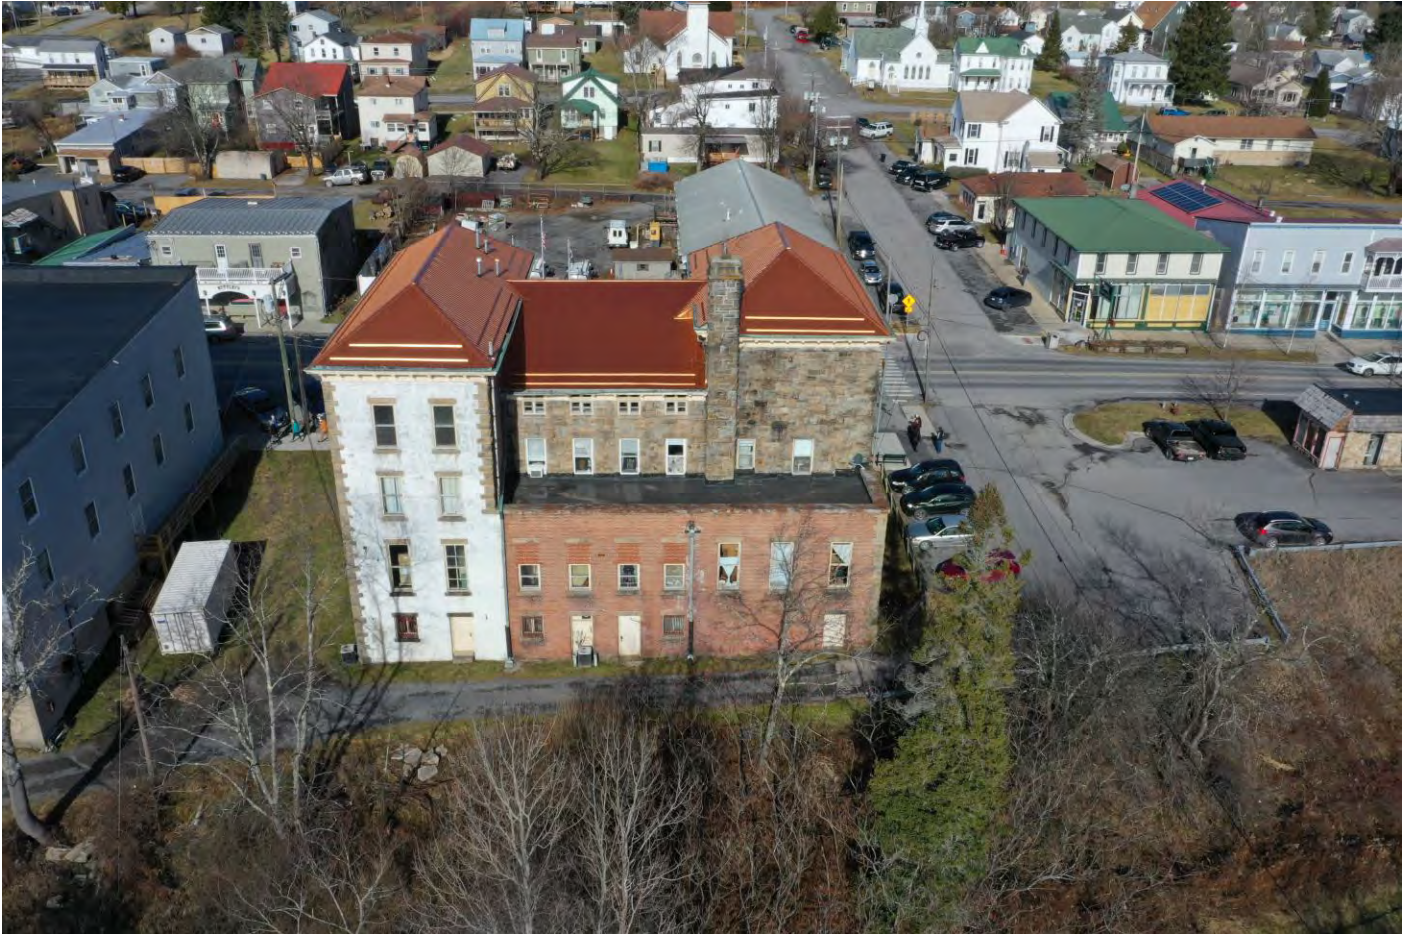
*Photo 4. South elevation and adjacent former drive-up building, facing north.*

Windows and exterior doors throughout the building are wood, except in the case of some modern aluminum or vinyl replacements. Six square wood casement windows open to the basement story, which is also accessible via four single-leaf wood doors along the south elevation. Exterior iron bars with decorative scrolls are set in all basement window openings. First-story windows at the south elevation are double-hung wood; four windows at the central section have been reduced in size and the upper thirds infilled with brick masonry, with original stone headers still in place (see Photo 4).

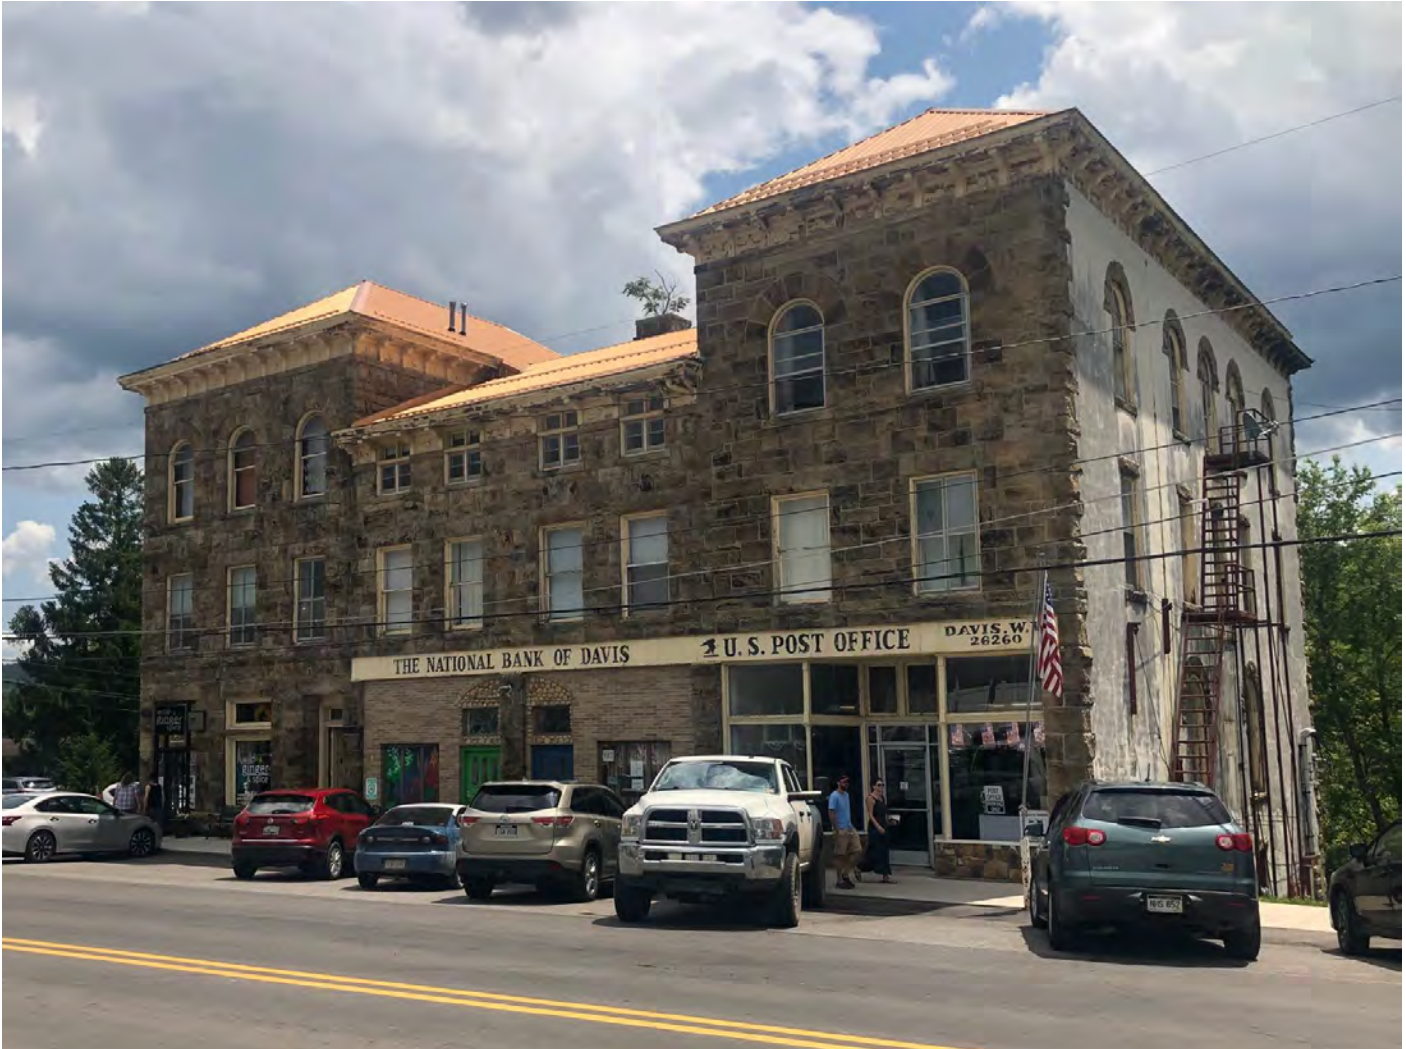
*Photo 6. Overview of building from William Avenue, facing southeast.*

All windows at the second story are wood double-hung. At the third story, half-round arched wood double-hung windows are present on the east and west elevations; however, at the west elevation, the three southernmost windows have been replaced with standard vinyl double-hung windows set beneath arched openings infilled with wood panels painted to match eaves (Photo 9). The northernmost two windows on the west elevation, third story, have divided lights in the upper sashes. The third-story windows on the southern elevation are rectangular and do not have arched tops. Windows opening to the half-story within the central portion of the building, both on the north and south elevations, are paired wood double-hung set beneath two-pane transoms that punctuate the wood frieze band beneath the bracketed eaves (see Photo 6).

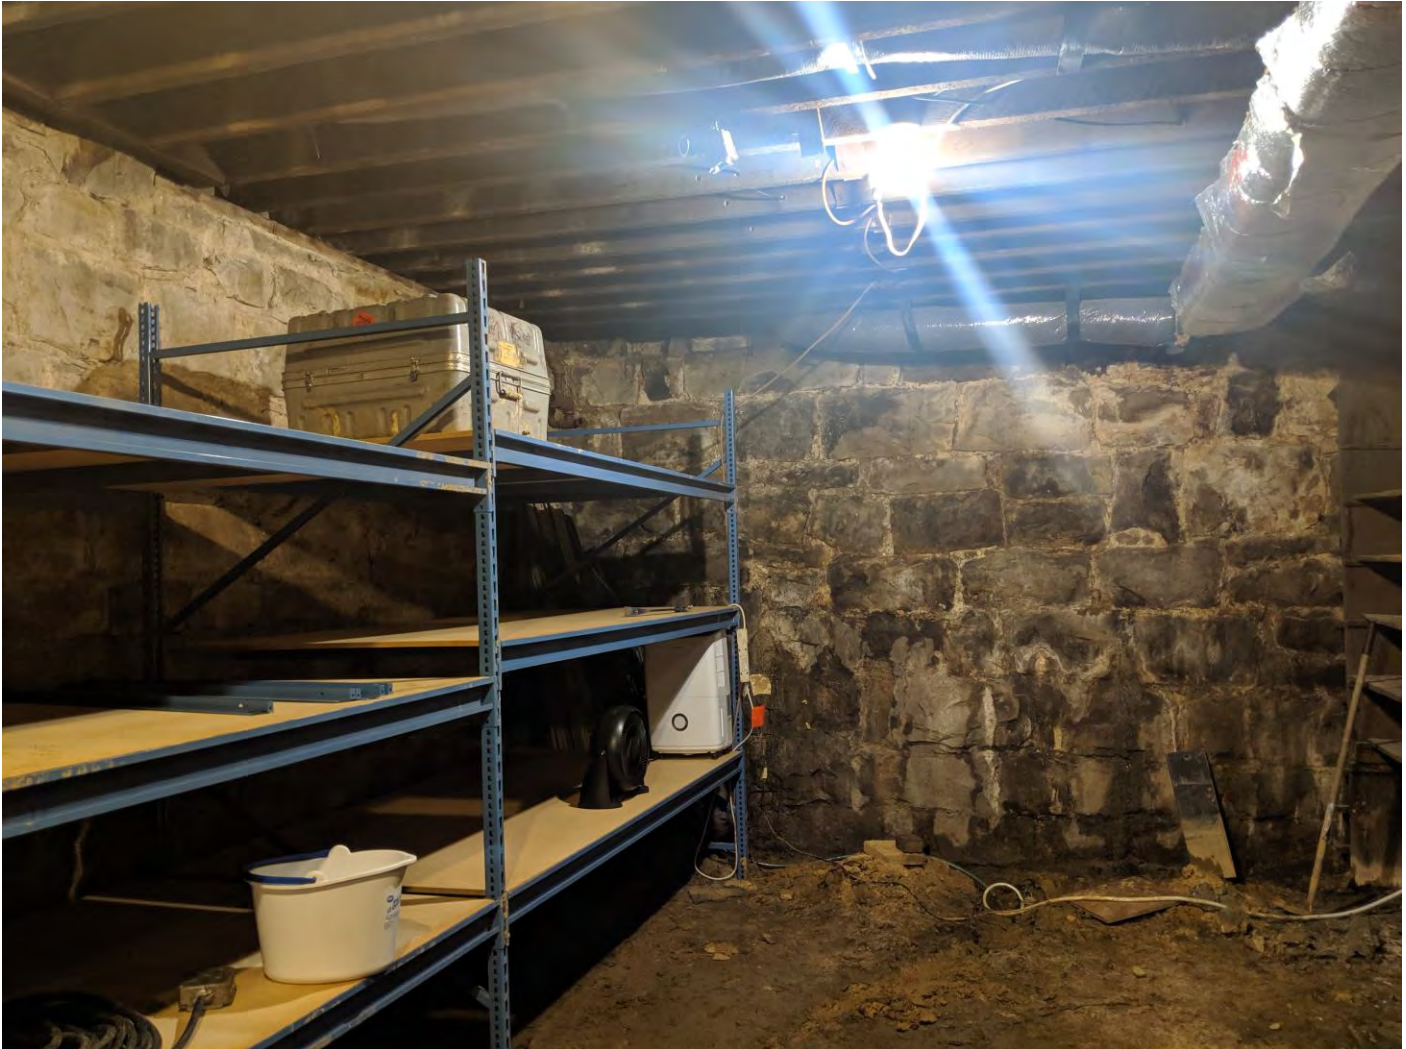
*Photo 8. Interior view of 1892 sandstone foundation construction from basement, facing northwest.*

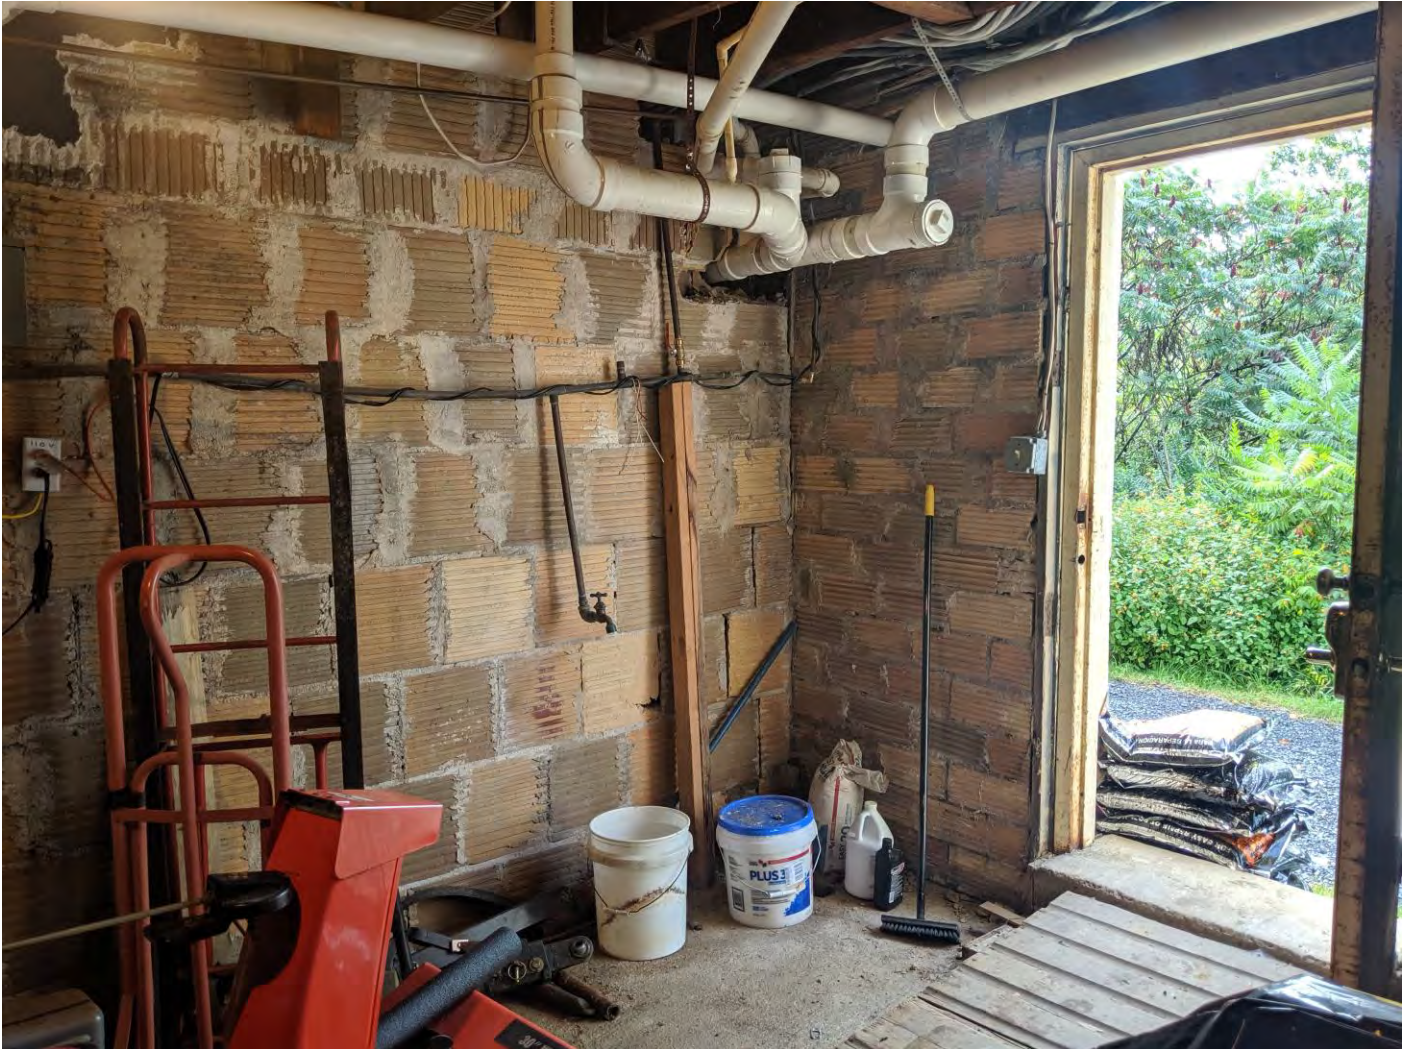
*Photo 9. Interior view of 1915 terra cotta block foundation construction from basement, facing southeast.*

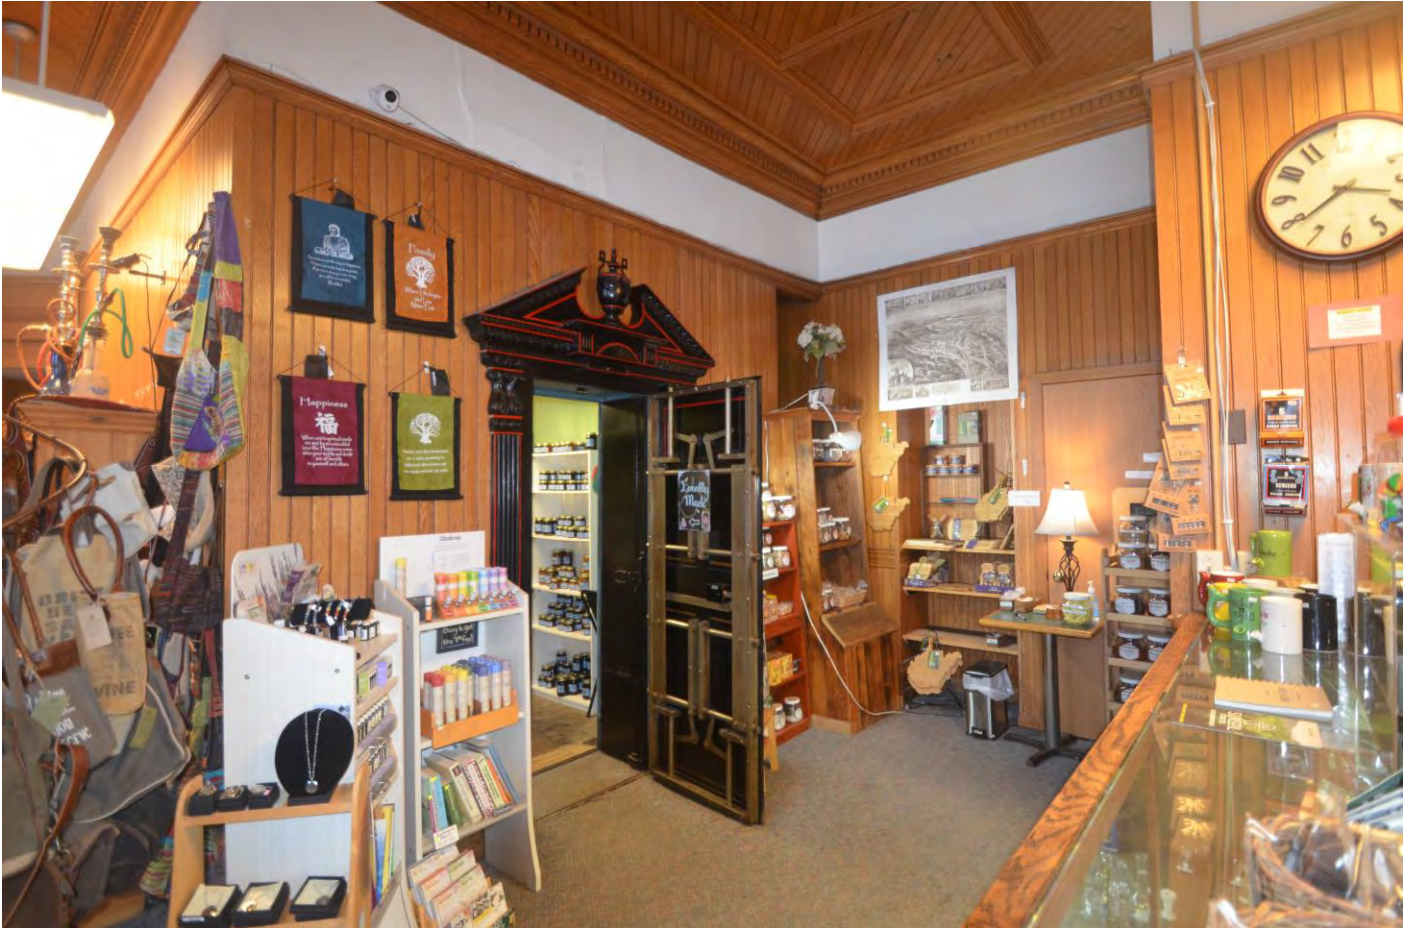
*Photo 11. Interior view of historic bank vault door and surround, facing southwest.*

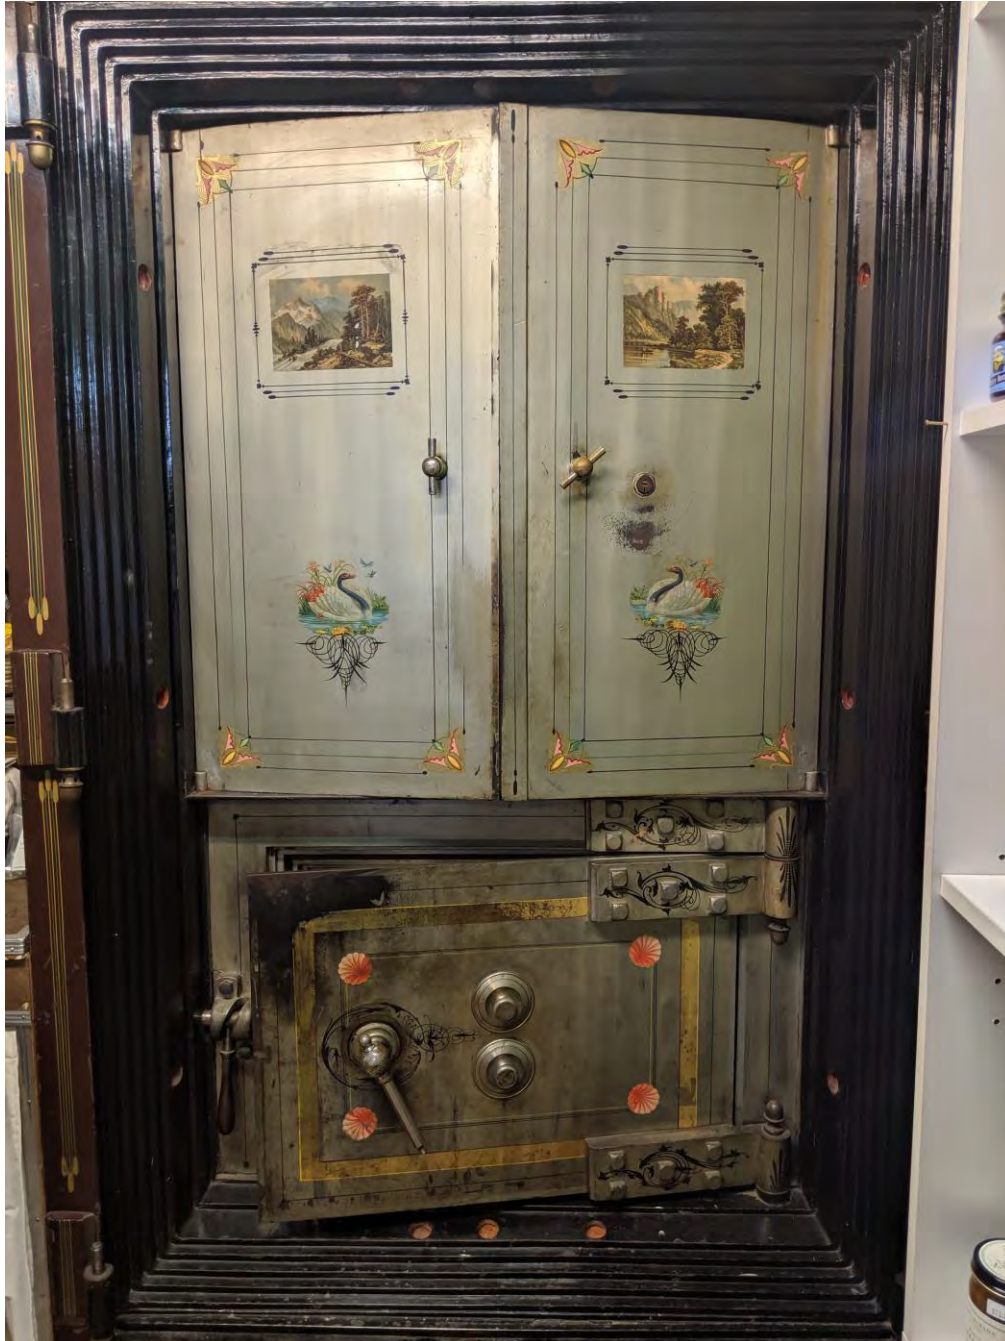
*Photo 12. Detail view of painted doors on internal vault safe, facing south.*

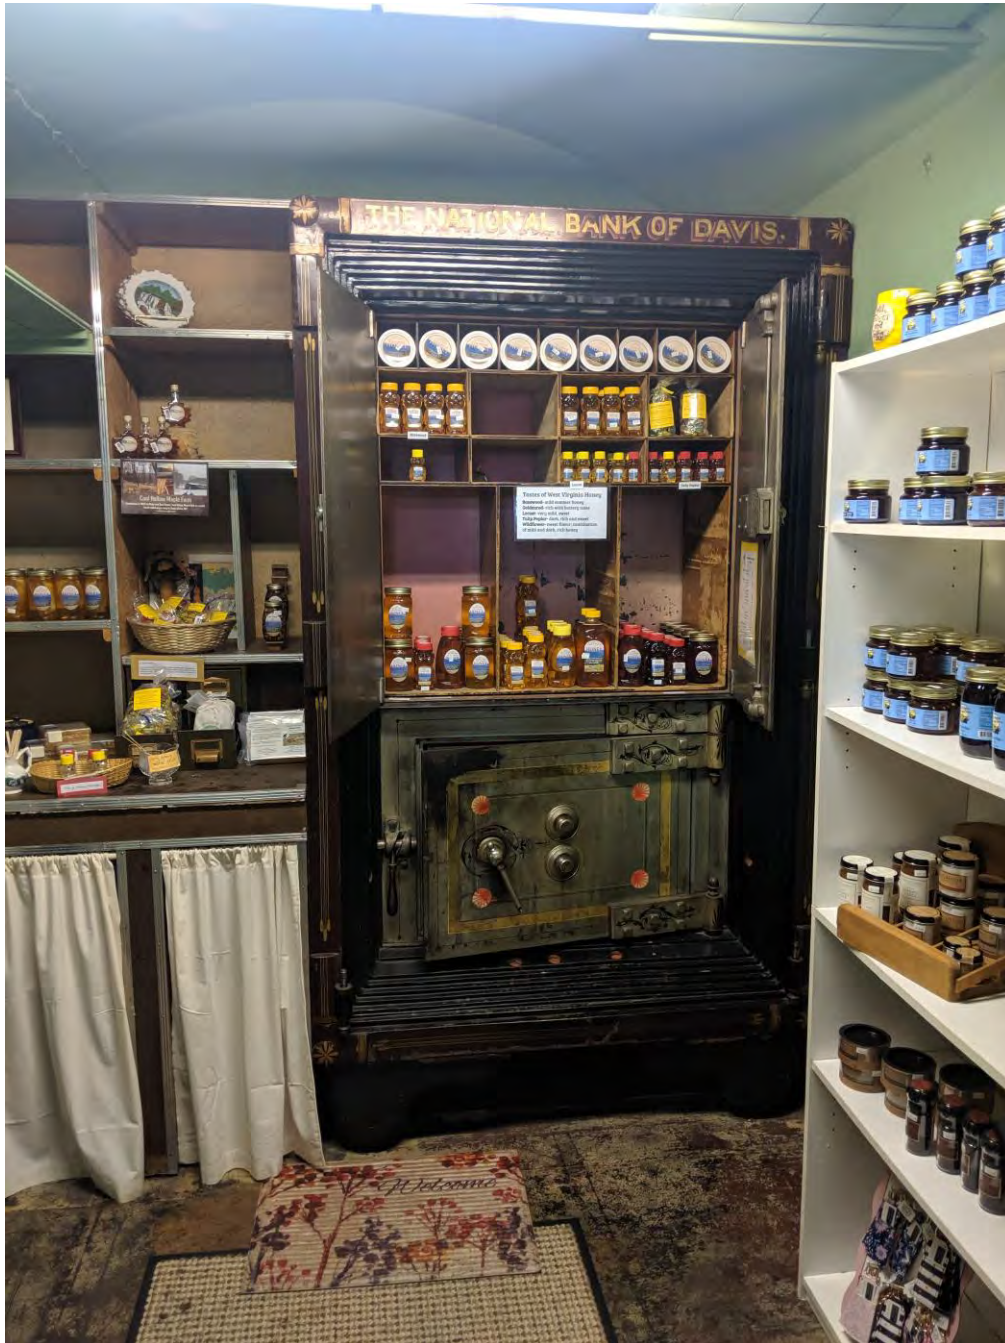
*Photo 13. Interior view of vault space with internal safe, facing southwest.*

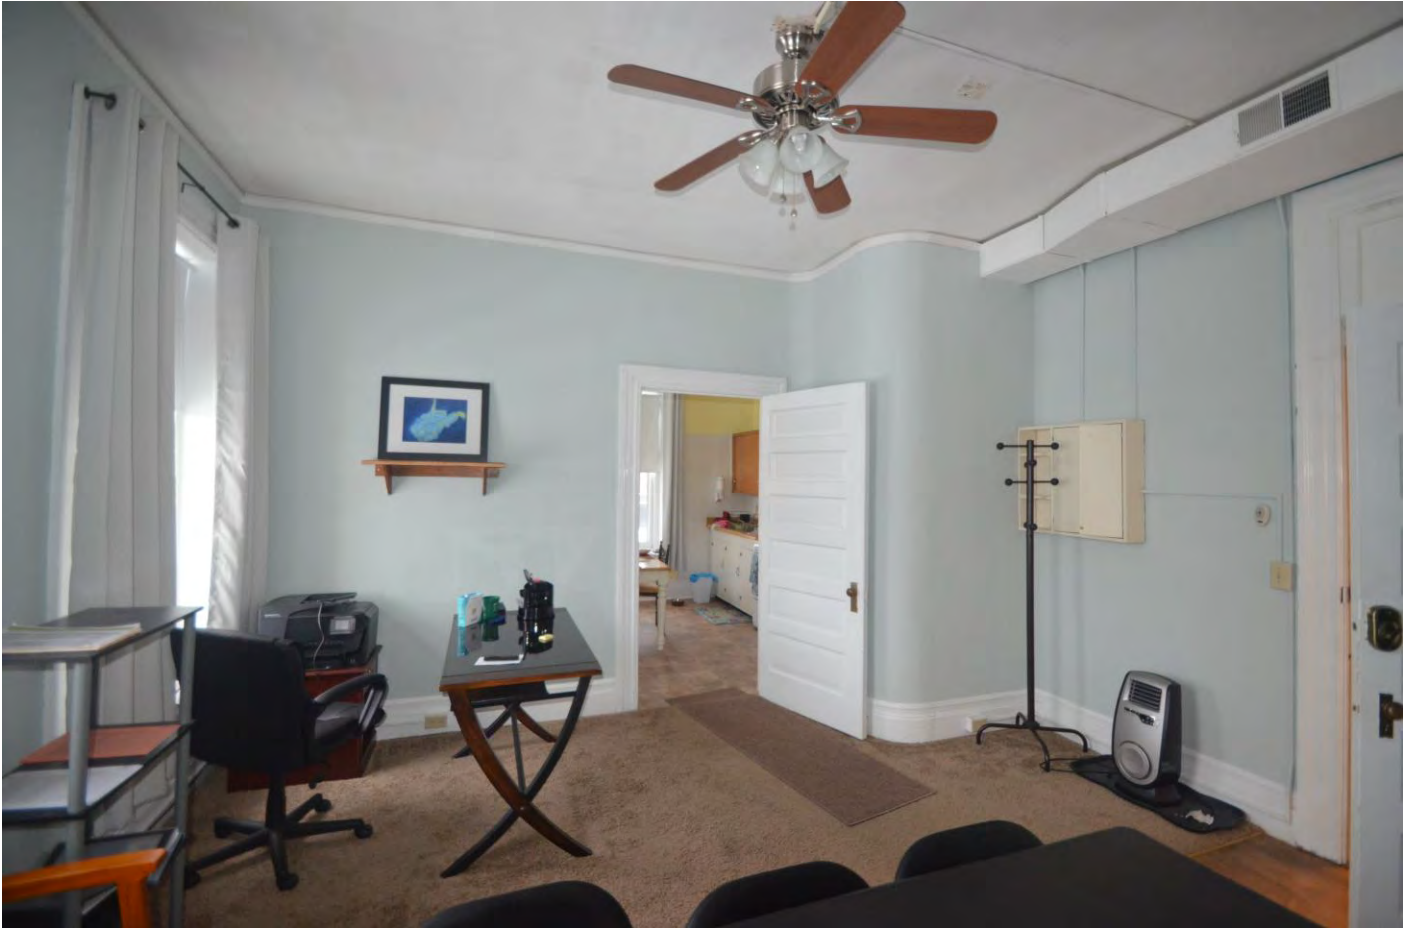
*Photo 16. Interior view of curved walls on second floor, facing southwest.*
