# National Register of Historic Places Registration Form

historic name National Bank of Davis

street & number 417 William Avenue

The National Bank of Davis is a nine-bay Richardsonian Romanesque building with wood bracketed eaves and decorative frieze set beneath a hipped roof (Photo 1). Constructed in two phases - in 1892 and 1915 - the building maintains a generally consistent exterior appearance, however, differences in construction techniques and materials typical of these construction periods are evident from the interior and rear of the building. Exterior walls are largely finished in random ashlar sandstone, with some secondary elevations finished with exposed or parged brick masonry. Double-hung wood windows, set in half-round arches at the first and third stories, are present throughout the building, along with stone headers and sills. The east and west wings are set beneath hipped roofs bridged by a side-gabled hyphen. This A combination hipped and side-gabled roof, recently sheathed with copper-painted standing seam metal, rests on bracketed wood eaves with a decorative frieze. The first-story storefront facing William Avenue maintains much of its historic fabric desp

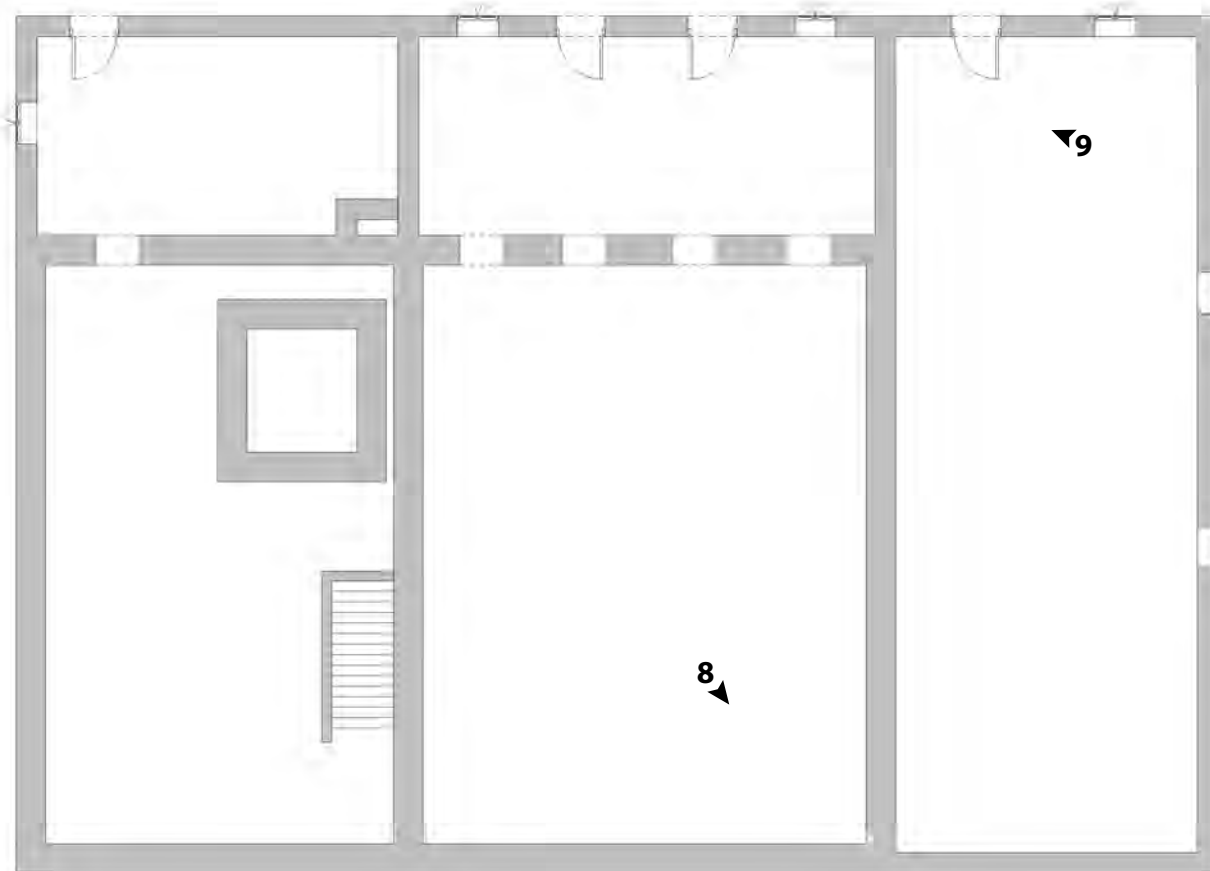
**BASEMENT FLOOR PLAN**

# **SKETCH PLAN - NOT TO SCALE**

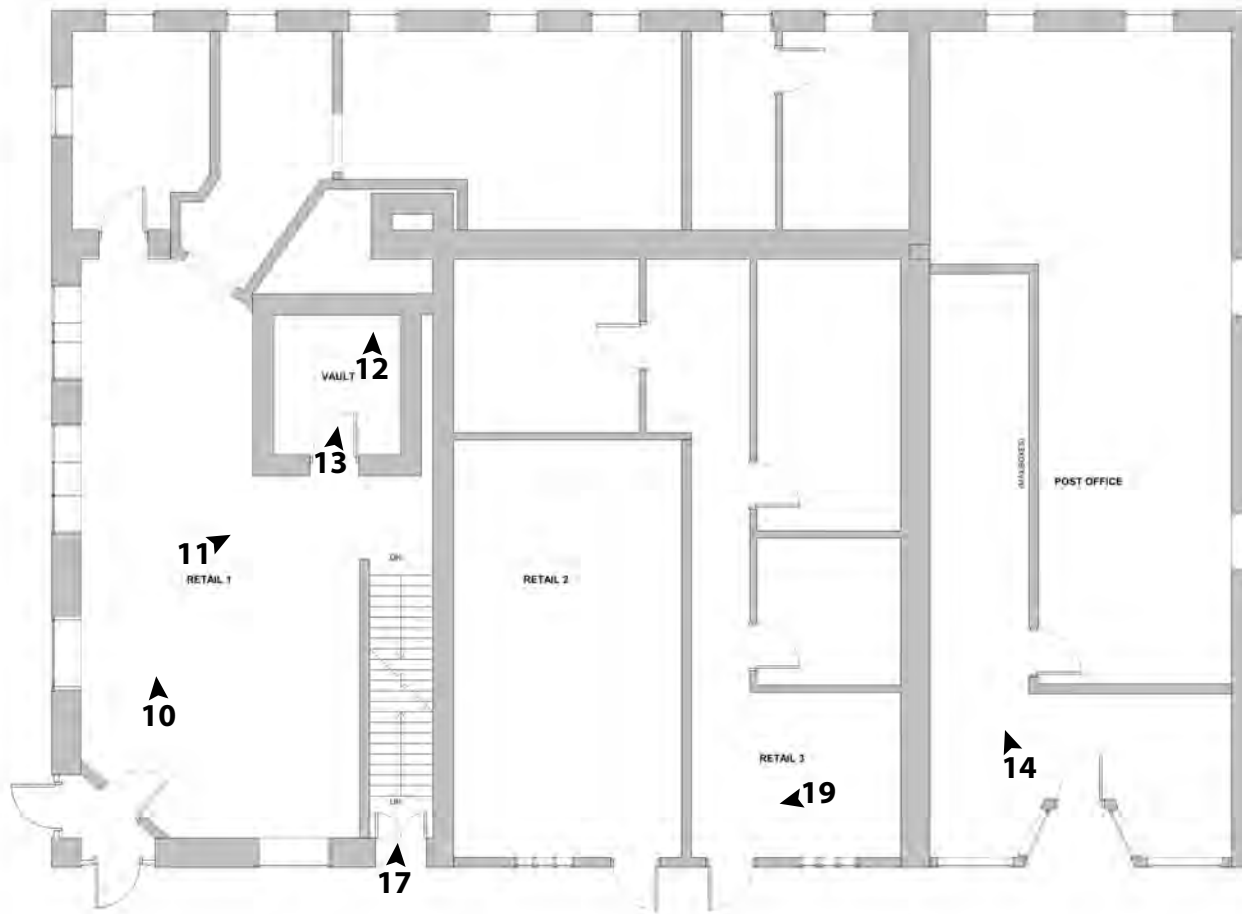
LEVEL 1 FLOOR PLAN

## SKETCH PLAN - NOT TO SCALE

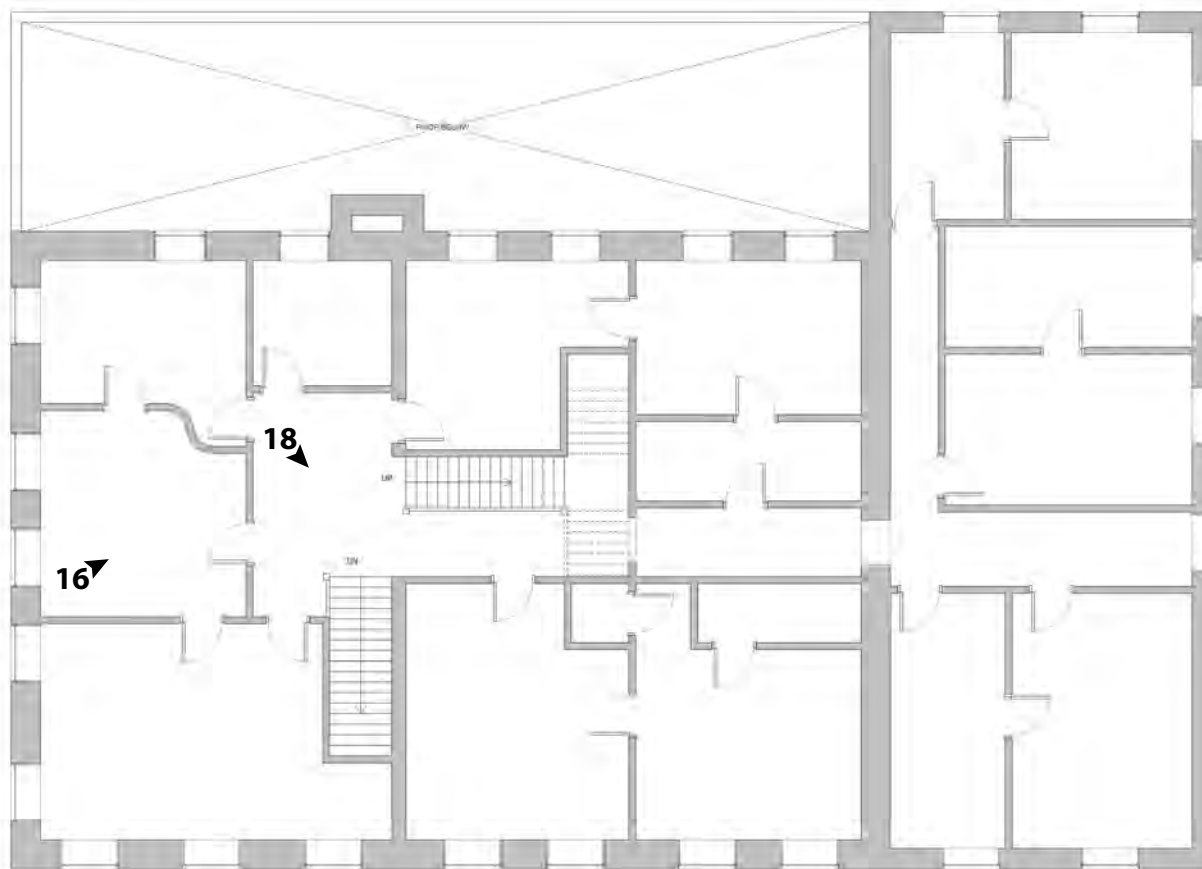
LEVEL 2 FLOOR PLAN

## SKETCH PLAN - NOT TO SCALE
