NATIONAL REGISTER OF HISTORIC PLACES  
REGISTRATION FORM

historic name: Vance Farmhouse

Vernacular I-House

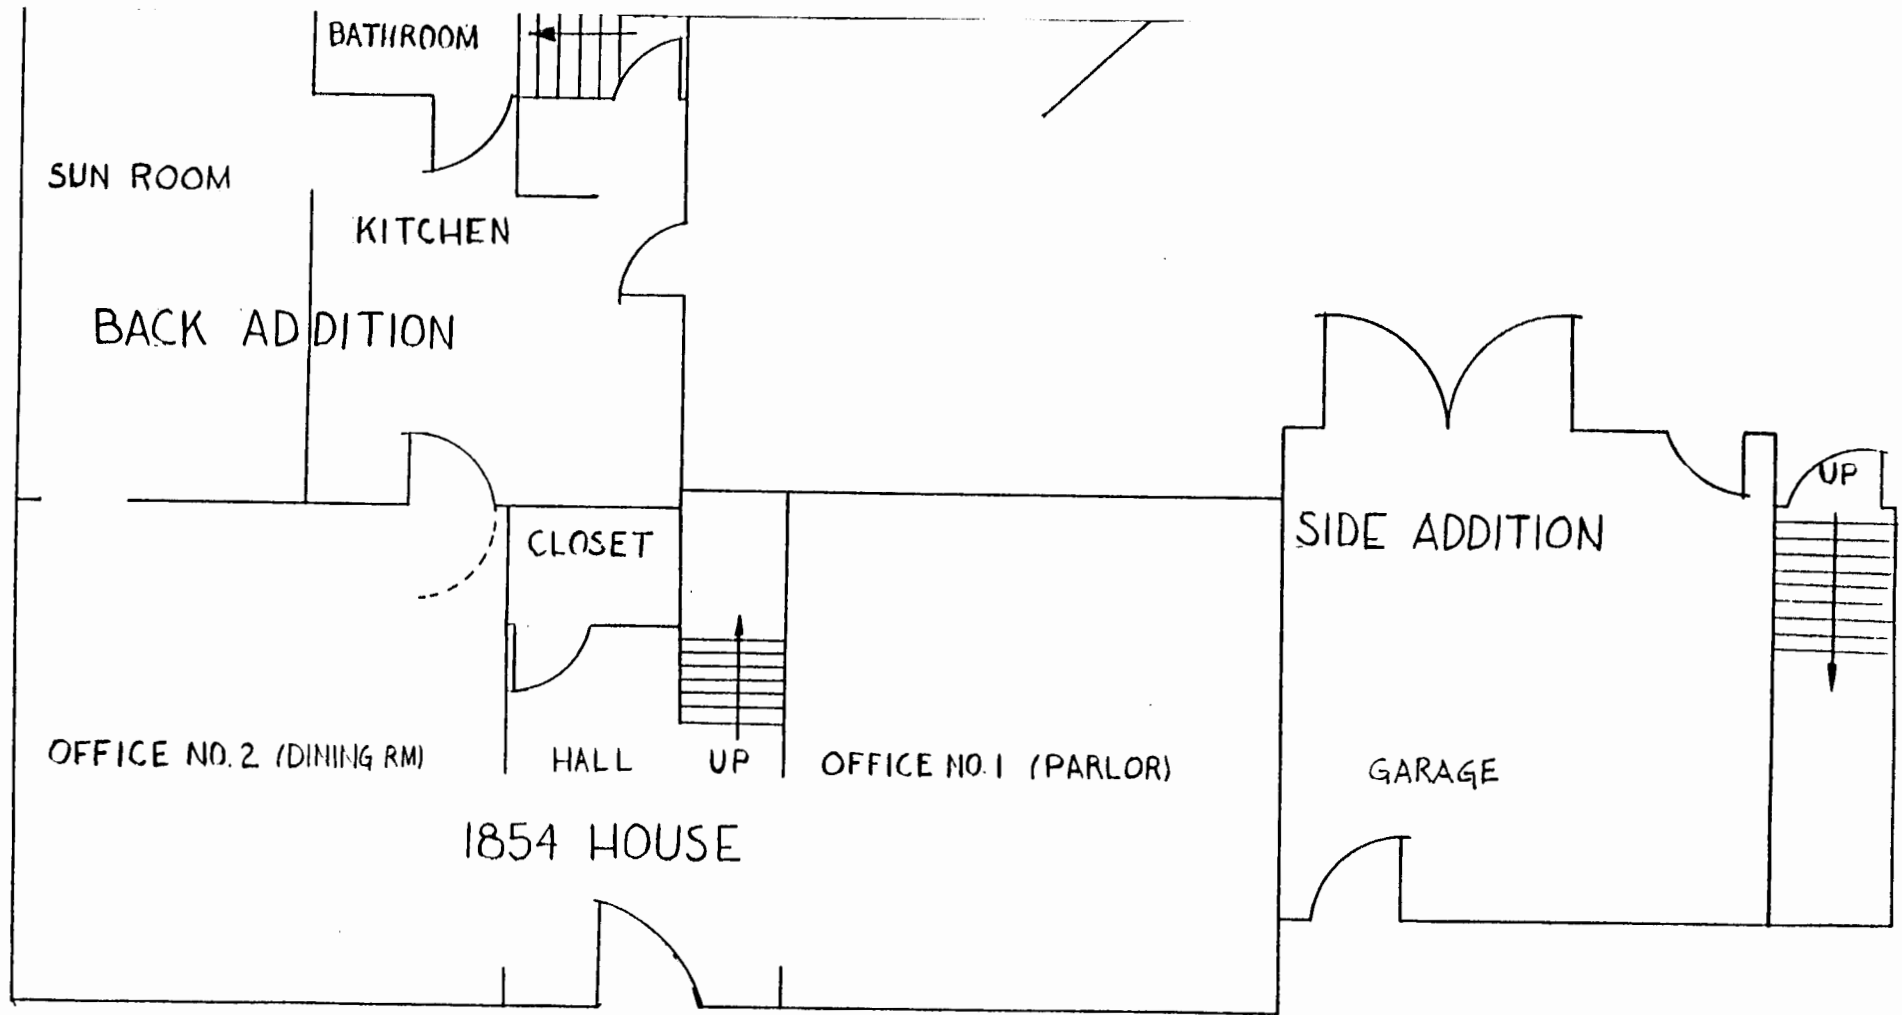
FIRST FLOOR.

To the right of the front hall is the former parlor and to the left, the dining room; both now are offices (See first floor plan). The former parlor, now Office No. 1, has a fireplace with an oak mantelpiece, with Ionic columns supporting the mantel shelf and a red tiled hearth (See photograph #9). To the left of the mantel is a built-in bookcase.
