File NPS Form 10-900 OMB No. 1024-0018 (Rev. 8-86) United States Department of the Interior National Park Service NATIONAL REGISTER OF HISTORIC PLACES REGISTRATION FORM 1. Name of Property historic name: Whipple Company Store other name/site number: _____ 2. Location street & number: intersection of county roads 15 and 21/20 not for publication: N/A vicinity: N/A city/town: Whipple state: <u>WV</u> County: <u>Favette</u> code: <u>019</u> zip code: <u>N/A</u> 3. Classification Ownership of Property: Private Category of Property: Building Number of Resources within Property: Contributing Noncontributing <u>0</u> buildings ____ sites _____ structures _____ objects _____ Total Number of contributing resources previously listed in the National Register: <u>N/A</u> Name of related property listing: N/A

ROOF PLAN SKETCH (not to scale) WHIPPLE COMPANY STORE WHIPPLE, FAYETTE COUNTY, WEST VIRGINIA

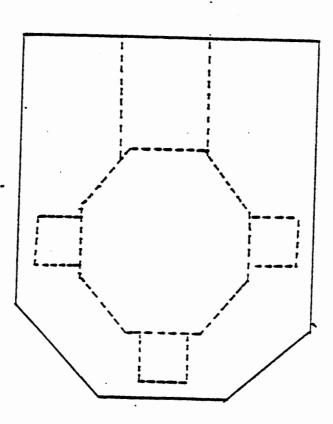
The core of the second story is octagonally planned and sits off-center towards the facade of the first floor. On four alternating sides of the octagon are projections that extend almost as far as the lower story roof (see roof plan). The extension in the rear is longer and almost equals the length of the lower story. The hipped roofs over these projections intersect with the main eight-sided pyramidal roof. The builder added a decorative finial to the apex of each roof (photos 2 and 3).

The wood frame Whipple Company Store building sits on a high cut stone foundation. Although its plan is symmetrical, the building's massing appears to be irregular because the first and second stories do not have the same plan. The first floor appears to be an octagon when viewed from the front but it actually has a six-sided plan. A shed roof covers the part of the first floor that is not directly under the second floor (photo 1).
