## National Register of Historic Places Registration Form

other names/site number North Wheeling Historic District – Boundary Increase

city or town Wheeling

state West Virginia code WV county Ohio code 069 zip code 26003

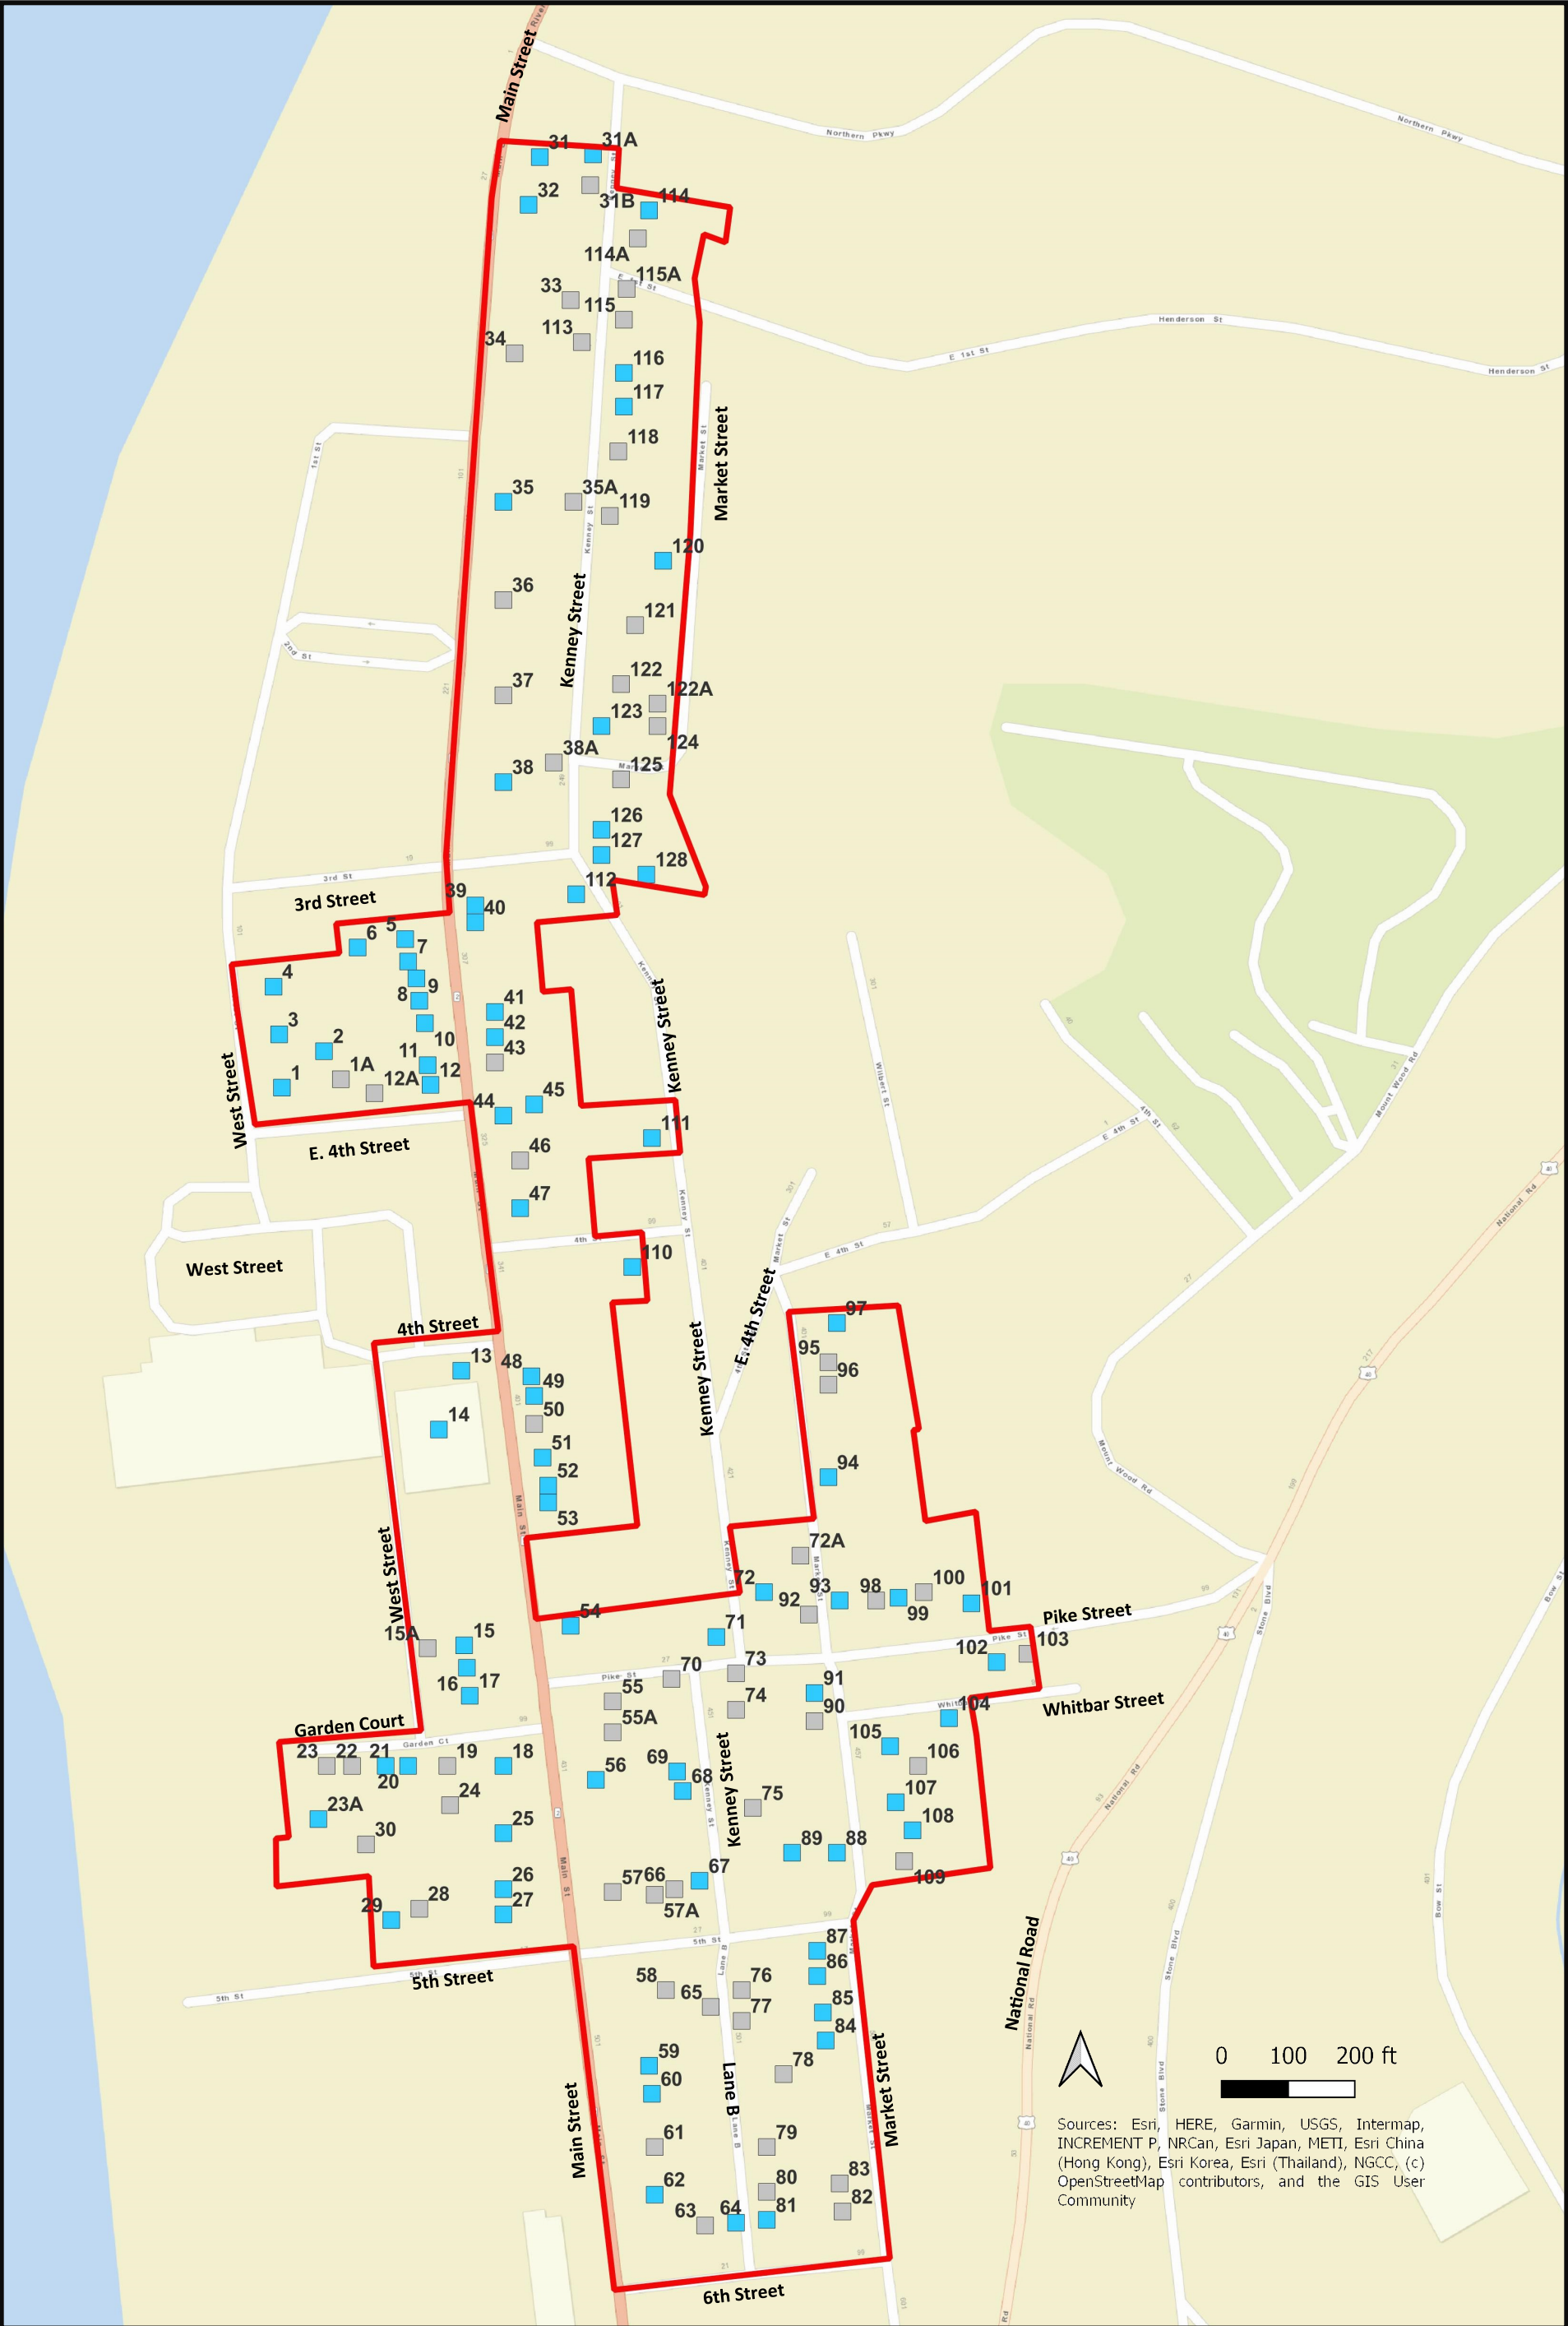
**Figure 1: North Wheeling Historic District (Boundary Increase)**  
**Ohio County, West Virginia**  
**District Map**

Contributing

Non-contributing

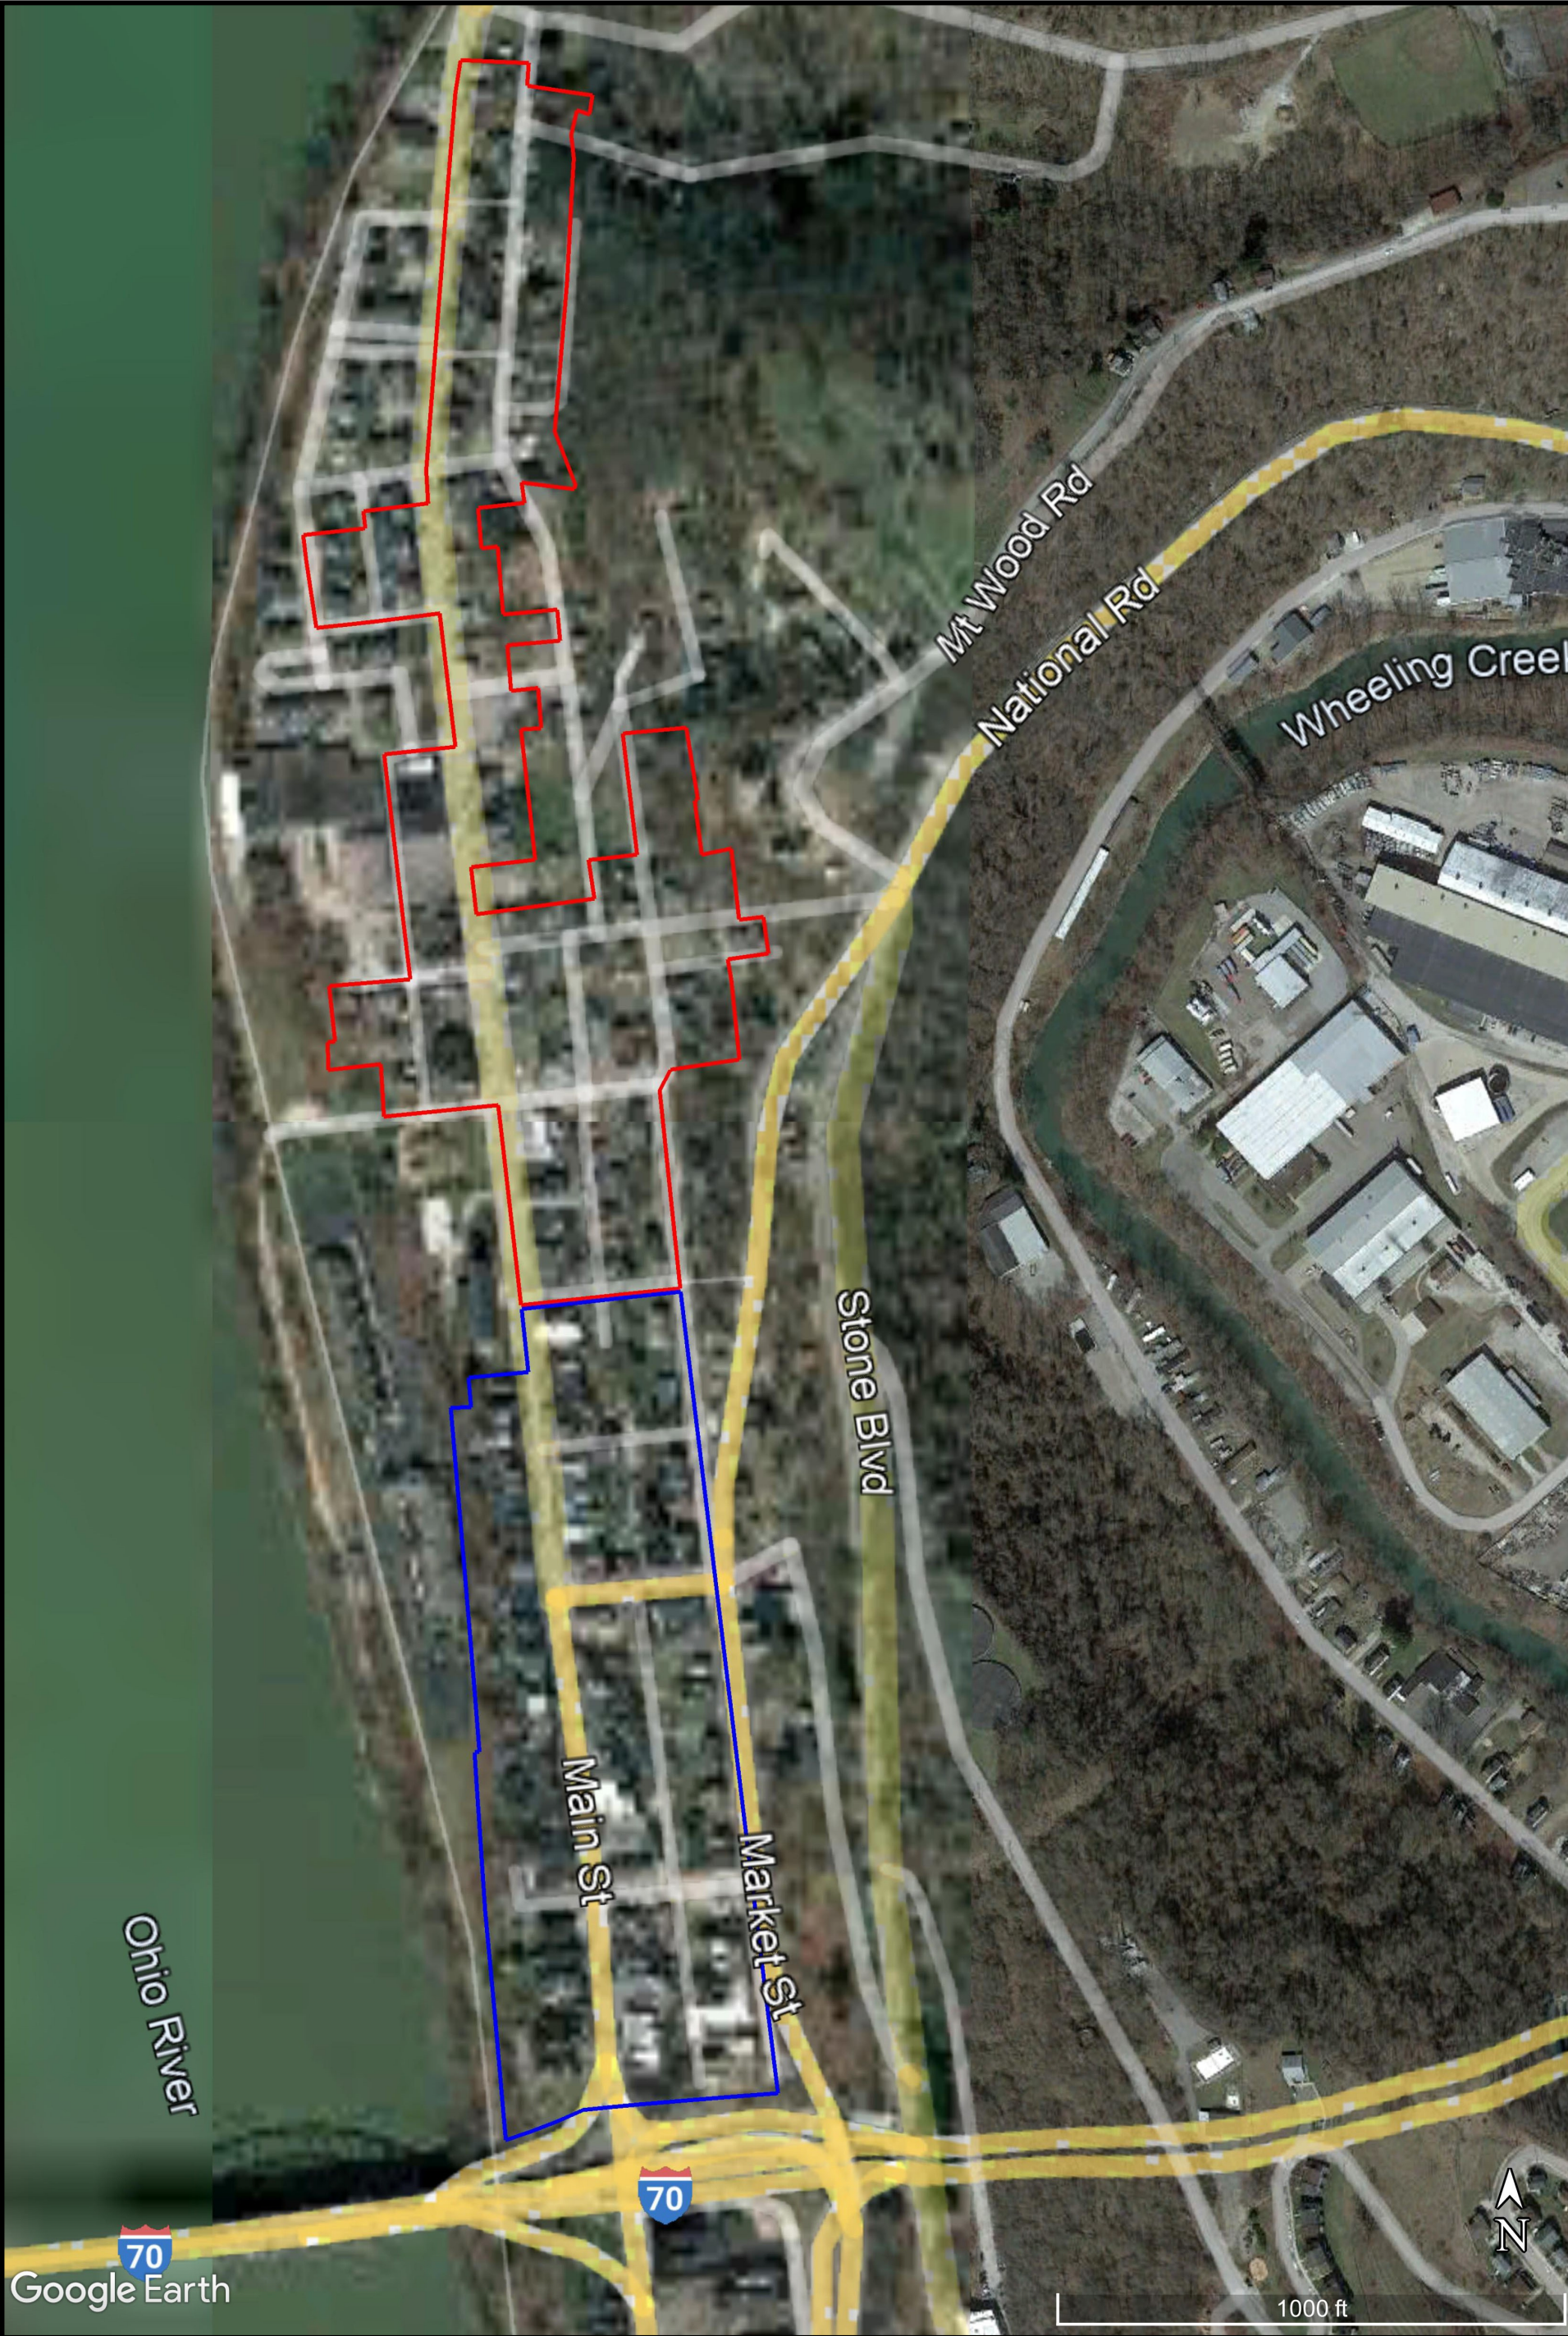
**Figure 5: North Wheeling Historic District (Boundary Increase)**  
**Ohio County, West Virginia**  
**Original and New Boundaries**

Legend	
<span style="color: blue;">—</span>	Current District Boundary
<span style="color: red;">—</span>	Boundary Increase Area

Figure 5 – Original and New Boundaries

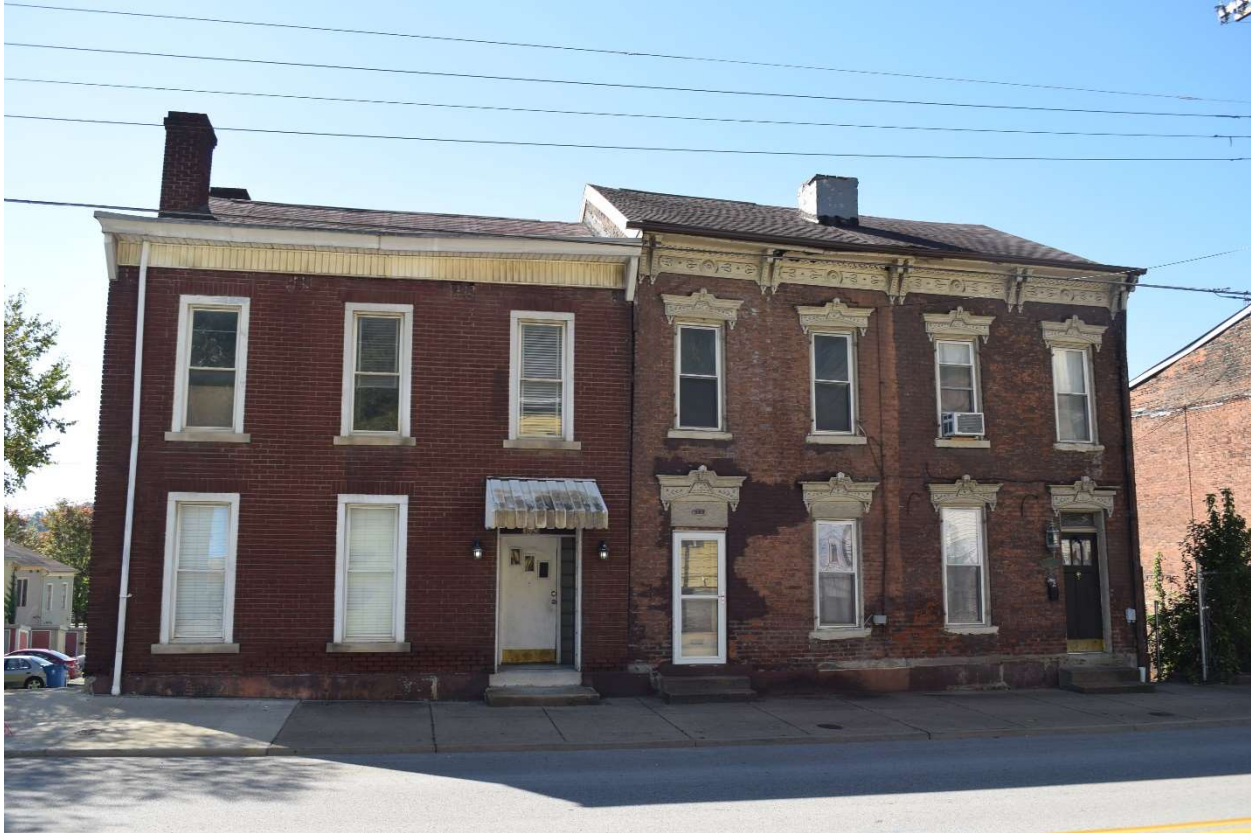
Photo 4. 325 (L) and 321-323 (R) Main Street, looking west.

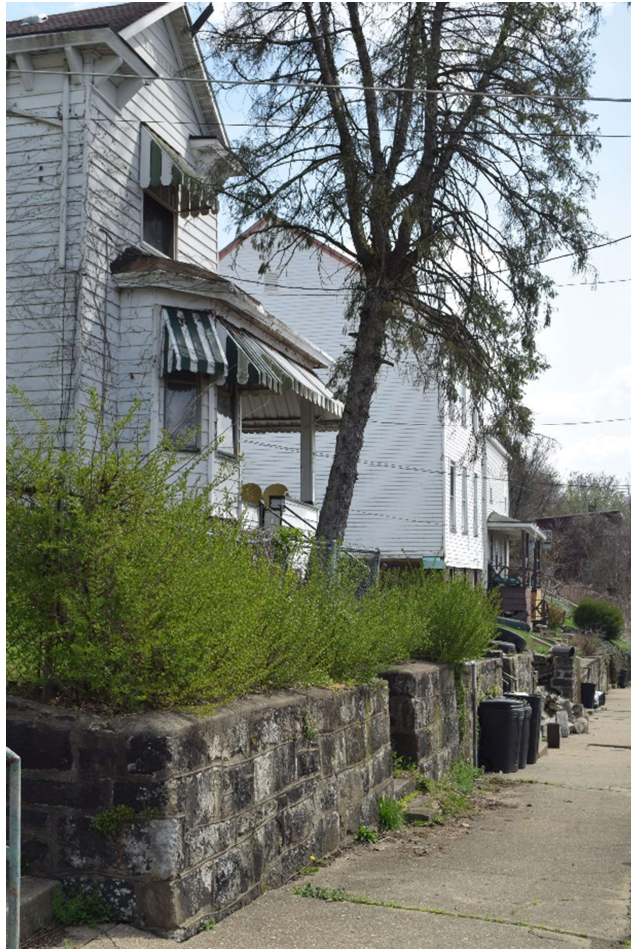
Photo 40. Example of typical sandstone block retaining wall, east Side of Market Street south of Pike Street, looking southeast.
