National Register of Historic Places Registration Form

1. Name of Property Historic name: Isaac Clymer Farm Other names/site number: Sycamore House Name of related multiple property listing: N/A
(Enter "N/A" if property is not part of a multiple property listing

2. Location Street & number: 2328 Engle Molers Road City or town: Harpers Ferry State: WV County: Jefferson
Not For Publication: Vicinity: X
3. State/Federal Agency Certification
As the designated authority under the National Historic Preservation Act, as amended,
I hereby certify that this <u>X</u> nomination <u></u> request for determination of eligibility meets the documentation standards for registering properties in the National Register of Historic Places and meets the procedural and professional requirements set forth in 36 CFR Part 60.
In my opinion, the property X meets does not meet the National Register Criteria. I recommend that this property be considered significant at the following level(s) of significance:
nationalstatewideX_local Applicable National Register Criteria:
<u>X</u> A <u>B</u> <u>X</u> C <u>D</u>
Susau ion 2 Deputy State Historic Preservation Officer 3-10-25
Signature of certifying official/Tit

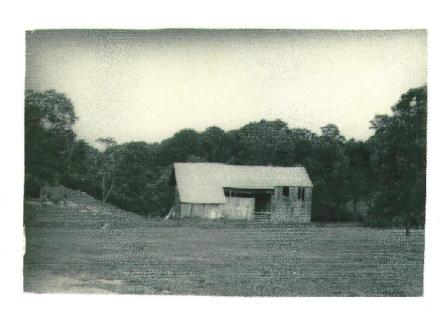
Hay Sam

The roughly 24 by 48-foot foundation is all that remains of a frame barn (noted as the "Hay Barn" in a photograph dated "?1954" – see Figure 8). The rectangular arrangement of stones is all that remains of this structure. The structure allegedly collapsed in the mid-1950s.⁷

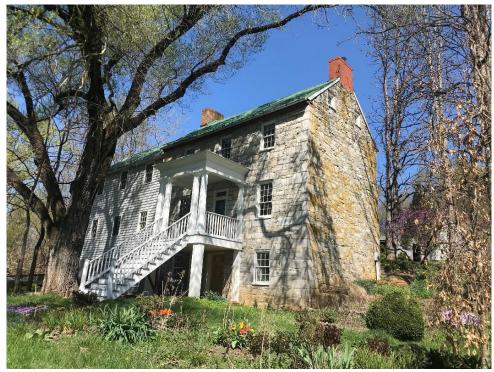
Photo 1. WV_Jefferson_County_Isaac Clymer Farm_001 Isaac Clymer House south and east façade. View to northwest.

The house is of coursed rubble limestone construction. The front, south facing elevation is three bays wide, three-and-a-half stories high, with center doors at the ground and first-floor levels, and windows to either side. The first-floor door is reached and protected by a Federal-style porch. Both corners and face of the south façade consist of finely dressed, massive limestone quoins. The stone has weathered to a mottled color of lighter and darker grays. The south and north stone walls are finished at the top with three courses of bricks corbelled outward with the middle course decoratively angled 45 degrees to form points (Photo 7). All windows of the house are double-hung wood sash set in large, beaded frames. Wood sills are set flush with the exterior wall.

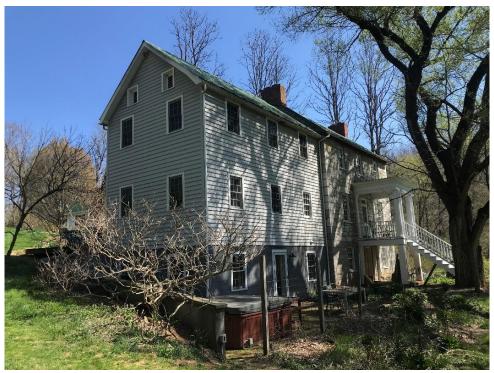
Photo 2. WV_Jefferson_County_Isaac Clymer Farm_002
1996 addition to the Isaac Clymer House. View to northeast. View to northeast.

Abutting west of the stone house is a three story, three bay, single pile, frame addition that the current owners built in 1996. A gable-extension was the only viable option in construction of the modern addition. Creating an L-addition would have greatly impacted either the north or south façade of the 1835 house. The addition design follows similar historic vernacular homes in the county (there are 13 houses built prior to 1835 in Jefferson County that feature telescope or side-hall additions where the addition is smaller than the main house (as noted in Allen [2011]⁶). Given the small footprint of the 1835 house, an addition was the only option for placement of modern heating, electrical, and plumbing systems. Any other option would have severely compromised the historic integrity of the 1835 interior. The 1996 addition height and walls are set shorter and narrower than the 1835 stone house so as not to overwhelm the original building,

and to accommodate the corner quoins. The addition provides space for a modern kitchen and bathrooms without compromising the integrity of the interior of the 1835 house, which would have severely impacted that interior. The addition is clad in beaded, beveled wood siding and has a metal roof. The ground floor concrete foundation is stuccoed and struck with "mortar" lines to appear as ashlar block. It has a simple rectangular footprint with three bays across the north and south walls and two bays on the west (gable) end.

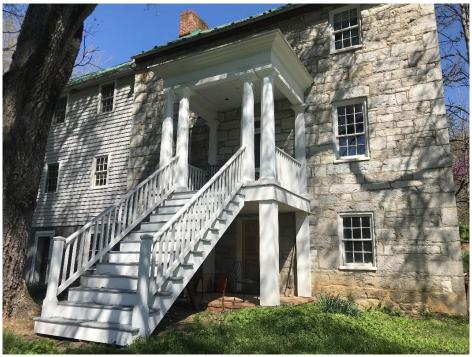
Photo 3. WV_Jefferson_County_Isaac Clymer Farm_003 Issac Clymer House south porch. View to the northwest.

The front porch has two outer pairs of tapering octagonal wood columns with tapered pilasters set against the stone wall. The columns are surmounted by a full classically-derived entablature with a plain board architrave, a simple board frieze, and mounded projecting cornice. The portico has a flat roof and a straight run of front stairs that lands on a massive stone (Photo 3).

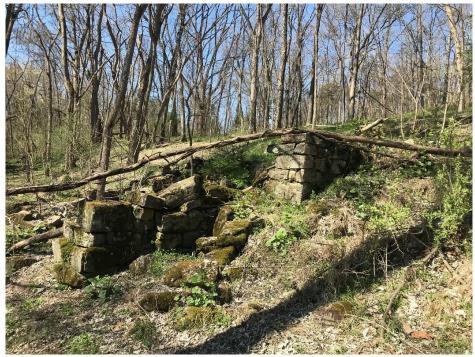
Photo 5. WV_Jefferson_County_Isaac Clymer Farm_005
Stone foundation remains (resource 7), likely of original house. View to the southwest.

Other historical resources on the property are a loafing barn (Photo 22), stone barn foundation (Figure 2), log cabin foundation (Photo 5) and stone ruins of a dam (Photo 6). Noncontributing resources include a combined woodworking shop and guesthouse (Photo 23), garden shed (Photo 24), and corn crib folly (Photo 25).

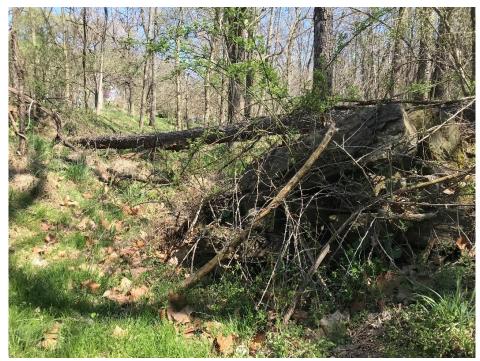
Photo 6. WV_Jefferson_County_Isaac Clymer Farm_006

Remains of stone dam (resource 8). A large pool area is excavated upstream (north) of this structure and likely served the agricultural uses. View north-northeast.

Located to the southeast of the house and close to the Barn foundation (Resource 5), all that remains of the dam is a pile of dressed limestone blocks embedded in the east and west bank of a former spring run (Photo 6). This run remains as a dry, roughly rectangular channel, located at the western flank of a steep ridge that marks the eastern property line. This run joins another channel arising from the southwest, at a point roughly 150 feet downstream from the Dam Ruins. The combined channel turns east and drains toward the Potomac River, cutting into a small water gap in the eastern ridge. The Dam likely was used to create a permanent pool for the use of domestic livestock.

Examination of the dam ruins, for example, could yield information about early water collection or control practices in local small scale farms. While no archaeological investigation has occurred within the Isaac Clymer Farm, there is potential for locating archaeological resources around the barn and cabin foundations. Below-ground features that may be present include cisterns, wells, outhouses, postholes, and refuse pits. Artifacts that may be uncovered included remains of various household items and agricultural tools. A future archaeological study of the Isaac Clymer Farm may contribute to a deeper understanding of agricultural practices on the property as well as of the lives of the occupants of the house. If this is found to be the case, a future update to this document may establish additional significance under Criterion D.

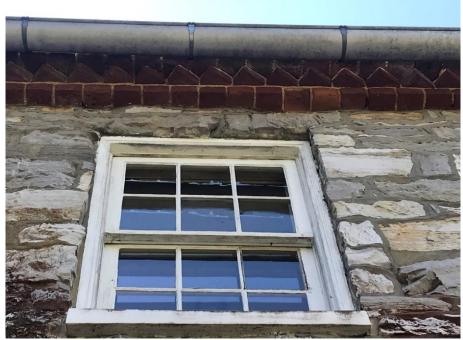
Photo 7. WV_Jefferson_County_Isaac Clymer Farm_007 Corbelled brick soffit on north façade. View south.

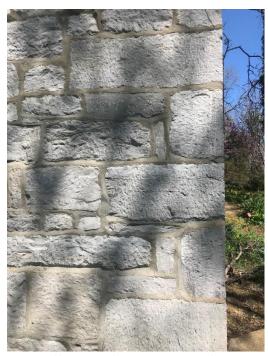
Photo 8. WV_Jefferson_County_Isaac Clymer Farm_008
Southeast corner of Isaac Clymer House showing large dressed limestone quoins. View north.

The east gable of the house is a solid wall of limestone, roughly cut, and loosely coursed. Large dressed quoins, some in excess of 24" high, define the gable corners (Photo 8). At the attic are a pair of square four-lite casement windows that flank the internal chimney stack. The roof is pitched at 11/12, and the roof rake is finished with a simple pair of beaded verge boards. The east chimney brickwork appears to have been replaced at some point as the bricks are hard fired as compared to soft bricks of the west chimney. Both gutters, north and south, originally drained into a Y-shaped funnel that directed rainwater into the cistern situated just east of the building.

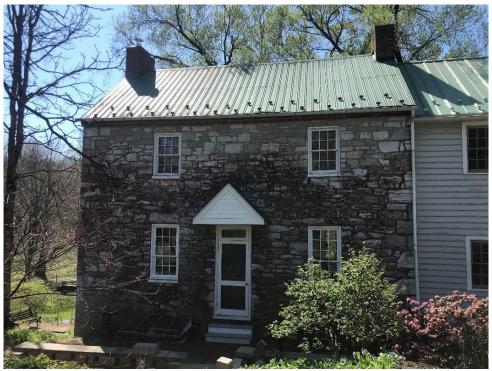
Photo 9. WV_Jefferson_County_Isaac Clymer Farm_009 Isaac Clymer House north façade. View south.

The north elevation is of limestone, roughly cut and loosely coursed, banked into the uphill side of the house (Photo 9). The building appears two stories in height. The first story is three bays across with a center door protected by a simple gabled pent roof. The door is six-paneled and has a simple four-pane transom. The door is flanked by two 9/6 lite windows.

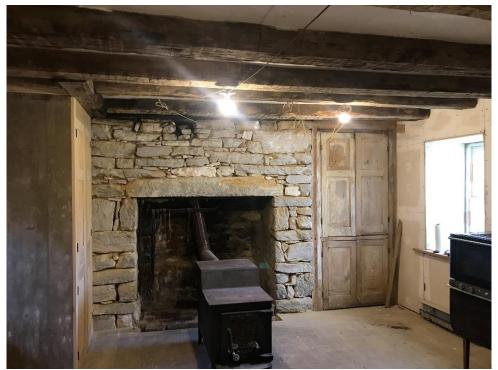
Photo 10. WV_Jefferson_County_Isaac Clymer Farm_010 Isaac Clymer House, ground floor kitchen fireplace. View east.

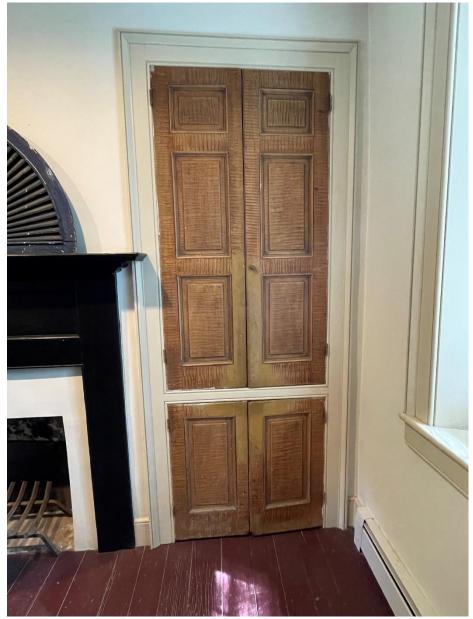
Photo 11. WV_Jefferson_County_Isaac Clymer Farm_011
Issac Clymer House, first floor parlor. Corner cupboard with grain-painted doors. View southeast.

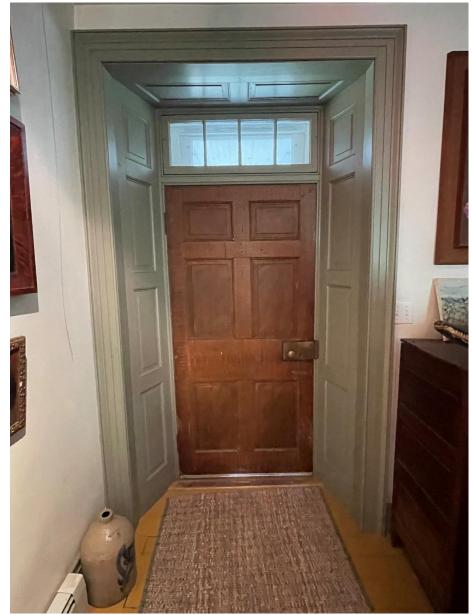
Photo 12. WV_Jefferson_County_Isaac Clymer Farm_012

Issac Clymer House first floor hall. South door with grain-painting. View south.

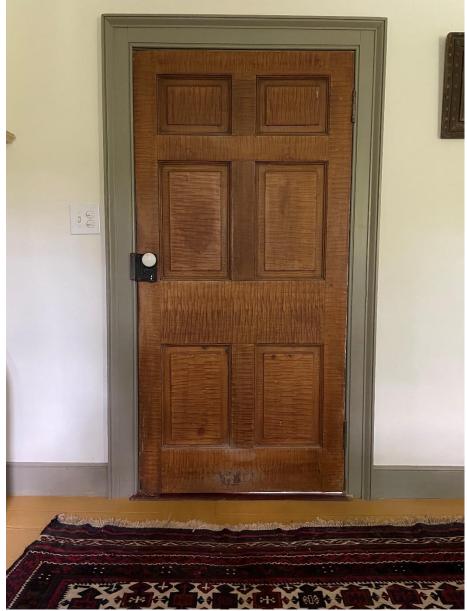
Photo 13. WV_Jefferson_County_Isaac Clymer Farm_013

Issac Clymer House second floor center bedroom. Grain-painted door. View north.

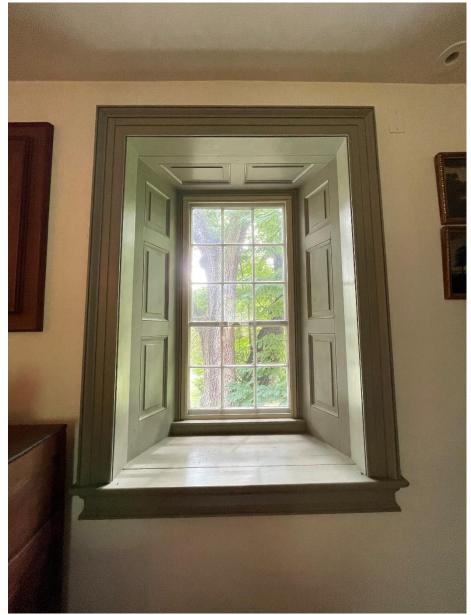
Photo 14. WV_Jefferson_County_Isaac Clymer Farm_014
Isaac Clymer House first floor hall. 9 over 6 window. View south-southeast.

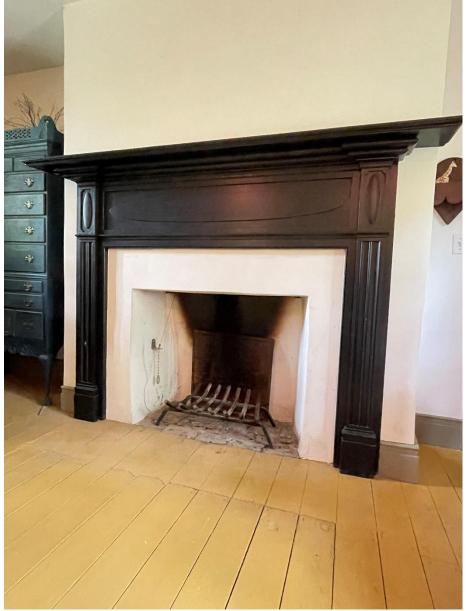
Photo 15. WV_Jefferson_County_Isaac Clymer Farm_015
Isaac Clymer House first floor hall fireplace. View west-northwest.

The west wall of the hall has a projecting chimney breast faced with a mantel surrounding a large firebox; the firebox and its surround are plastered. The mantel features an oval horizontal block with oval end blocks (Photo 15) and a projecting shelf typical of the Greek Revival style. Architectural historian John Allen credits this and other mantels to the expression of new tastes of the 1830's throughout the county.⁵

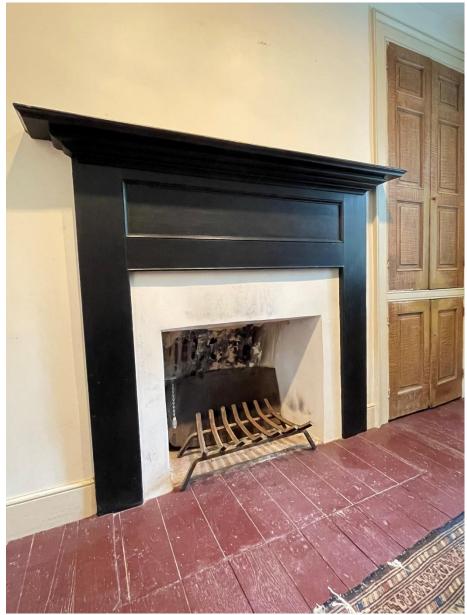
Photo 16. WV_Jefferson_County_Isaac Clymer Farm_016
Issac Clymer House first floor parlor fireplace. View east.

The east wall of the hall has a centered door that opens to the parlor and the parlor's stairwell in the northeast corner. The east wall of the parlor has a fireplace with a smaller firebox and simpler mantel than the hall (Photo 16). A four-door cupboard is to the right of the fireplace. (Photos 11, 16). The cupboard doors are grained similar to other interior doors. The shelves are simply beaded on upper and lower edges.

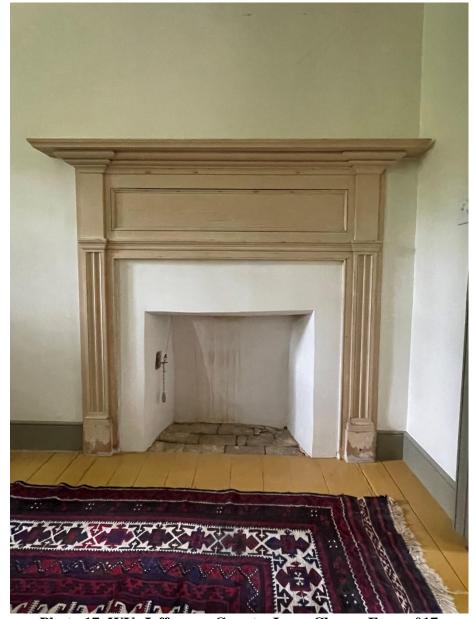
Photo 17. WV_Jefferson_County_Isaac Clymer Farm_017
Issac Clymer House second floor center bedroom fireplace. View west.

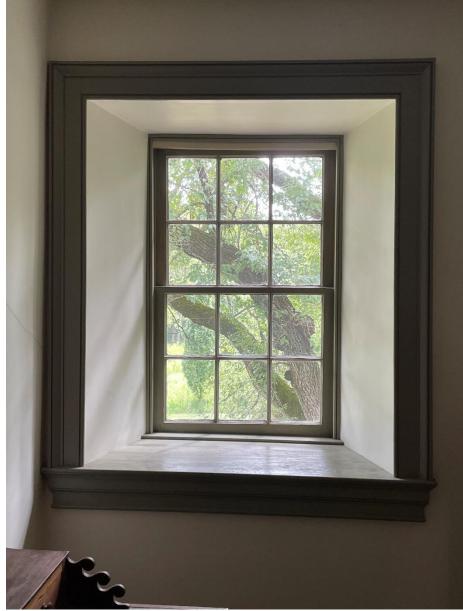
Photo 18. WV_Jefferson_County_Isaac Clymer Farm_018
Isaac Clymer House second floor center bedroom. Plastered window well. View southeast.

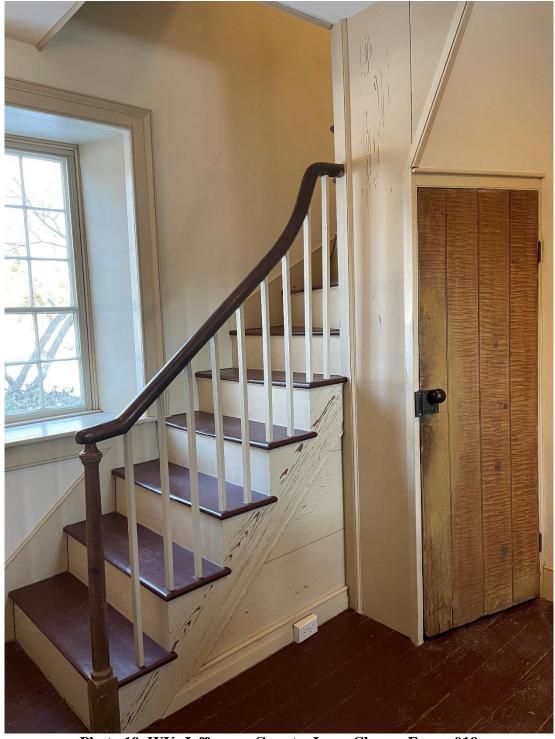
Photo 19. WV_Jefferson_County_Isaac Clymer Farm_019
Isaac Clymer House first floor parlor. Transitional ramp/winding staircase. View northeast.

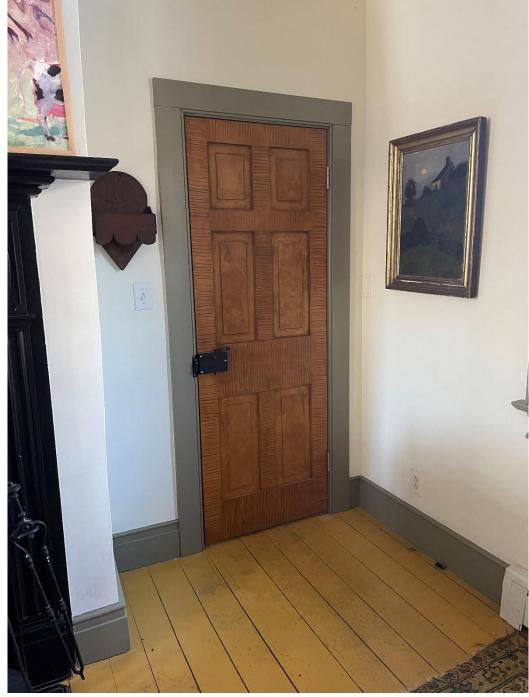
Photo 20. WV_Jefferson_County_Isaac Clymer Farm_020
Isaac Clymer House first floor hall. Modern door connecting 1835 stone and 1996 frame wings. View west-northwest.

To the right or north of the mantel is a 1996 doorway created to provide direct access to the western addition. This door and its surround were built to match existing woodwork and graining (Photos 20 and 21).

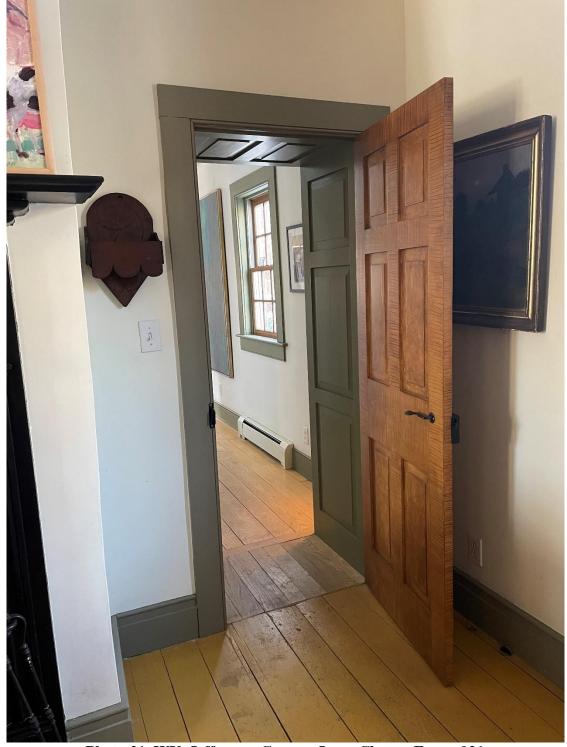
Photo 21. WV_Jefferson_County_Isaac Clymer Farm_021
Isaac Clymer House first floor hall. As Photo 20 except door open showing view into 1996 wing. View west-northwest.

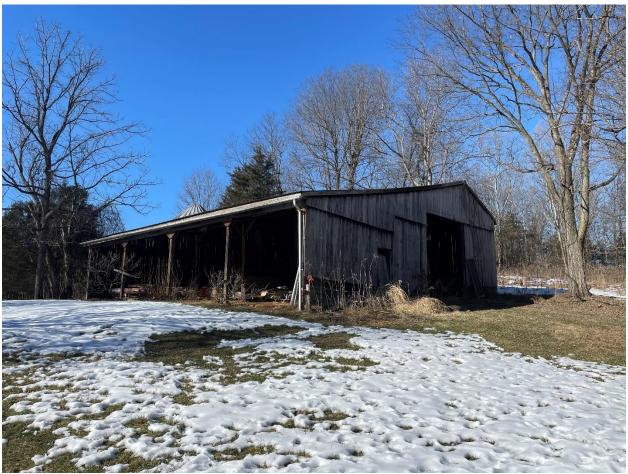
Photo 22. WV_Jefferson_County_Isaac Clymer Farm_022 Loafing barn. Resource #2. View northwest.
