## **A HISTORIC FARMSTEAD SURVEY OF WAYNE COUNTY, WEST VIRGINIA**

By: Janie-Rice Brother  
Apogee Environmental & Archaeological, Inc.

14-518.04

West Virginia Department of Environmental Protection

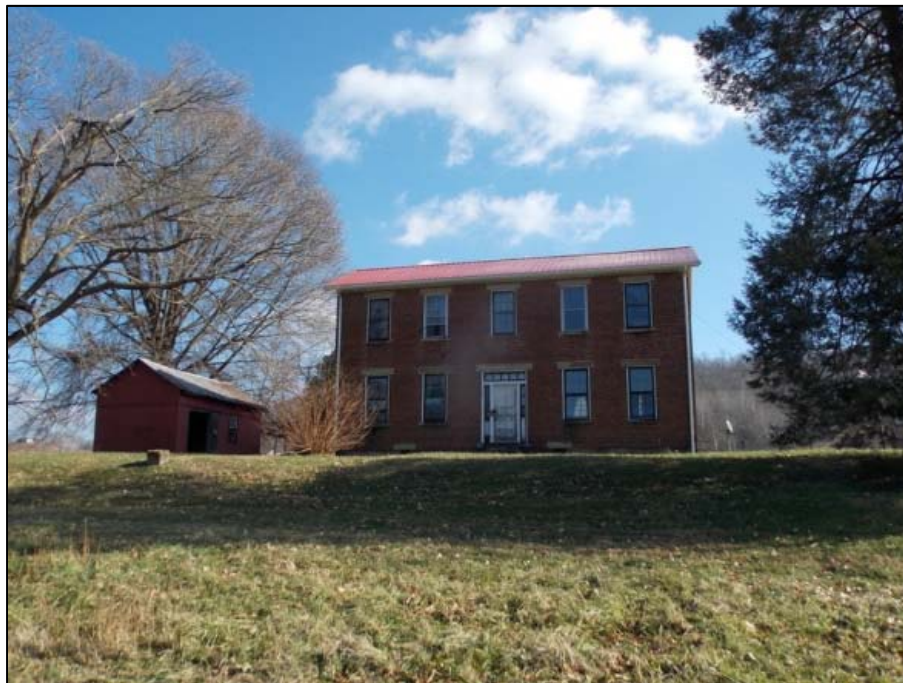
Figure 7 Façade of Roswell Cyrus House (Resource 5) and domestic outbuilding, facing east.

The main dwelling (Resource 5) is a two-story brick, common bond I-house that faces west, toward the Big Sandy River (Figure 7). Though a specific date has not been determined, archival research and an examination of the dwelling indicates that it was built in the late 1840s/mid-1850s. The rural character of the site helps explain the transitional nature of the style of the house, which combines the restrained façade of the lingering Federal style with elements of the Greek Revival style, which was nationally prominent at the time.

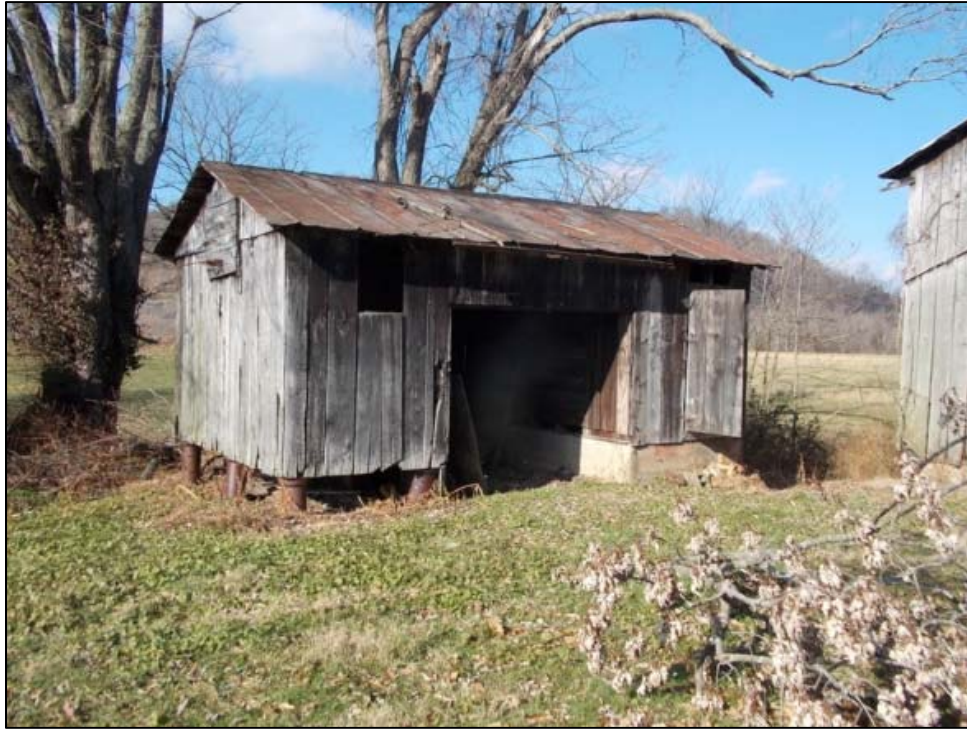
Figure 18 Drive-through corncrib (Resource 2), facing northwest.

Resource 2 is a frame, drive-through corncrib (Figure 24). The southern crib is elevated on ceramic drainage pipes, while the northern crib sits on a poured concrete foundation. The box-frame corn crib is clad in vertical boards with a gable metal roof. Double hinged doors have been added to the west elevation, while a loading bay on the south gable end has been boarded over.

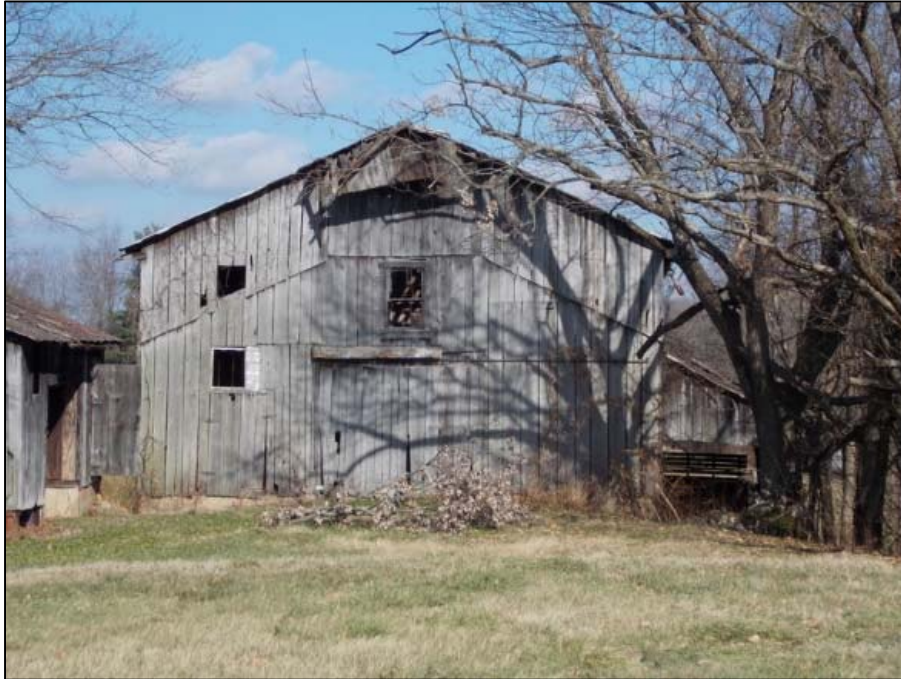
Figure 24 South gable end of barn.

The barn, clad in vertical boards, rests on a stone foundation. The south gable end shows evidence of the barn being reboxed, with the opening for the front gable hay hood covered up (Figure 30). Access to the barn on this gable end is through sliding wooden doors. A sash window (the muntins are mostly gone, making identification of the number of lights impossible) is located below the hay hood. Sills in the lower part of the barn are hewn

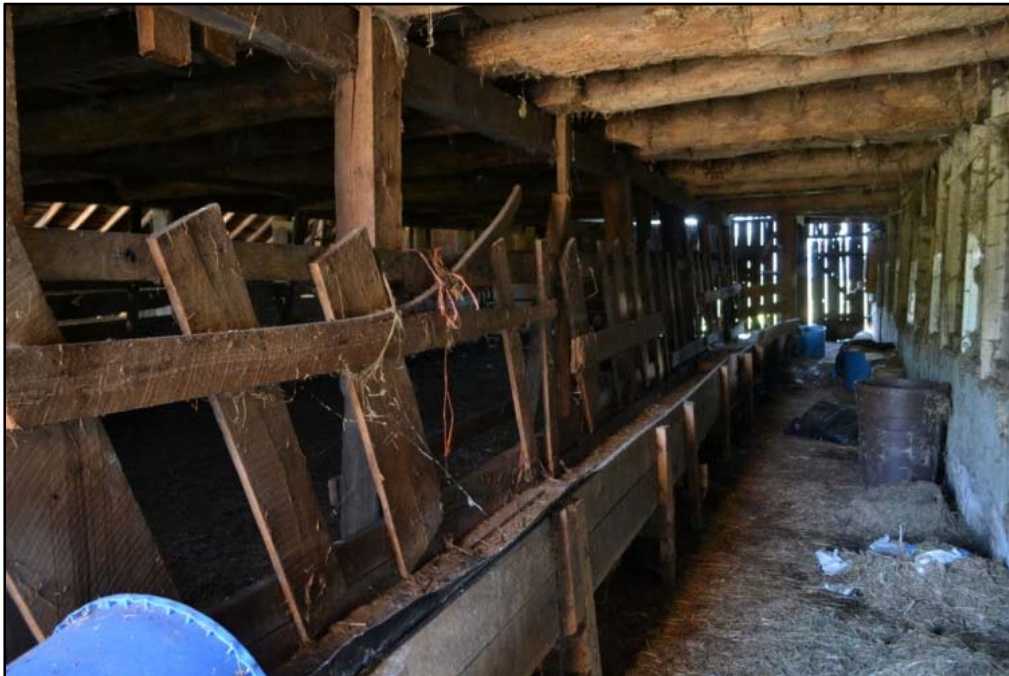
Figure 37 Built-in mangers and hay racks in original central portion of barn.

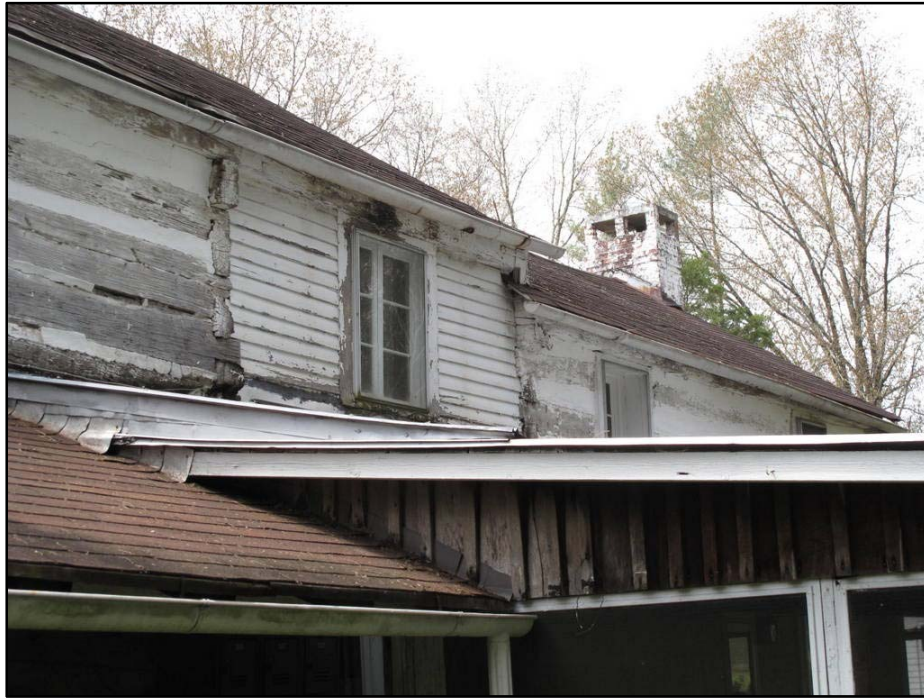
Figure 46 Detail of the enclosed dogtrot between the two pens, WA-0223.

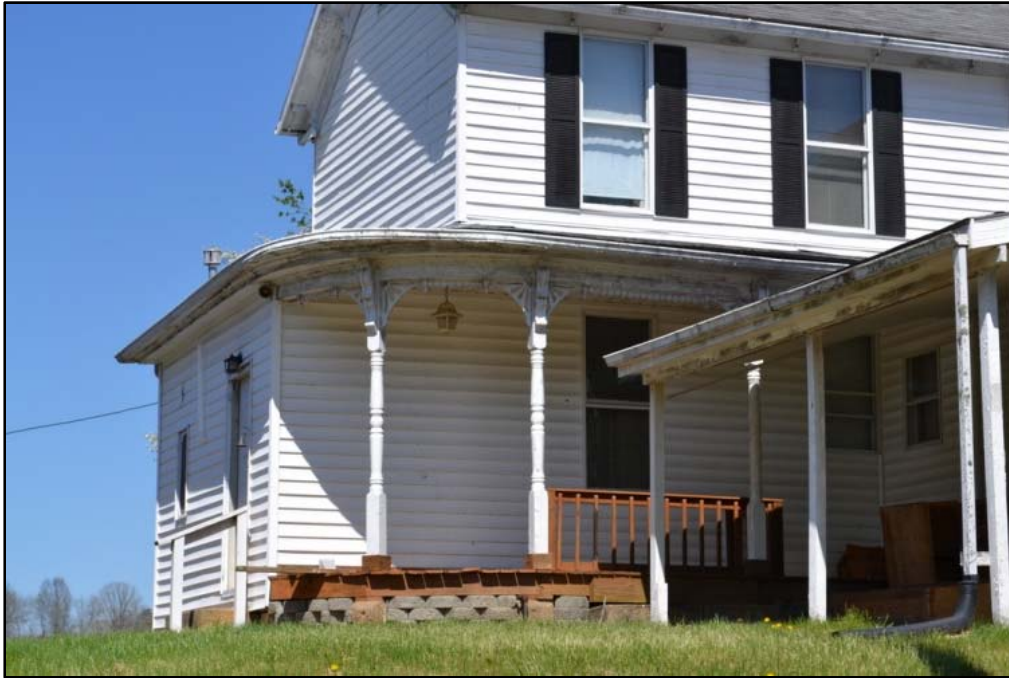
Figure 47 The brackets, turned and chamfered porch posts and sawtooth frieze are all machine made elements applied to the curved porch of the late-19<sup>th</sup> century house at WA-0214.

The majority of buildings documented in the survey were frame, most of them built with milled, sawn lumber with cut or wire nails. Most were either balloon frame, with stud wall construction (or platform frame), or box framing (no studs, with the wall itself – vertical boards – forming the structure). The railroad helped disseminate new architectural styles and materials across Wayne County. Dwellings were built in the Italianate style, with elongated arched windows, bay windows and decorative brackets. The late nineteenth century saw an increase in frame construction, largely due to the introduction of balloon framing. The ease and affordability of this construction method allowed standard rectangular and square forms to be modified. T-plans and cross-plan houses became common, as did the addition of porches and decorative Victorian elements to otherwise plain and traditional house forms.

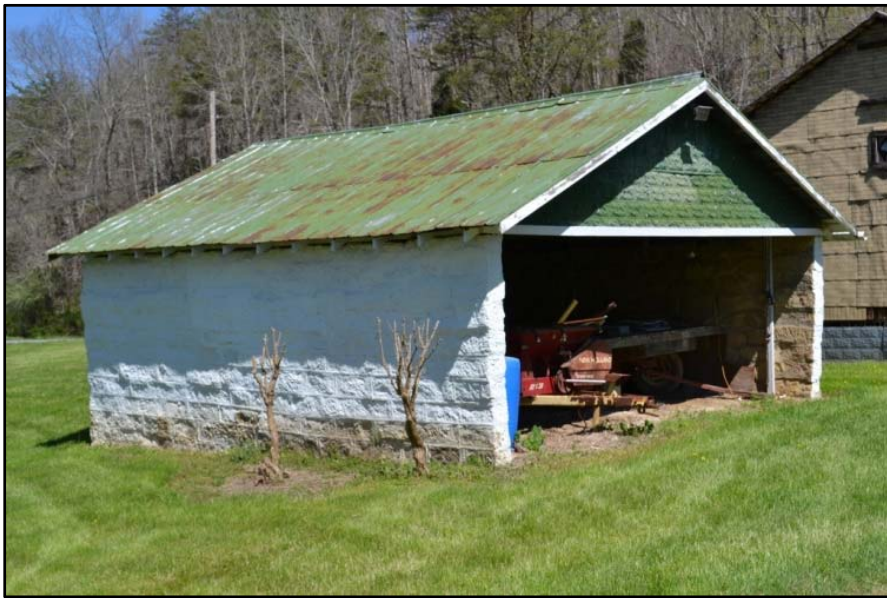
Figure 64 This rusticated concrete block garage with its exposed rafter tails, associated with WA-0215, displays the influence of the Craftsman style.

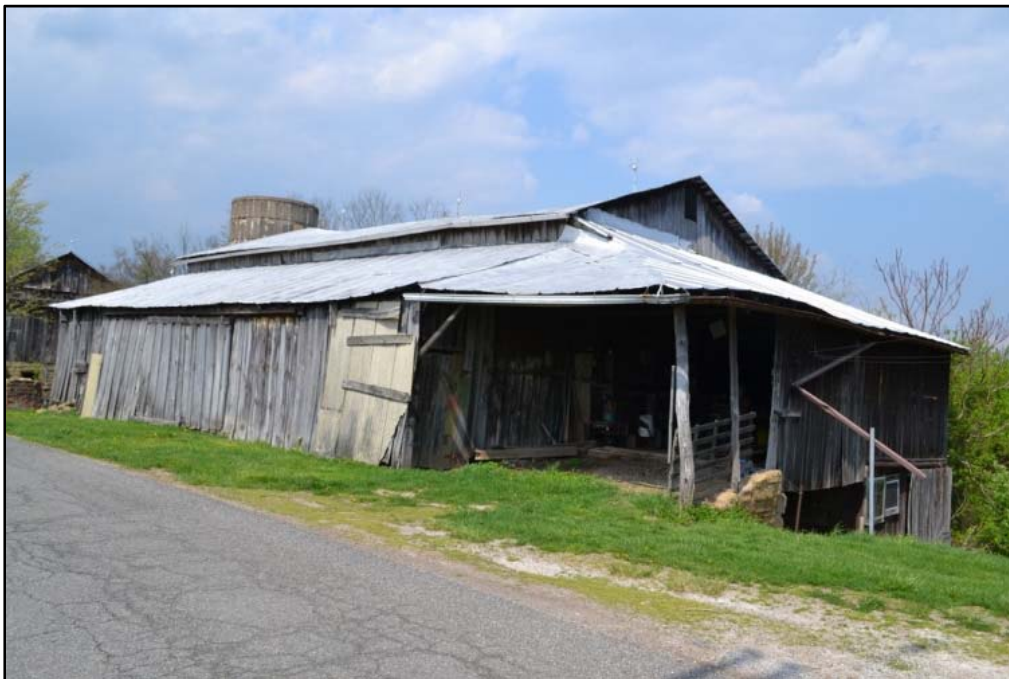
Figure 79 One of two bank barns at WA-0206. This barn has shed additions on the west and south elevations, and a concrete stave silo at the north gable end.

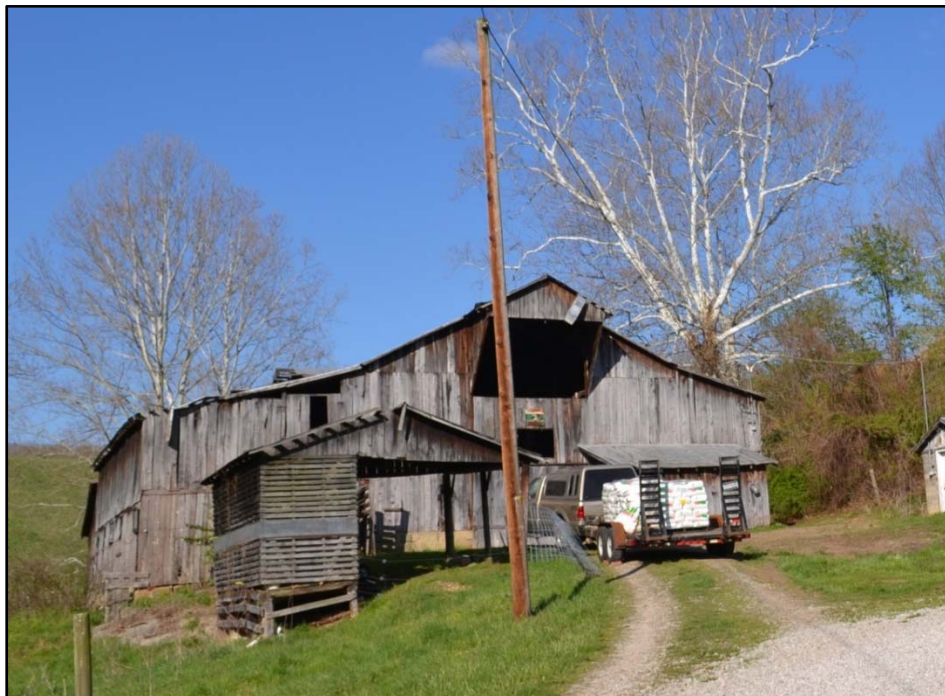
Figure 89 Transverse frame barn with enclosed side shed additions, WA-0209.

Whereas the traditional transverse frame barn contains three aisles under one roof (an open central aisle, and an aisle to either side, either open or divided into stalls), some barns in Wayne County have additional aisles formed by shed additions to the side. Allen Noble classifies these barns as Midwestern three-portal barns, which are essentially an “expanded barn achieved by adding enclosed side aisles.”<sup>62</sup> These side aisles are easily seen on barns with broken roof lines, like WA-0212 and WA-0209 (Figures 94 and 95).

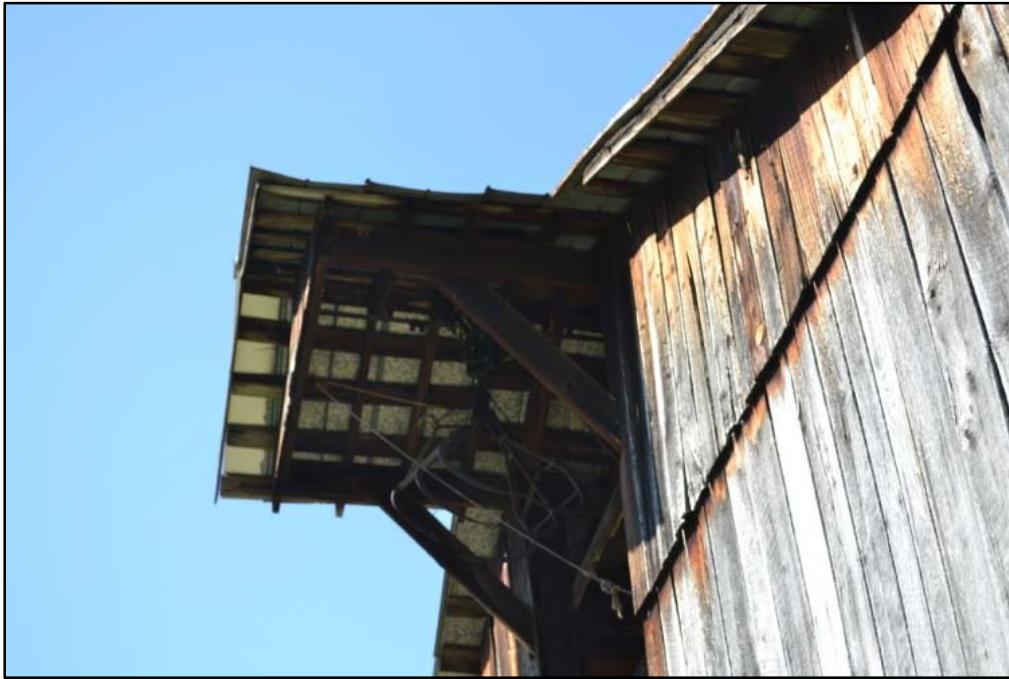
Figure 90 Front gable braced hay hood with hay rake extant, at WA-0212.

Many of the surveyed barns have hay hoods, which project from one gable end, above the opening to the loft. Originally likely only a projection from the gable at the ridgeline to accommodate a pulley for raising hay into the loft, over time, hay hoods became more elaborate. Hay hoods protected the hay fork (WA-0212, Figure 96 which gripped loose (or baled) hay and deposited it the loft, and also protected farm workers and hay from the weather. Some hay hoods are simple triangular shaped projections, like the one on the barn at WA-0204 and WA-0223 (Figures 3.24 and 3.27). Squared and boxed-in hay hoods, like the ones on the barns at WA-0209 and WA-0200

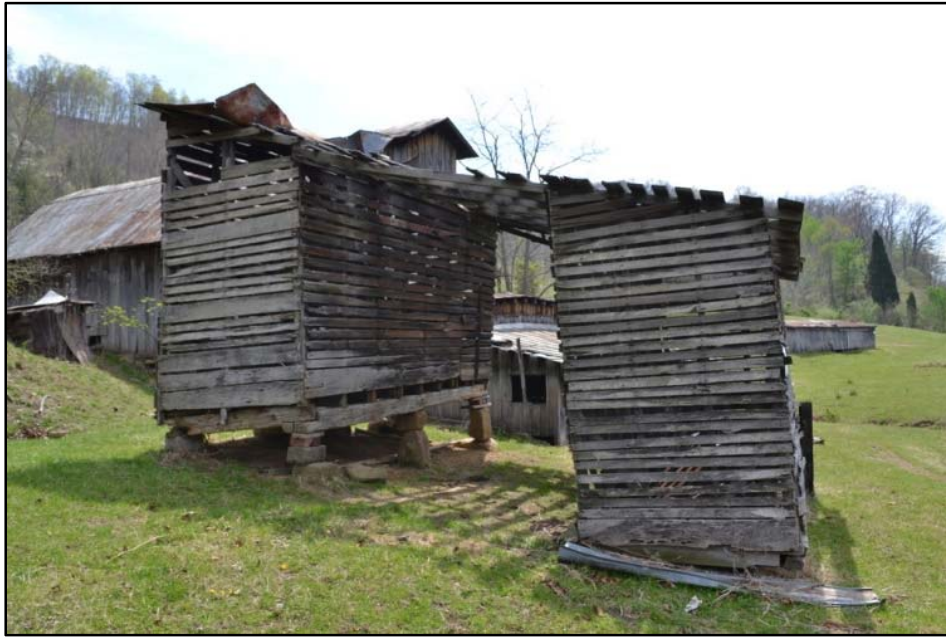
Figure 109 The slope of the site at WA-0199 allows for the single shed roof.

The crib at WA-0199 was modified to function like a drive-through corncrib, though it appears to be two single cribs unified under one shed roof by benefit of a sloping hillside (Figure 115 ). The lower crib rests on half-lapped sills on top of concrete piers. It appears to be later in construction than its counterpart. The upper crib, raised off of the ground by a combination of stones and paving bricks, has massive half-lapped sills displaying hewn marks. Both cribs, which are in poor condition and have not been used for some time, have human-sized doors on their west and east elevations.

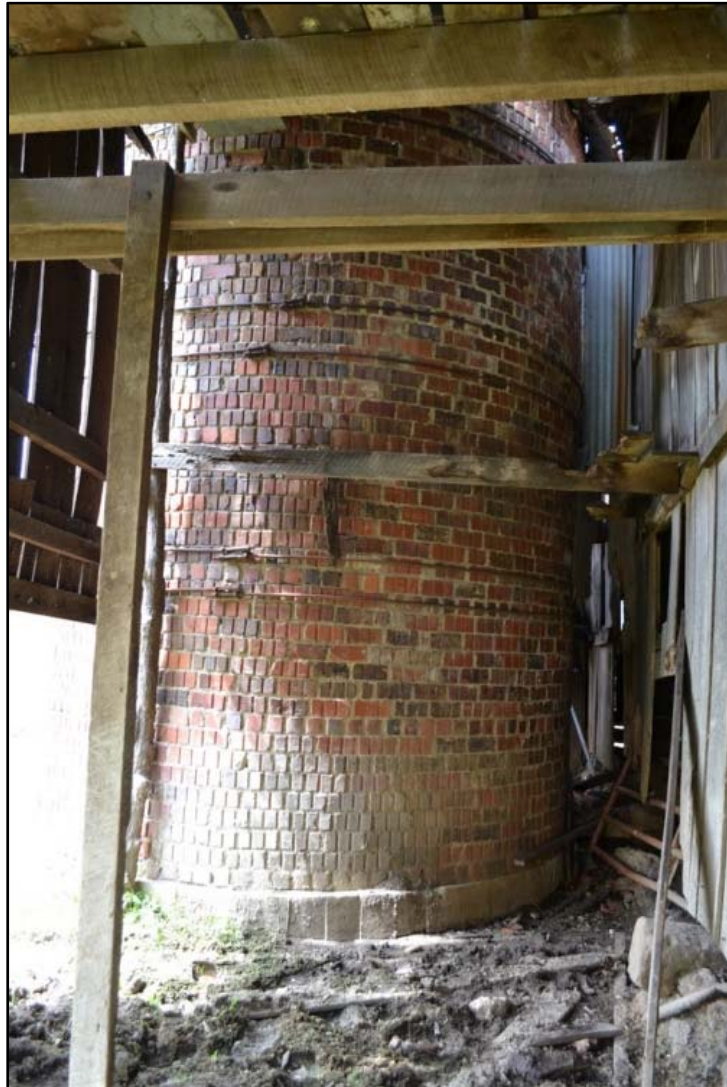
Figure 119 Circa 1937 silo made from brick pavers at WA-0199.

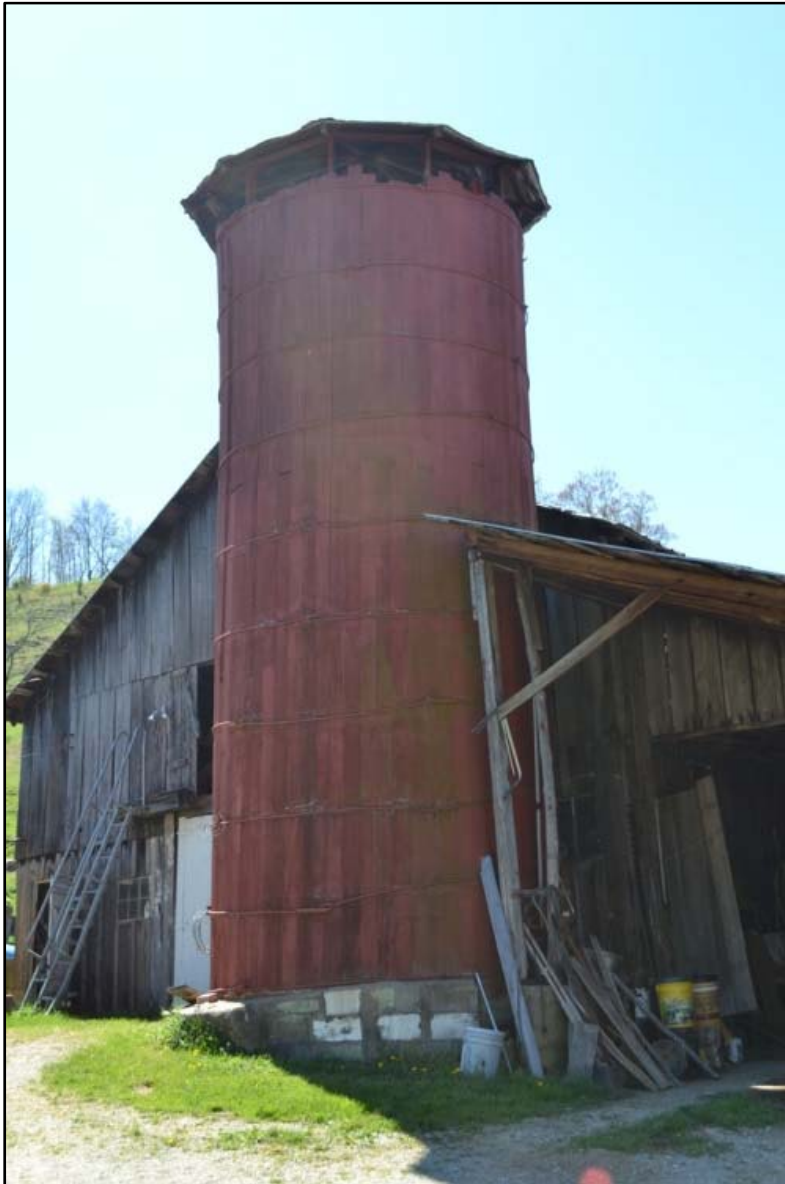
Figure 120 Wooden stave silo at WA-0217.
