National Register of Historic Places
Registration Form

historic name A. W. Gribble Farm
other names/site number Deerwood Farm

street & number Loop Road not for publication
city or town Pisgah vicinity
state West Virginia code WV county Preston code 077 zip code 26625

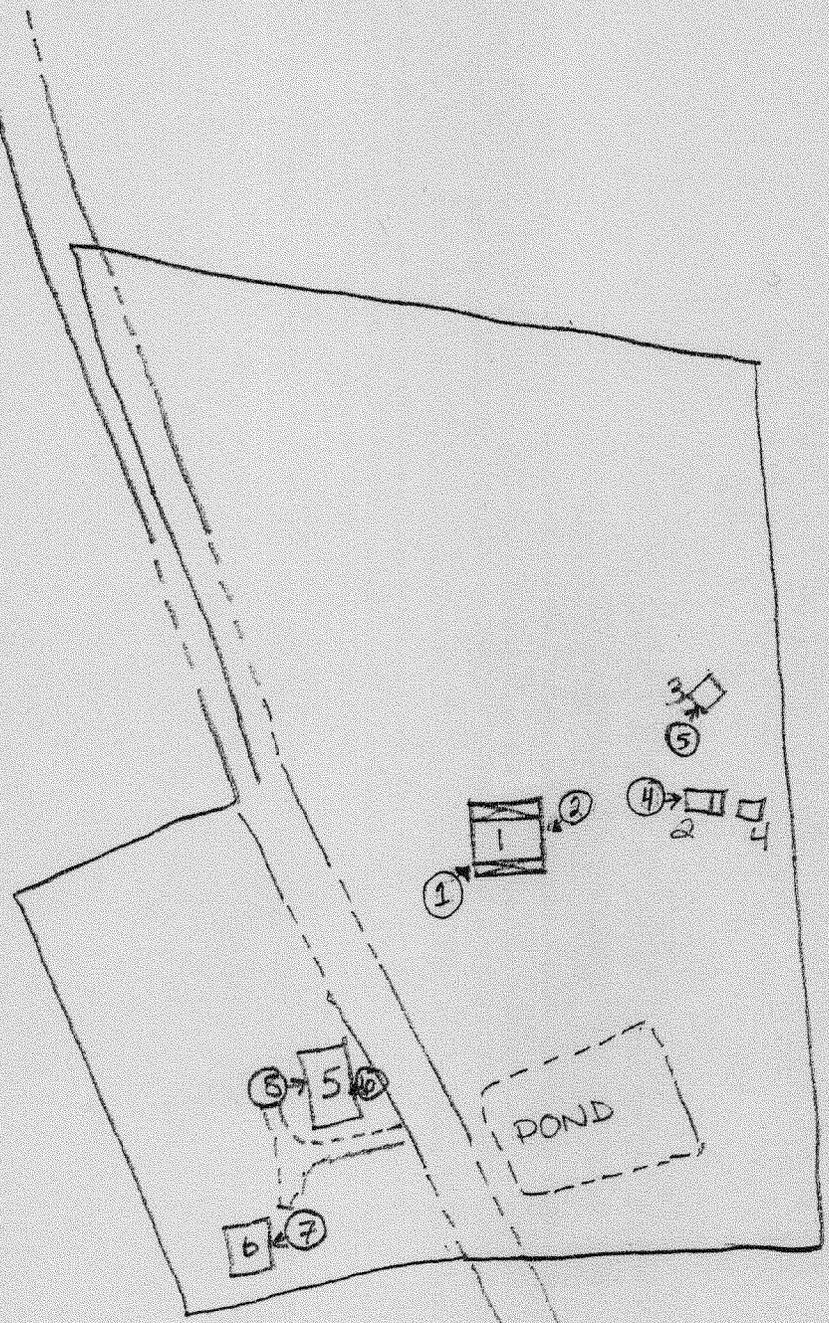
A. W. Gribble Farm Site Plan Preston County Pisgah Vicinity

- 1. House
- 2. Springhouse
- 3. Pantry
- 4. WPA. Privy
- 5. Barn
- 6. Log Dwelling Remains

① depict camera views

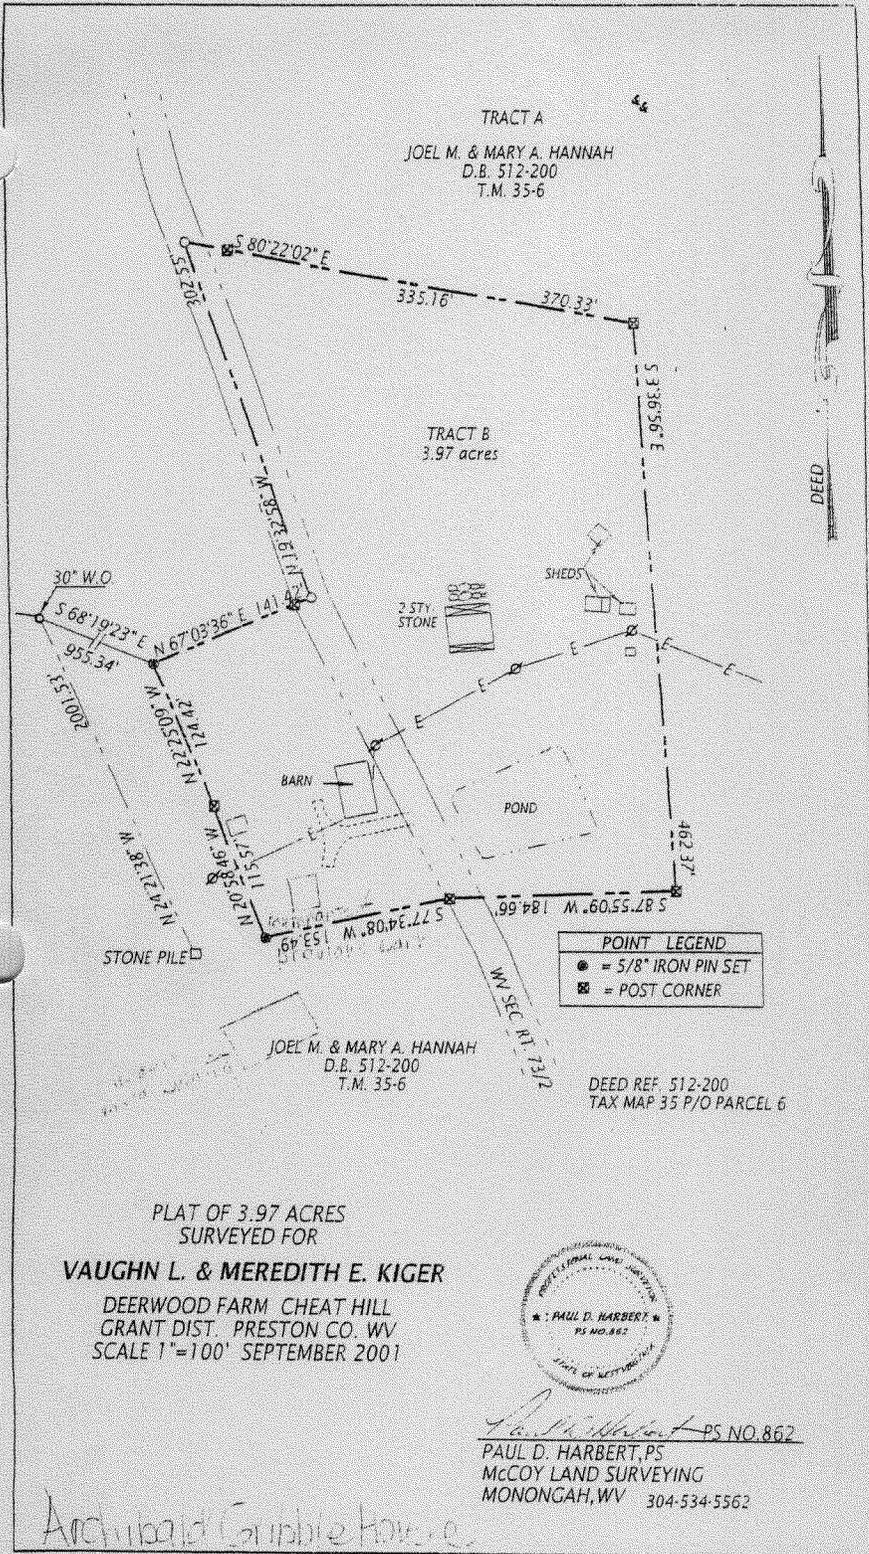
Deerwood
A.W. Gribble Farm
(not to scale)

PLAT OF 3.97 ACRES
 SURVEYED FOR
VAUGHN L. & MEREDITH E. KIGER
 DEERWOOD FARM CHEAT HILL
 GRANT DIST. PRESTON CO. WV
 SCALE 1"=100' SEPTEMBER 2001
