**National Register of Historic Places  
Registration Form**

historic name Altona

other names/site number Altona Farm

Altona, Jefferson, WV

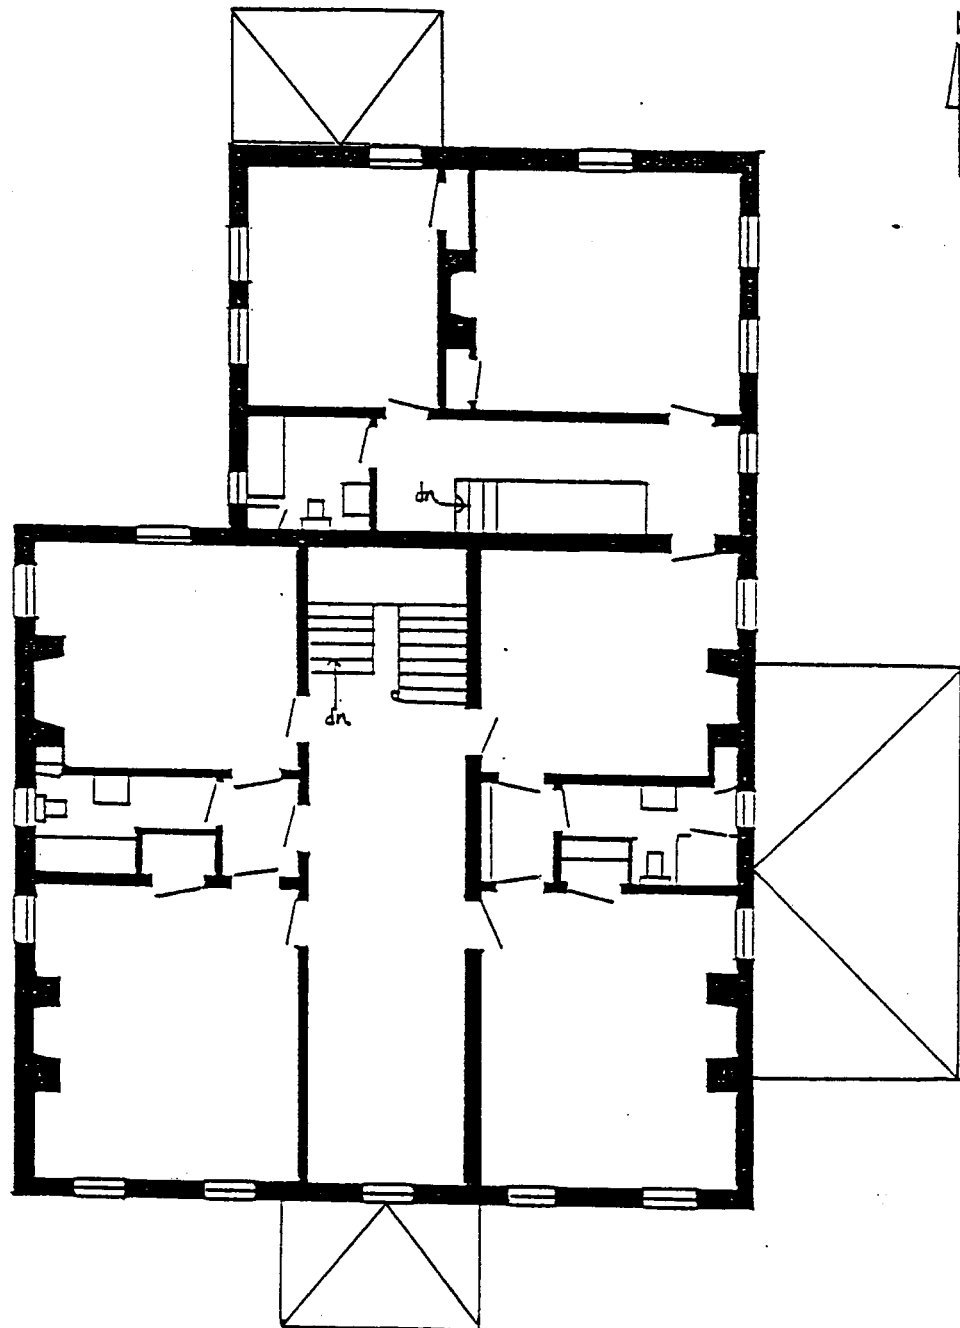
#1b Altona - Mansion  
second floor  
nts

The second floor configuration is the same as the first floor. The fireplaces, doors, windows and surrounds all are identical with the first floor. Exceptions are: the center hall at the south end has had closets added into the hall, the bedrooms have been invaded by bathrooms built between each pair on either side of the center hall. The hall at the top of the back stairs has a bathroom at the west end. All rooms have fireplaces with the exception of the room at the northwest corner.

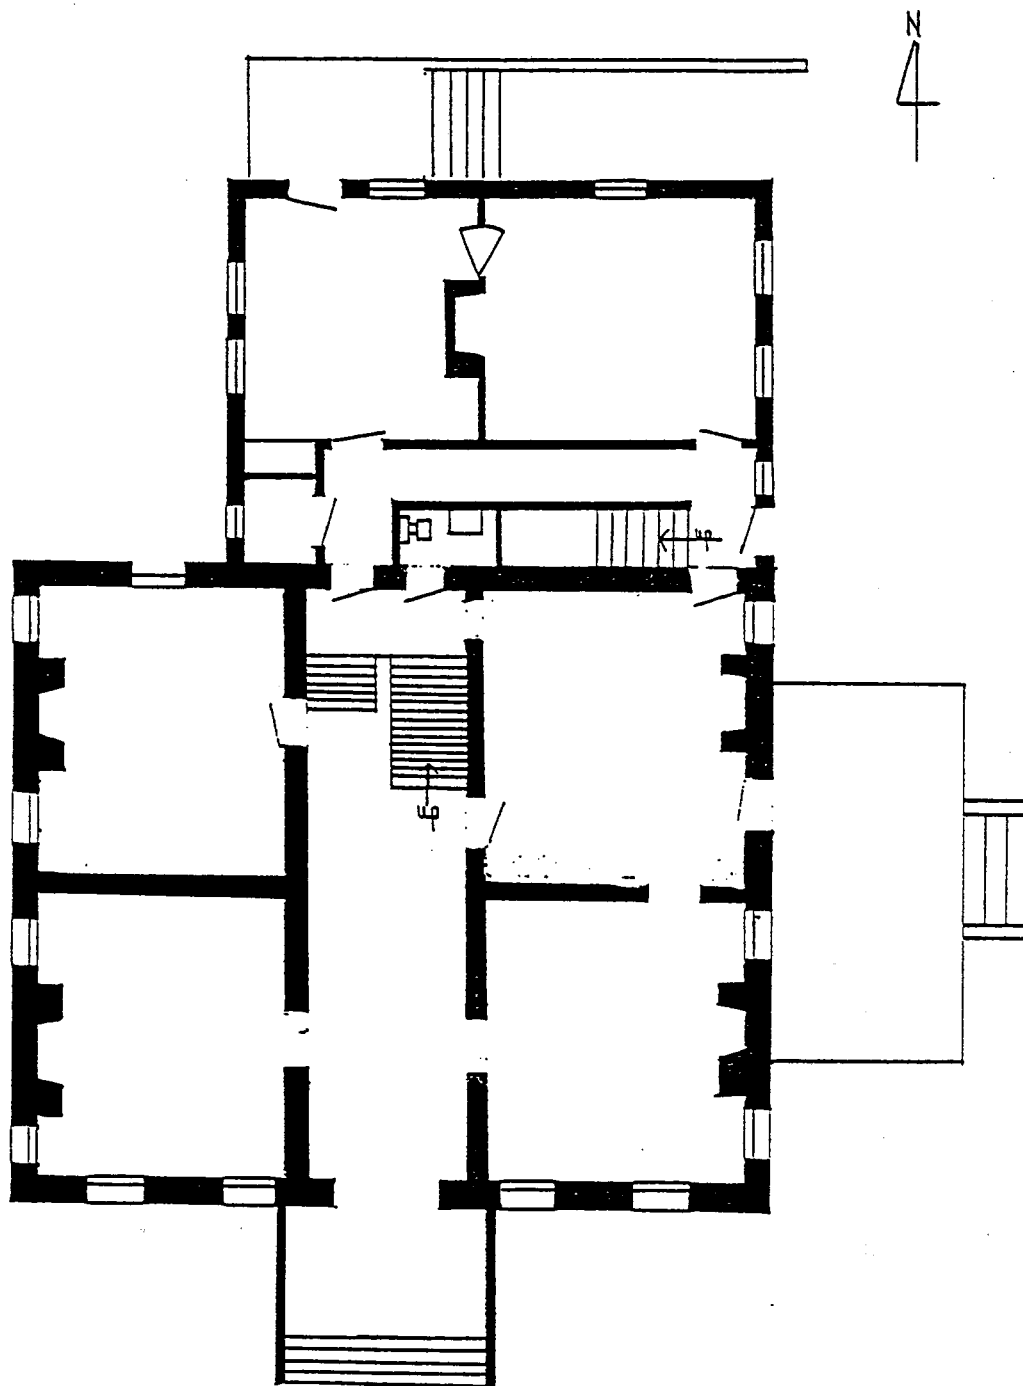
# 1a. Altona - Mansion  
first floor  
nts

Mansion House, ca. 1793-1936, contributing, good condition  
See Sketch # 1a-1c, Photo # 1-11.

A wide wallpapered center hall, ca. 1830, leads to the kitchen at the rear of the house. The hall wood surrounds at its doorways are double wide center bead with bulls eye corner blocks. The doorways have deep panelled reveals due to the brick partitions between the rooms. Framing the 3" oak floor is an 8" baseboard capped with a flat bead. On the south wall is a federal-style front entrance with a leaded glass fanlight over a 6 panel door flanked by side lights above a single fielded panel. Along the rear of the east wall is a wide staircase, ca. 1830, with a curved balustrade at the foot. The newel post and handrail are mahogany with simple round white painted balusters.

Entrances from the hall to the two living rooms, ca. 1830, are at the south end of the hall. The rooms mirror each other in placement of fireplaces on their outside walls opposite their doorways from the center hall and placement of windows. One exception is a door at the north wall of the east room which leads to the reception room. Also in the same room is a bookcase above cupboards at the south side of the fireplace.

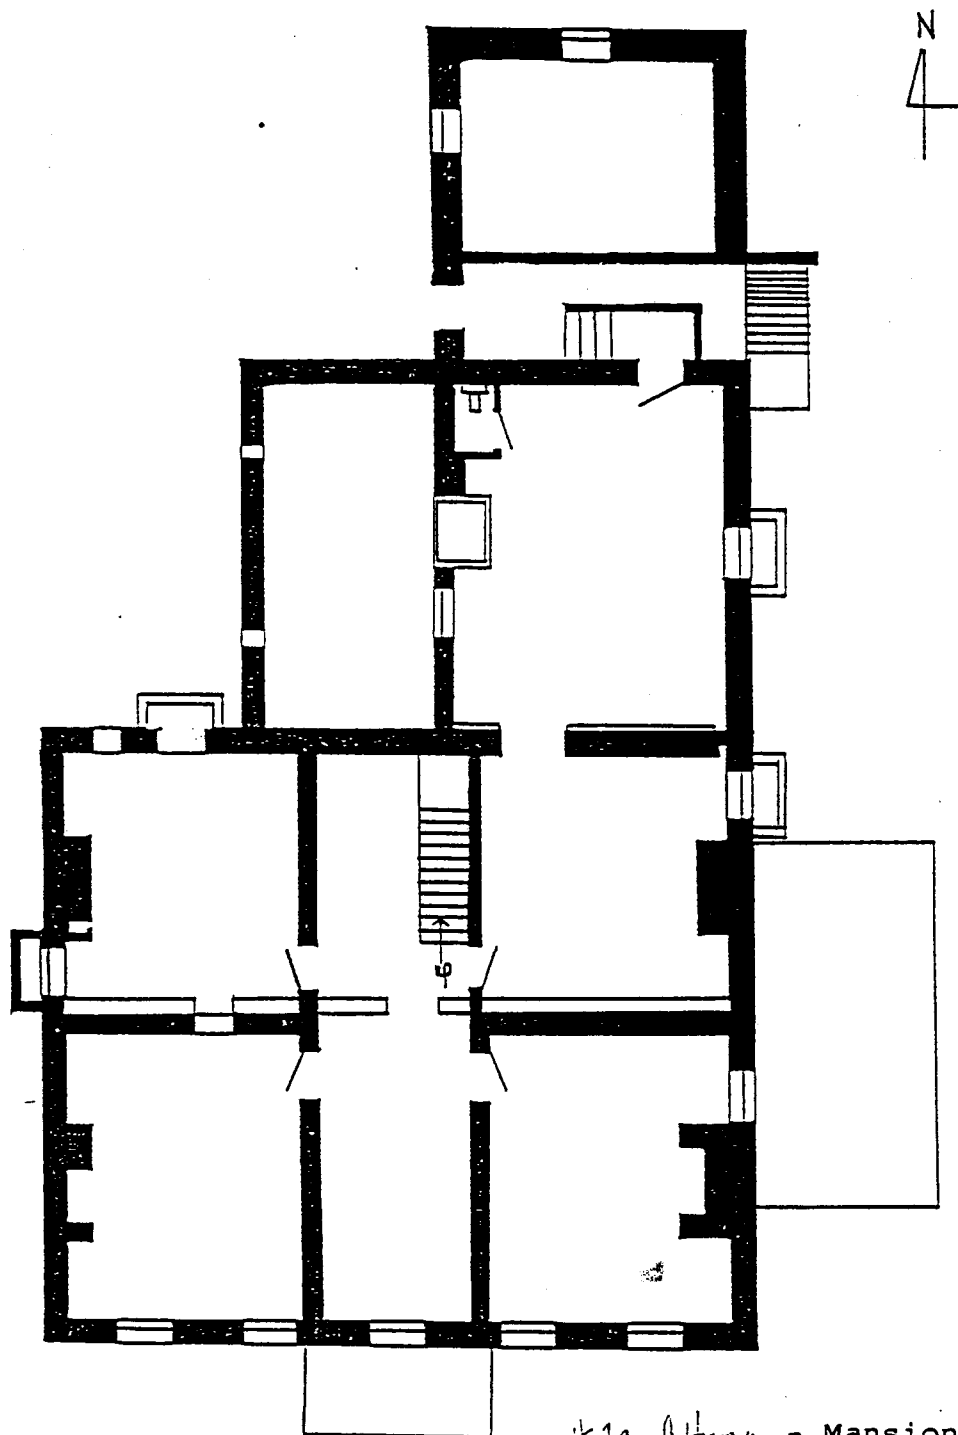
#1c Altona - Mansion  
casement  
n/s

The basement floor plan repeats that of the first floor. Here is visible the 3 foot wide stone foundation, the other walls are plastered brick. There is a concrete floor throughout. There are 6 light English basement awning windows that swing in. Fireplaces remain in their original position but two have been altered to accommodate furnaces. Tongue and groove doors with strap hinges are evident in the doorways of the two front rooms.

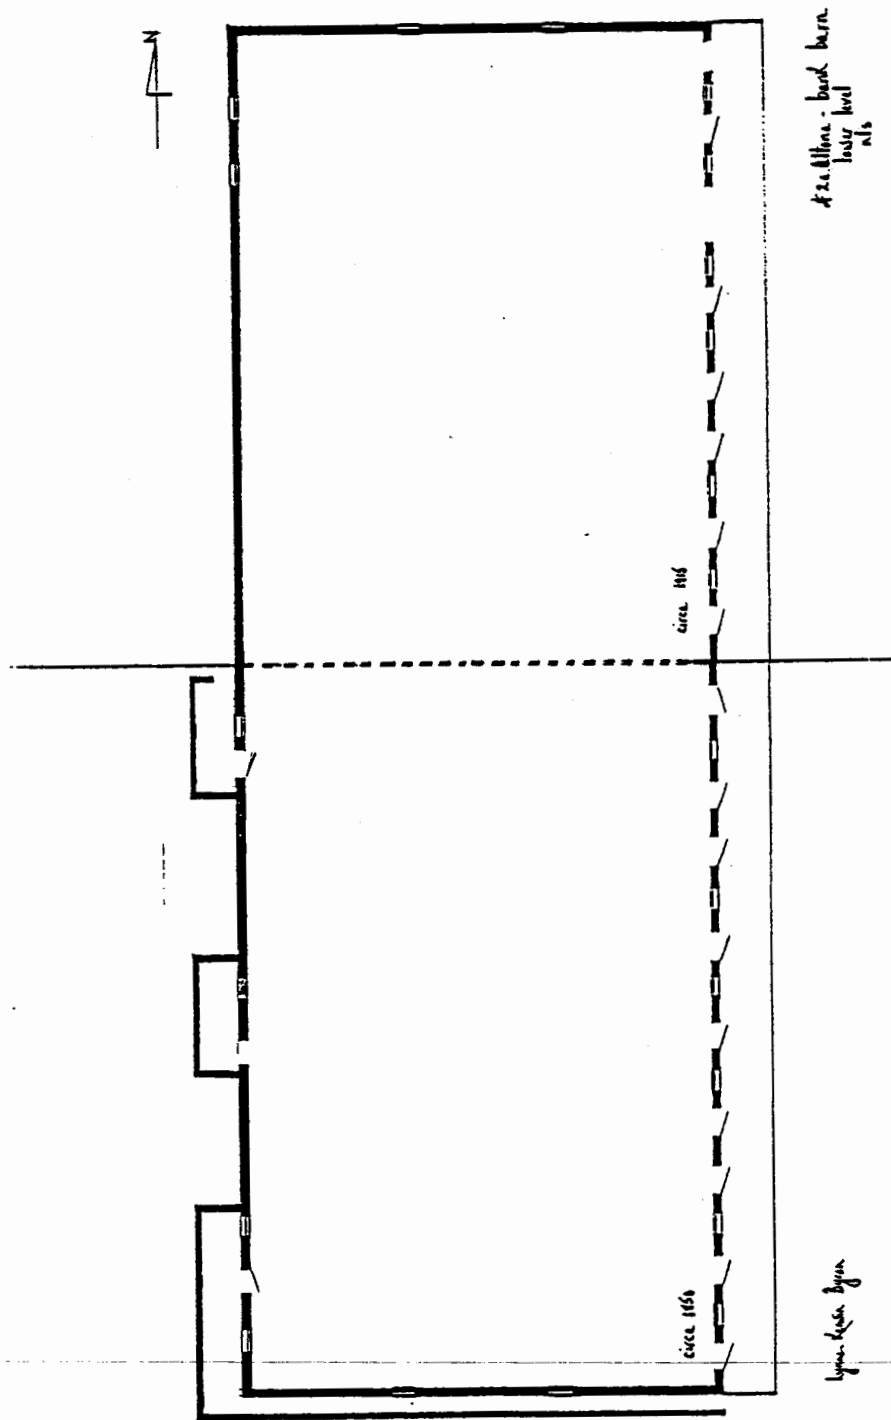
Section number \_\_\_\_\_ Page \_\_\_\_\_ Sketch 2a Altona, Jefferson County, WV

Bank Barn, ca. 1850 and 1915, contributing, good condition  
See Sketch # 2a-2b, Photo # 12-16.

This 198' common bond brick gable end standing seam tin roof bank barn is built on a cut limestone foundation with quoins. The stone is surrounded by raised mortar and the brick gable ends are reinforced with "S" shaped iron braces. The original mid-19th century southern end was doubled in size by an addition at its north end in about 1915 to accommodate horses and mules.

The addition duplicates the original section. At the west elevation common bond continues and each section has a pair of centered barn doors flanking weather-board siding. Symmetrically placed vertical vents are in the brick sections. These vertical vents form a pleasing design at the gable ends. Decorated verge boards are also at the gable end.

Beneath the random width white painted weatherboard forebay at the east elevation is a row of alternating stall doors and window grates. The doors are of beaded-edge random width boards with strap hinges and the window grates are of square horizontal wood dowels. These windows are spaced equally in the rest of the barn foundation. The older section has a row of eight windows in the forebay.

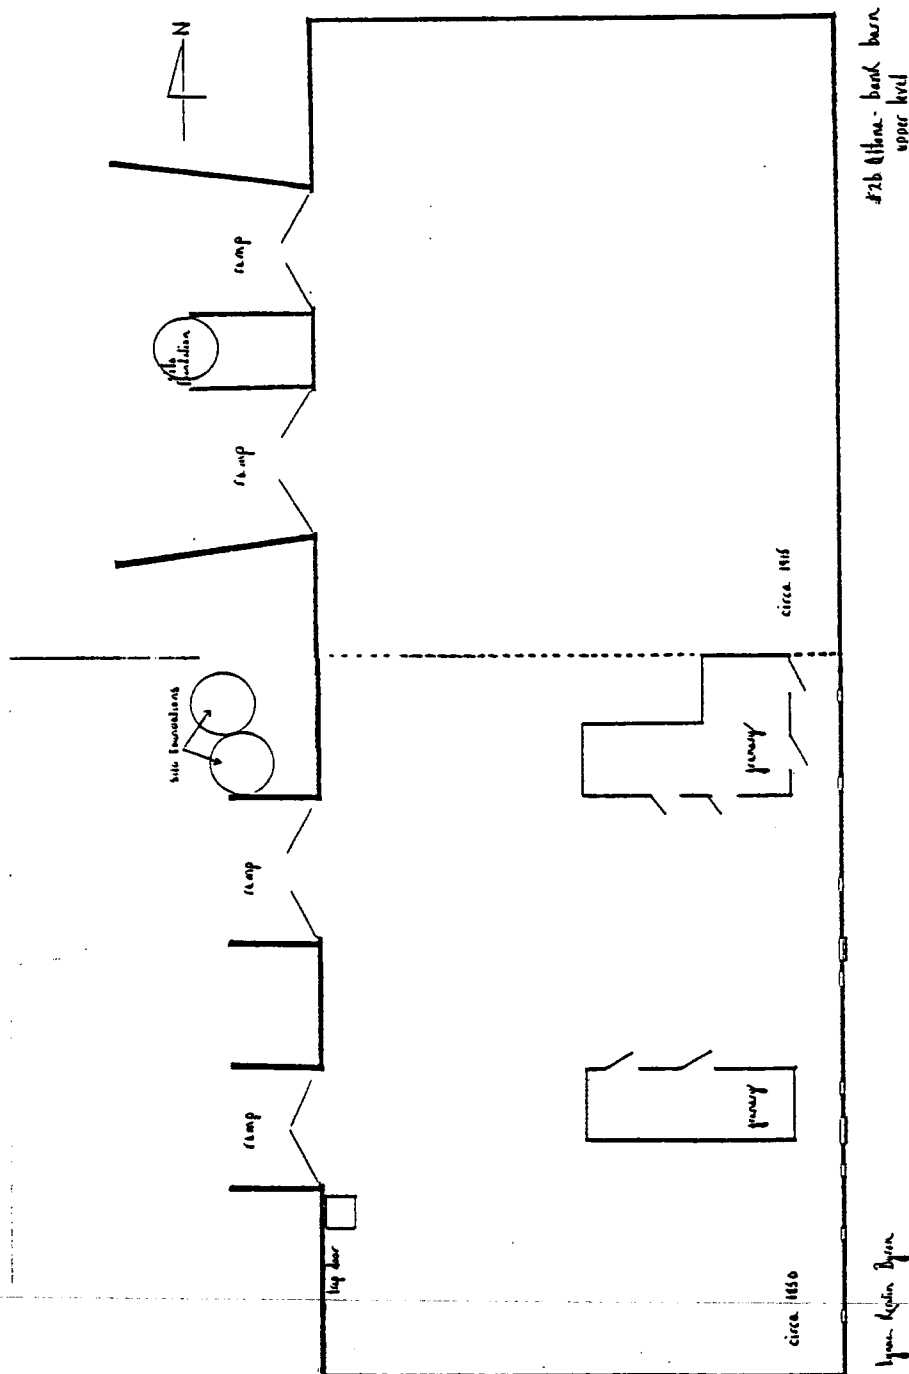
Section number \_\_\_\_\_ Page \_\_\_\_\_ Sketch 2b Altona, Jefferson County, WV

The upper level interior is interrupted at the middle by the original brick north gable end of the earlier barn. It was white washed and an outline of a shed that was attached on the outside wall is still evident.

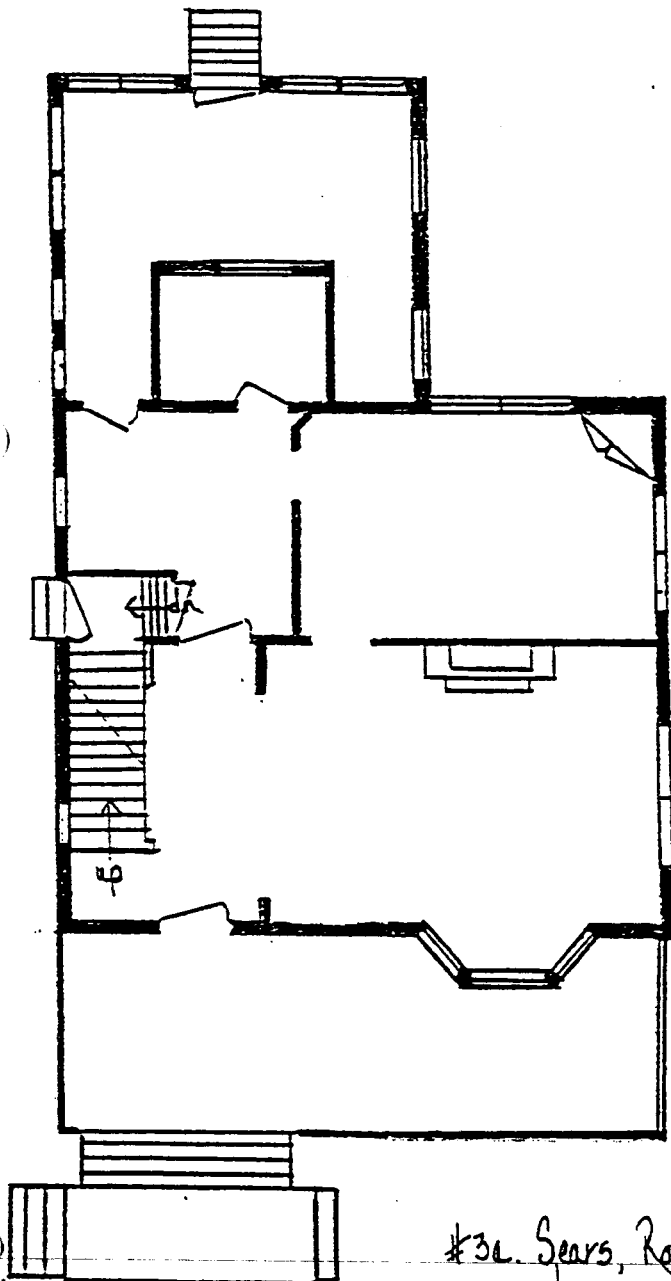
#3a. Sears, Roebuck house  
nts

Sears Roebuck House, ca. 1920, contributing, good condition  
See Sketch # 3a-3b, Photo # 17-20.

The entrance door is a single recessed panel beneath a 4 over 4 light panel and opens to the front hall at the west end of the front elevation. A stairway to the second floor is on the west wall. Its balustrade is of a flat handrail above square balusters. The square newel post has a flat square cap and beveled collar. The landing to the second floor is two-thirds up from the bottom. Directly opposite the entrance door is a swinging door into the kitchen.

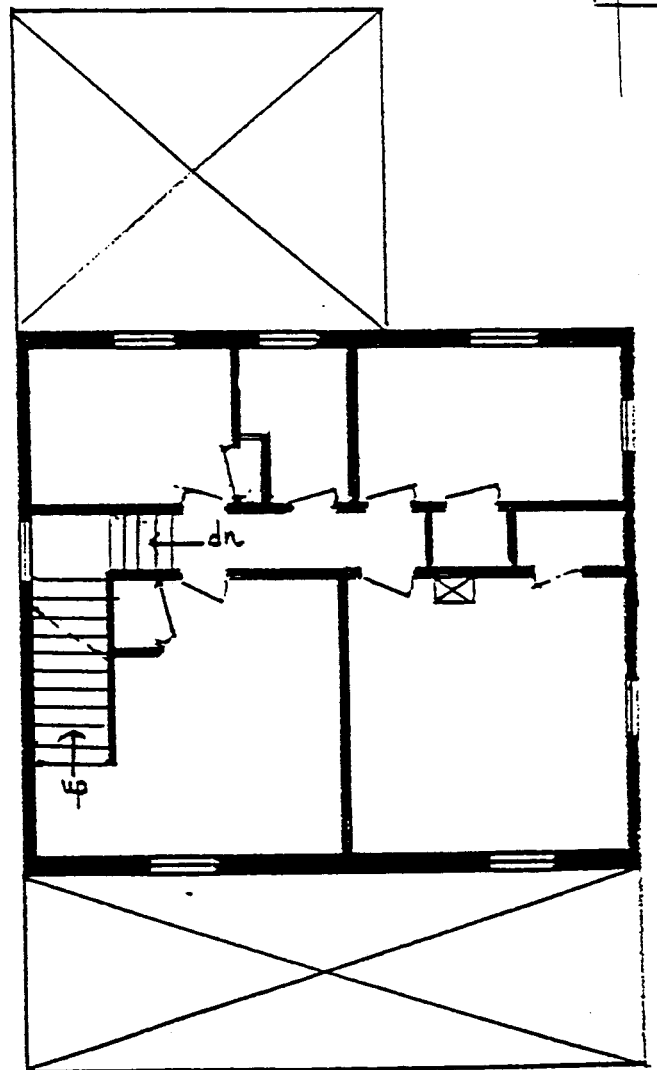
#3b. second floor

On the east wall is a wide flat archway into the living room which has a rounded stone fireplace and concrete mantel with a glazed tile hearth on the north wall. Opposite the fireplace is a shallow bay window. At the west of the fireplace is a door into the dining room. It has a corner cupboard at the northeast corner of the room and a flat board chair rail. The kitchen has recently been upgraded with contemporary cabinets, appliances and tile floor. Two doors are on the north wall, one to a laundry/powder room and the other a single light over three raised horizontal panels was originally to the back porch entrance which has now been enlarged to an enclosed porch. From the kitchen one can descend stairs to the basement and the side entrance. Flanking the stairway is the original beaded edge wainscoating. The basement is stone and has a concrete floor and a brick pier for the fireplace. The second floor has a center hall flanked on the south by two bedrooms and opposite by a contemporary bath between two corner bedrooms. The walls, surrounds, floors and doors are as described on the first floor. The southwest corner bedroom has a door to the attic.

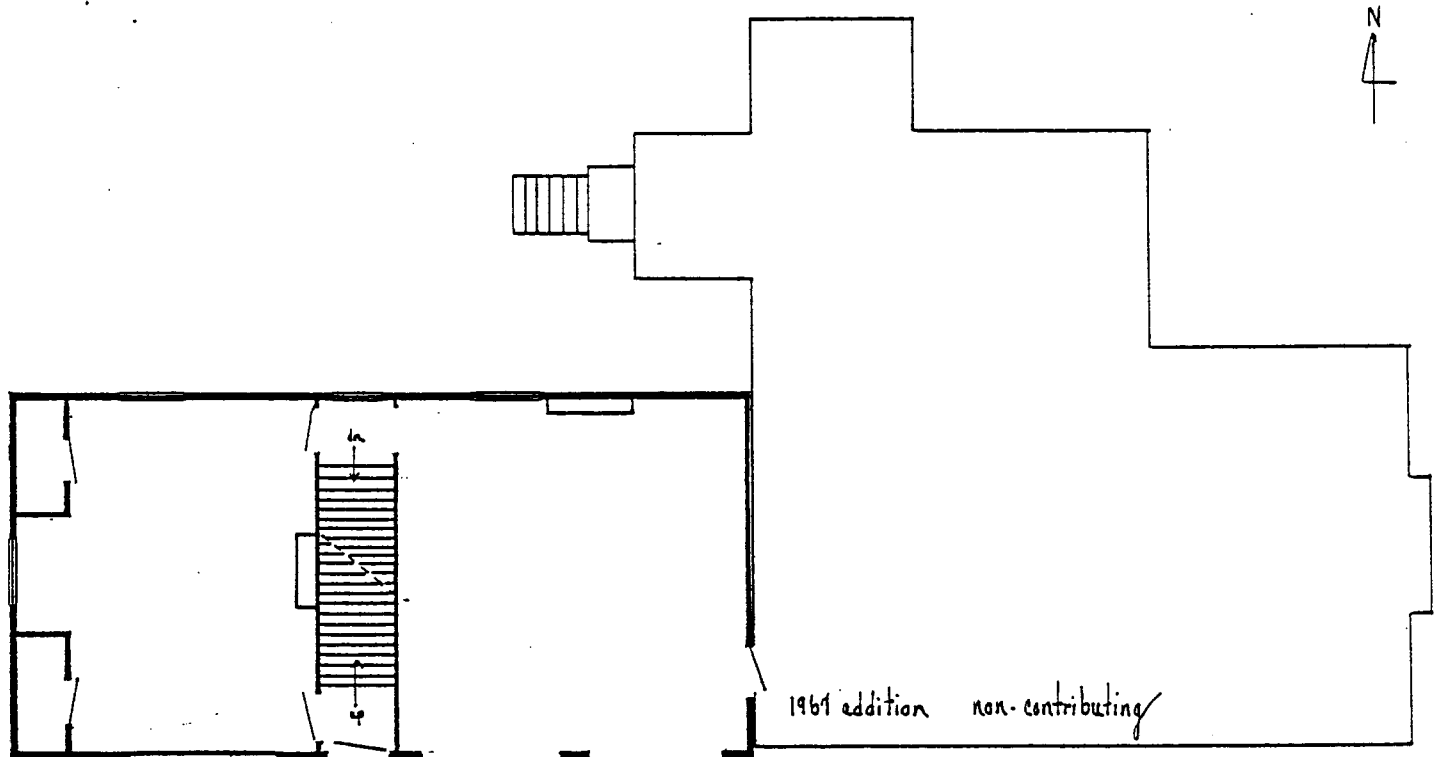
#4a Altona - garage/guest house  
nts

Garage/Guest House, ca. 1936 and 1967 addition - contributing, good condition  
See Sketches 4a-4c, Photos 21-25.

The three bay white painted running bond brick two story garage, ca. 1936, has symmetrically placed French windows throughout and a slate roof. The non-contributing 1967 guest quarters addition obscures the original east gable-end that mirrored the west elevation with its symmetrically placed French windows. However, at the attic level one with a curved transom is still visible.

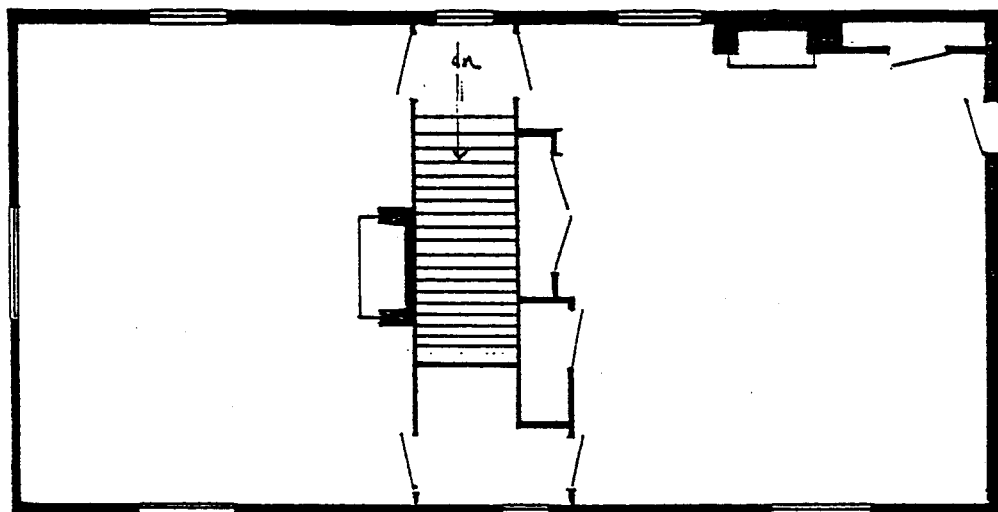
#4b. Altona - second floor garage/guest house  
nts

The interior of the 1936 section has two basement rooms flanking a stairway from the ground level garage bays which have concrete floors and centered drains. The rooms on both floors have plaster walls and ceilings. The ground level rooms or bays have been used as recreation areas and garages. The west room has a fireplace centered on its east wall. Two bedrooms with fireplaces are above these rooms. They were altered to be compatible with the colonial revival style of the 1967 addition. A ceramic tile bathroom is between the bedrooms. This area at one time was servants quarters and became bedrooms for the one story 1967 addition.

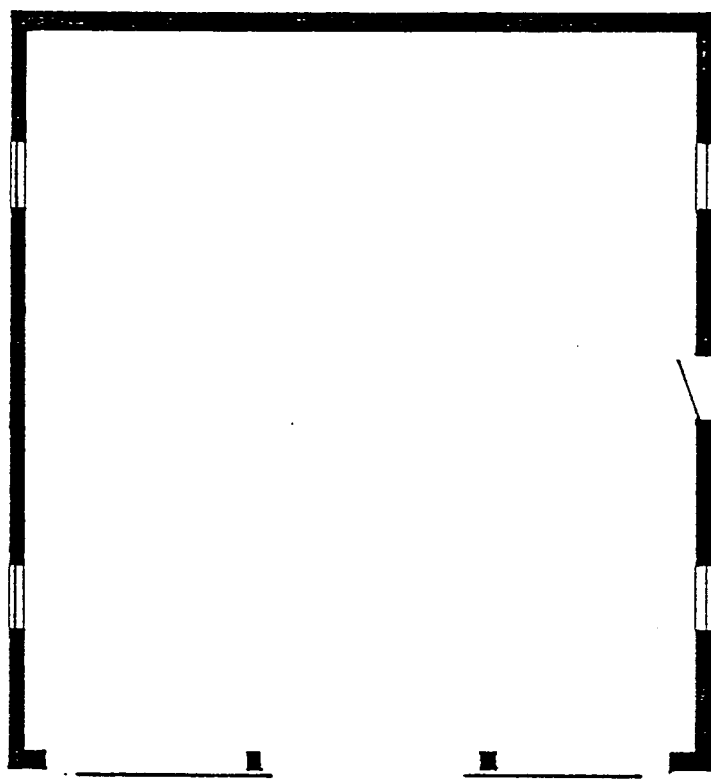
#11 Altona - stone garage  
nts

Stone Garage, ca. 1899, contributing, good condition.  
See Sketch # 11, Photo @ 31.

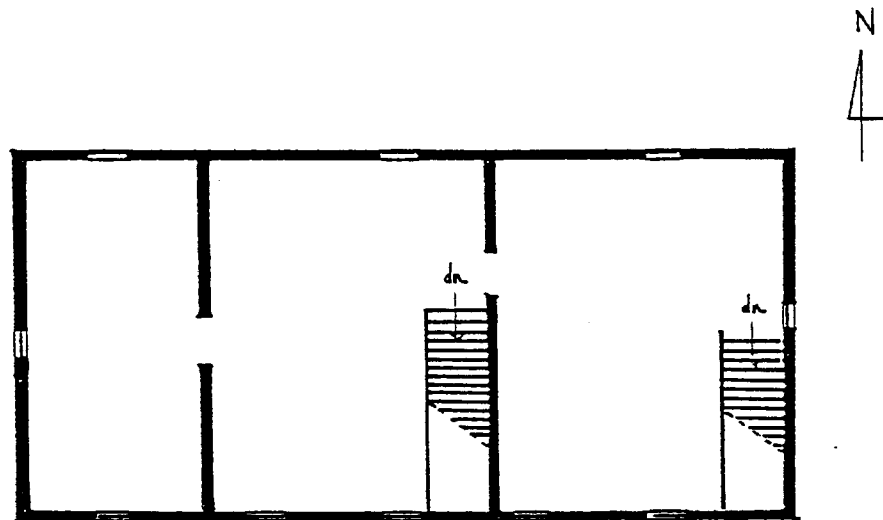
#6b: second floor

The two white clapboard over log buildings are on stone foundations. They have standing seam tin roofs. The 5 bay one on the western side has two entrances in order to separate the men and women. It also has separate stairways to the bedrooms. The other one has an ell at the north elevation for a kitchen. The windows are 6x6 double hung. Six light eyebrow windows are under the eaves on the facades and at the gable ends. Both houses have hair plaster over hand planed slats and flat board surrounds at the doors and windows. The exception is the office space on the first floor of the 5 bay house which has contemporary panelling. The kitchen ell of the smaller house has a cooking stove at its north/back wall.

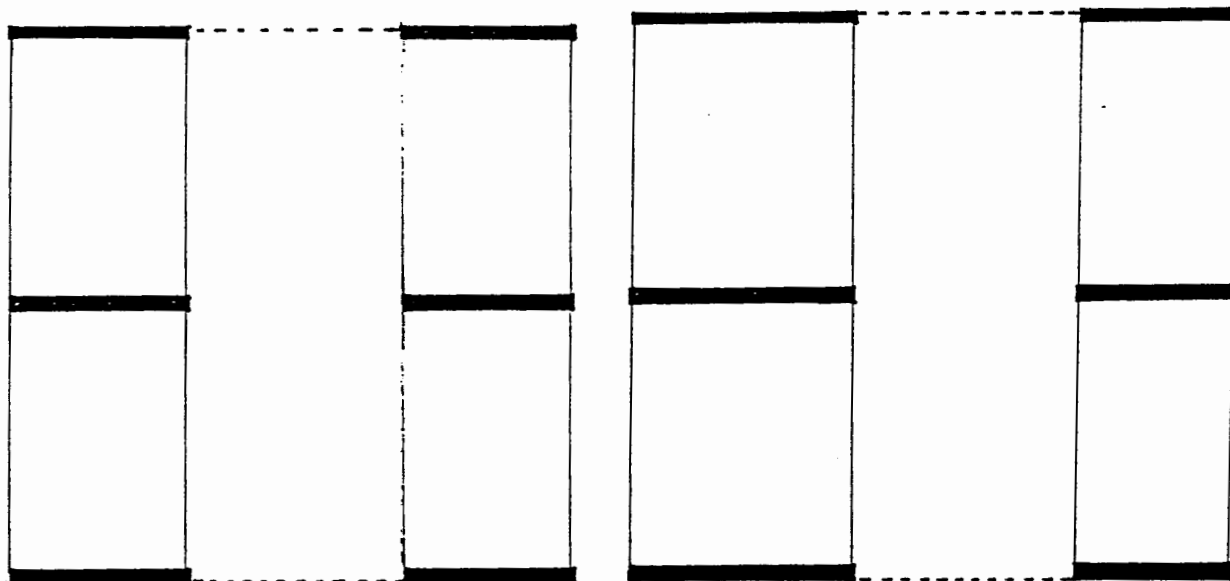
#8-Altona - corn cribs  
nts

Corn Cribs, ca. mid-late 19th century, contributing, good condition.

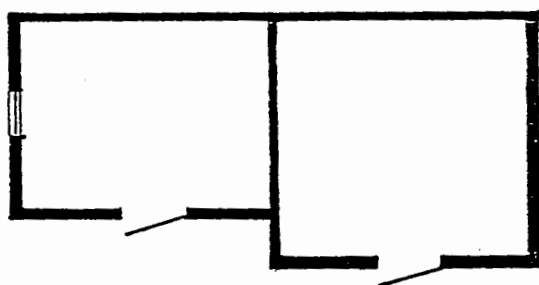
# 1 Altona smokehouse  
nts

Smoke House, ca. late 19th century, contributing, good condition.

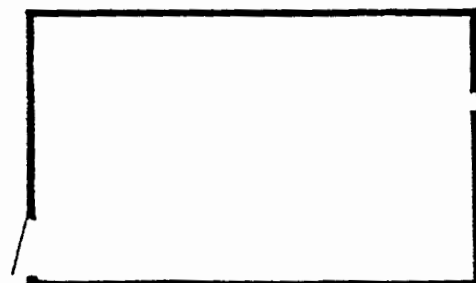
# 10 Altona outbuilding # 2  
nts

Outbuilding #2, ca. 1938, contributing, good condition.  
See Sketch # 10, Photo # 30.

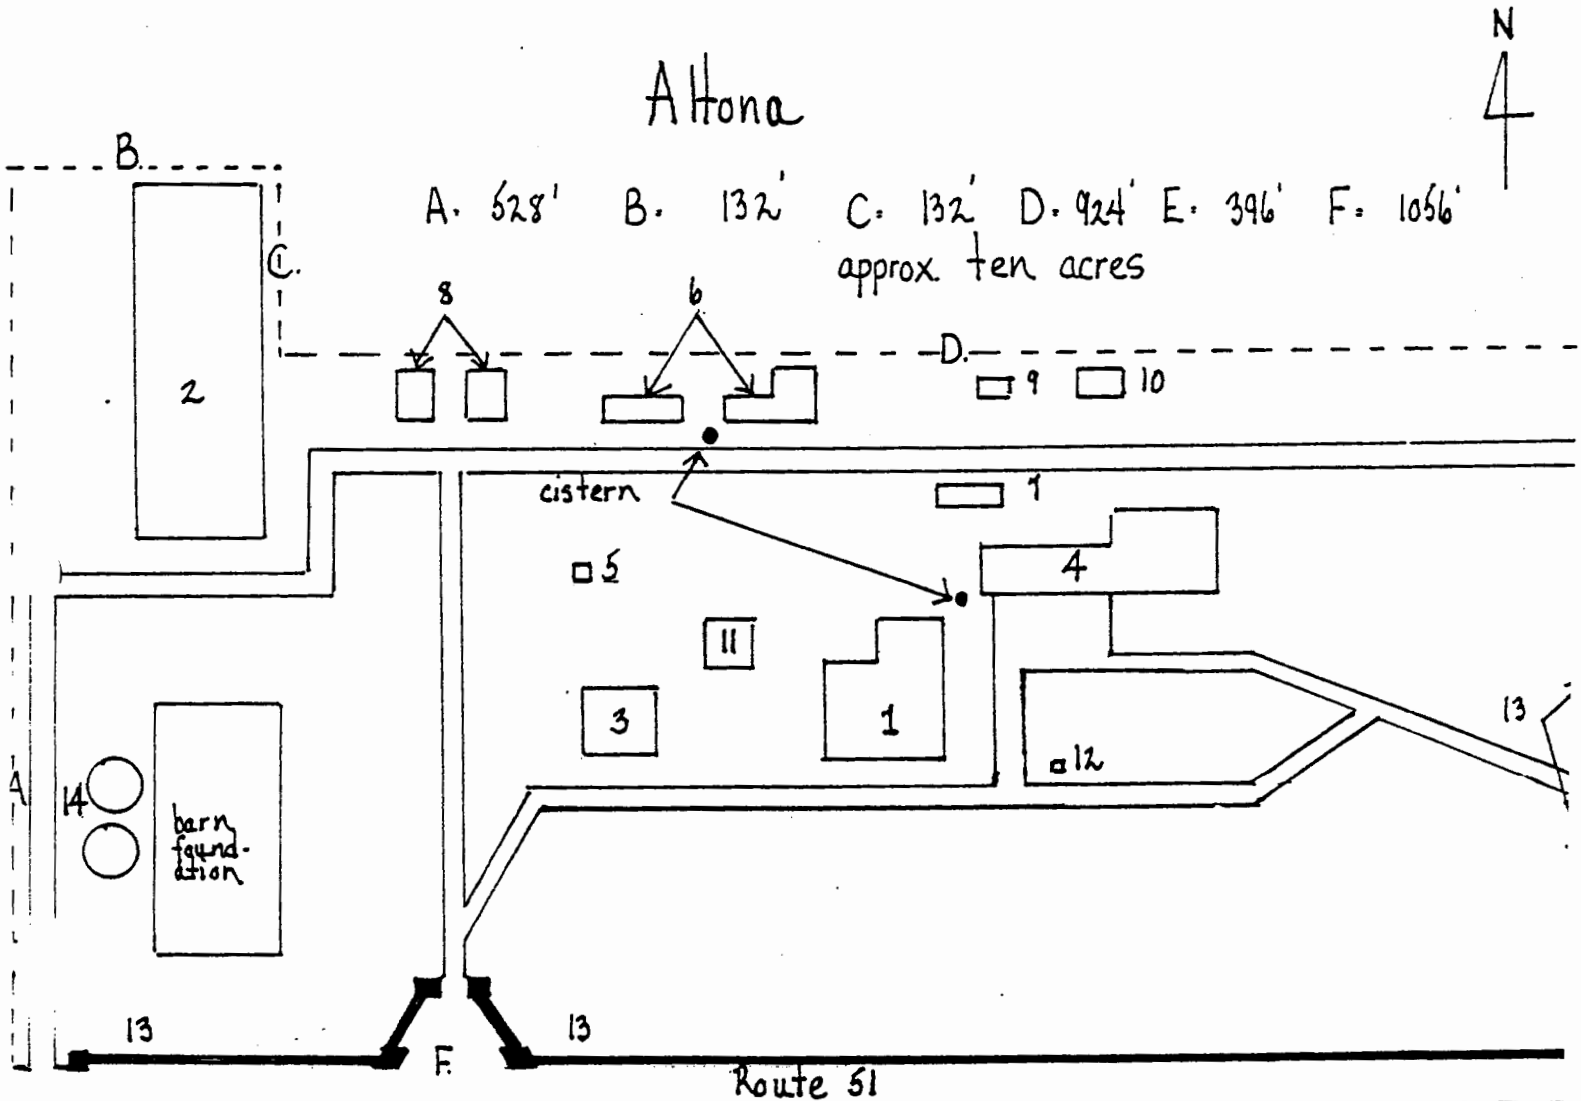
Section number \_\_\_\_\_ Page \_\_\_\_\_ Sketch 12 Altona, Jefferson County, WV

- 1 mansion house
- 2 bank barn
- 3 Sears, Roebuck house
- 4 garage/guest house
- 5 stone outhouse

- 6 slave quarters
- 7 smoke house
- 8 corn cribs
- 9 outbuilding # 1
- 10 outbuilding # 2

The boundaries as displayed in Sketch # 12, though larger than the recommended 10 acre parcel, is dictated by the spacing of Altona's historic resources.
