**National Register of Historic Places**

Registration Form

historic name Brookside Historic District

state West Virginia code WV county Preston code 077 zip code 26705

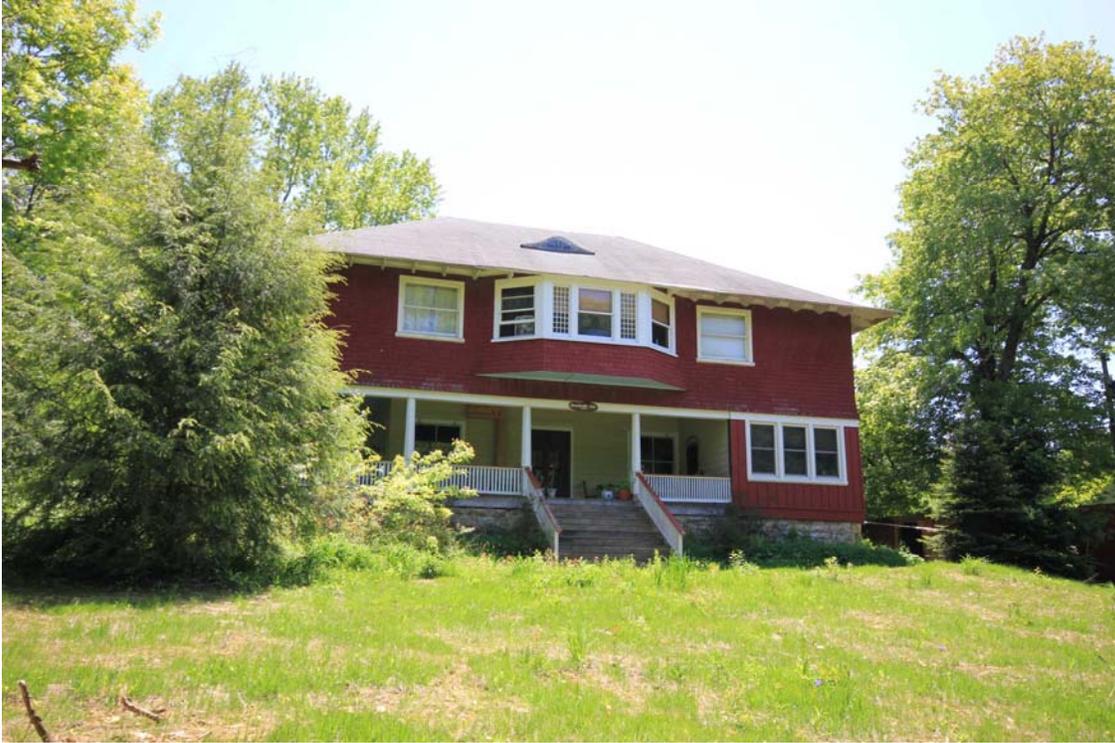
1 - Gaymont: Front elevation looking south.

**1. Brookside Inn/Gaymont**                      **ca. 1895**                      **Photos 1, 2**                      **Listed**

Gaymont (now known as the Brookside Inn) is a two-story residence with a rectangular plan and a low-pitched hipped roof with very deep bracketed overhangs. A large brick chimney projects from the center of the roof. The house is wood balloon frame construction and is covered in wood clapboard siding on the first floor and wood shingles on the second floor. The foundation is random course sandstone. Two gabled bays project from the east and west sides of the house on the second floor level. A wraparound porch extends around the front (north) and two sides (east and west) of the building and is recessed beneath the second floor, projecting out with the gabled side bays. The porch is five bays wide on the front façade and is supported by wood tapered columns. Porch railings are simple closely-spaced vertical wood spindles. On the east elevation, the porch extends along the exterior wall past the projecting second floor bay and is covered with a pyramidal roof supported by tapered columns with no railings. The west portion of the porch has been enclosed and is covered in clapboard siding. Originally some portions of the first floor exterior consisted of rustic log siding; some of this siding is still visible in the enclosed porch area. The porch is accessed by a wide staircase on the north (front) façade and is at grade level on the side elevations.

The front entrance is centrally located on the north façade and has large dimensions of 4'-8" x 7'-6". It is flanked by two sets of paired one-over-one sash windows. The second floor contains a wide central projecting bay with a one-over-one sash flanked by fixed 36-pane windows in the front panel, and one-over-one sashes in the angled side panels. One-over-one sashes are placed closely on either side of the central bay. At the roof/attic level, a three-pane eyebrow window is centrally located over the second-floor bay window.

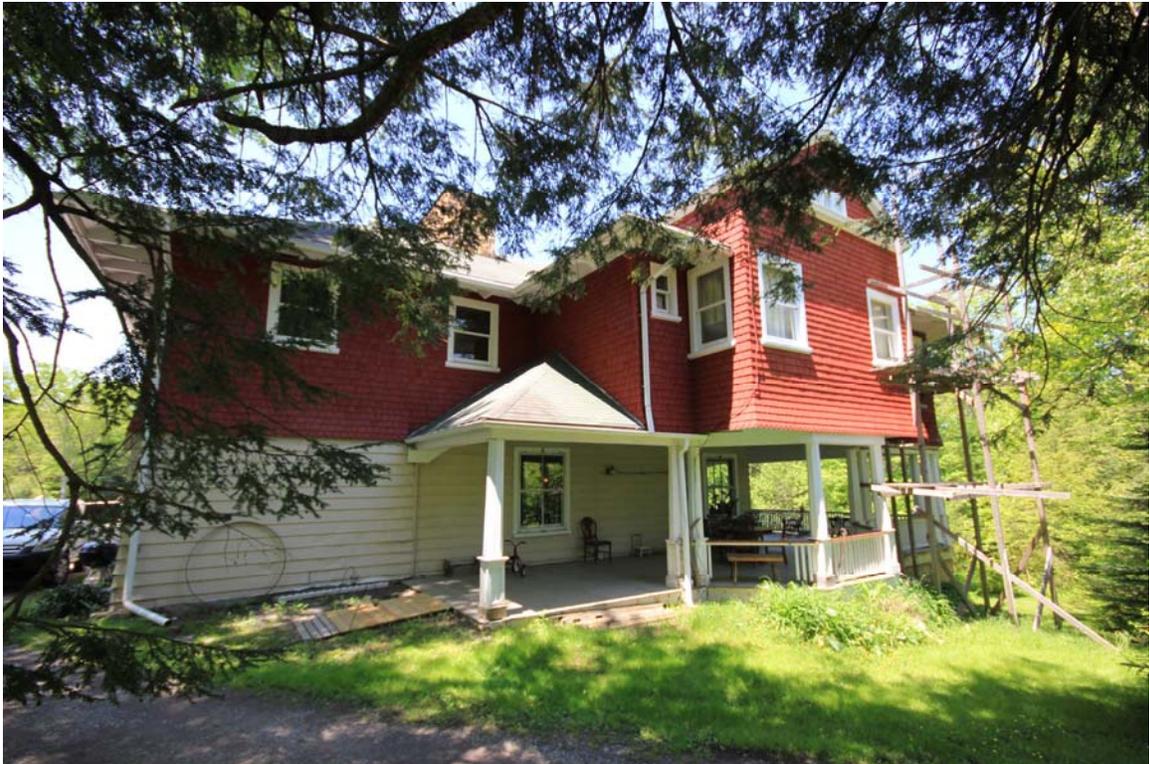
2 - Gaymont: Side elevation looking northwest.

The east façade contains two large one-over-one sashes at the first floor level, looking onto the porch. Second floor windows consist of four one-over-one sashes on the front and sides of the projecting bay, as well as two similar windows on each section of the main wall. The gable contains one small horizontal three-pane window. The west façade windows mirror the east façade. The enclosed porch on the first floor west façade contains a three-sided projecting bay following the original footprint of the porch, with one-over-one windows in the side panels, two narrow one-over-one sashes on the left portion of the west wall, and a triple set of one-over-one sashes on the right portion of the west wall. An uncovered wooden deck is located at the southwest (rear) corner of the house, providing access to the enclosed porch. This is currently used as the main entrance. The rear façade of the house contains an exterior door to the kitchen. The entrance to the cellar was enclosed in 1908 and a second floor room was added above this enclosure. A shingle was found during a recent restoration of the shingles with the names of the workers and the date.

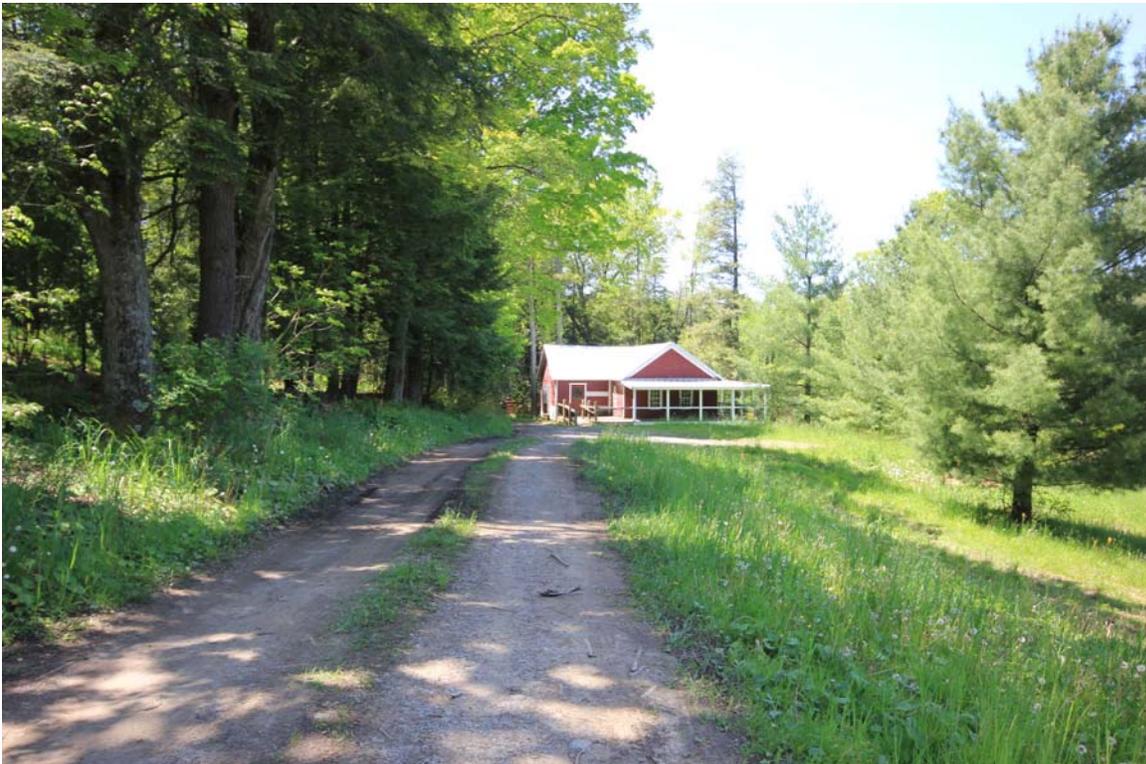
4 - Brookside Cottages: General view looking west towards Linden Cottage.

Linden Cottage (historic name) is an L-shaped one-story frame building. The ell extends approximately 12' back on the west side of the building. The cottage has a gabled roof and a porch extends around the east and north façades. The porch is approximately 8' deep and has a shed-type roof supported on simple wood posts. An uncovered section of the porch continues around the back of the house in the corner formed by the ell. Railings consist of a white wood rail cap and black metal spindles and bottom rail. The main portion of the building is 2 bays deep and 5 bays wide. Windows consist of six-over-six wood sashes and are placed as follows: two in the main section east façade; four in the main section north façade; two on the west façade; one in the ell south façade; one in the main section south façade. A door is located off the deck in the ell and is the primary entrance. Another door is centrally located on the north façade and is accessed via the porch. A third door is centrally located on the south façade and is accessed via a simple 3-step staircase. The interior of Linden consists of one room in the ell and a wide central hallway flanked by two rooms on each side in the main part of the building.

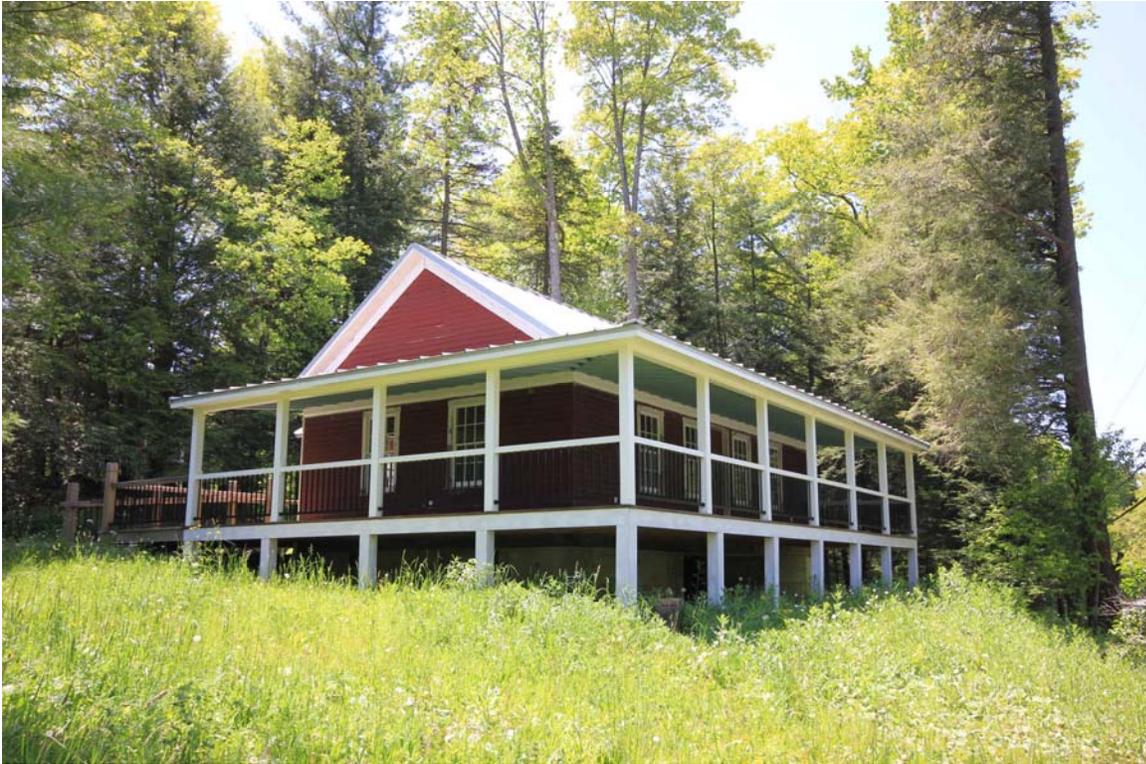
5 - Brookside Cottages: Oblique view of Linden Cottage looking southwest.

Linden Cottage was restored in recent years. A concrete foundation was added and interior and exterior finishes were restored in keeping with the period

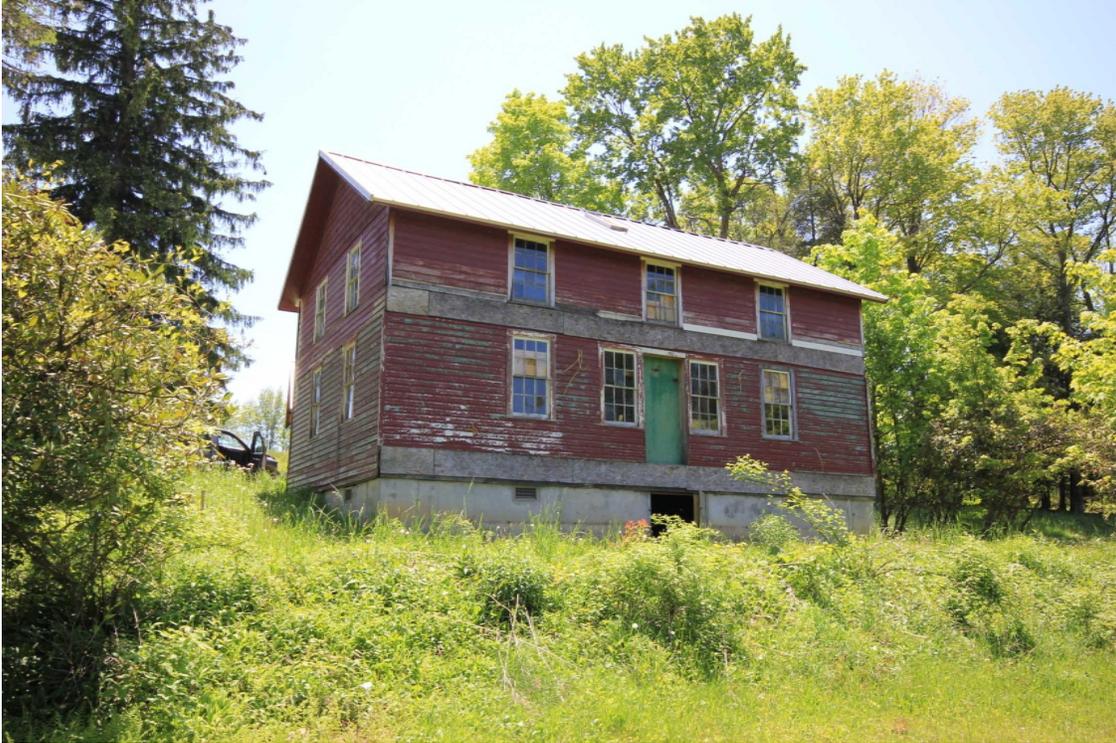
7 - Brookside Cottages: Front elevation of Sycamore Cottage looking south

### **3. Sycamore Cottage**                      **ca. 1885**                      **Photo 7**                      **Contributing building**

Sycamore Cottage (historic name) is a wood-frame two-story building in the I-house tradition. Sycamore and Maple cottages have the same design. The house has a gabled roof and is oriented parallel to US Route 50. The house is two bays deep and four bays wide. Windows are six-over-six wooden sashes. The front (north) façade contains a central front door with two closely abutted windows on either side, and two additional windows spaced farther out beyond those. The second floor contains three symmetrically placed windows. The side elevations contain four windows, two on each story, except for south by of the west façade, which contains an additional entrance. The building originally had a wood one-story porch with a shed-type roof that extended around the east, north and west sides; this porch was removed due to deterioration. All of the two-story cottages had rear staircases for use by housekeeping staff; they were removed in the 1930s in order to add bathroom additions.

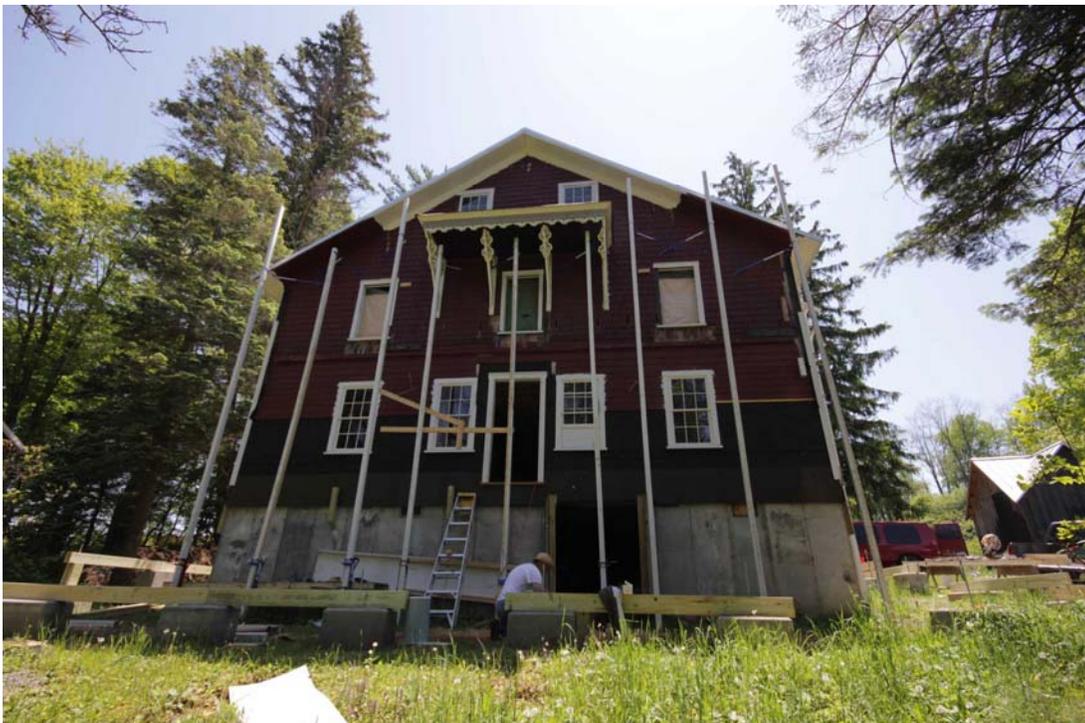
8 - Brookside Cottages: Front elevation of Keystone Cottage looking south.

### **4. Keystone Cottage**                      **ca. 1885**                      **Photo 8**                      **Contributing building**

Keystone Cottage (historic name) is a large two-story plus attic frame building with a rectangular plan and a gabled roof with deep overhangs. The building is five bays wide and three bays deep. A large hipped dormer extends from the roof on the west elevation. A small one-story addition with gabled roof projects from the south side center bay of the building. The primary façade faces US Route 50 and consists of a central entrance flanked by two size-over-six sash windows on each side. The second story contains three equally-space sash windows. A large decorative roof with scalloped trim extends over the central second-story window and is supported by four gingerbread brackets. The attic/third story contains two sash windows placed in a staggered position above the second story windows. The east and west elevations contain three symmetrically placed six-over-six sash windows on each story. The dormer on the west elevation contains two sets of paired sash windows. The rear elevation is similar to the front, but lacks a decorative roof overhang and contains a small one-pane window on the second floor central bay. The rear extension contains two six-over-six sashes on each side, and a door flanked by sash windows on the rear elevation.

The building exterior was originally board-and-batten but was altered in ca. 1900 with Shingle Style/ Queen Anne features added to the exterior in a more vernacular surface application, rather than an extensive redesign. The exterior of the building consists of wood clapboard at the first floor level and wood shingles at the second floor. A one-story porch with a shed-roof and decorative gingerbread accents formerly extended around three sides of the building. The cottage is in the process of being restored. A new concrete foundation

Also under the McBrides' ownership, part of Rhine Creek was dammed to create a pond for boating, fishing and winter ice skating; ice from the pond was stored in the icehouse for use throughout the summer.<sup>29</sup> The resort produced its own acetylene gas<sup>30</sup>, a.k.a carbide, for lighting in a small building still standing and known as "Carbide Cottage." (Photo 10) The residential cottages were upgraded and the board-and-batten replaced with German clapboard and shingle siding. Decorative gingerbread moldings, wood shingle exterior wall coverings and a second-story faux balcony were added to Keystone (Photo 8).

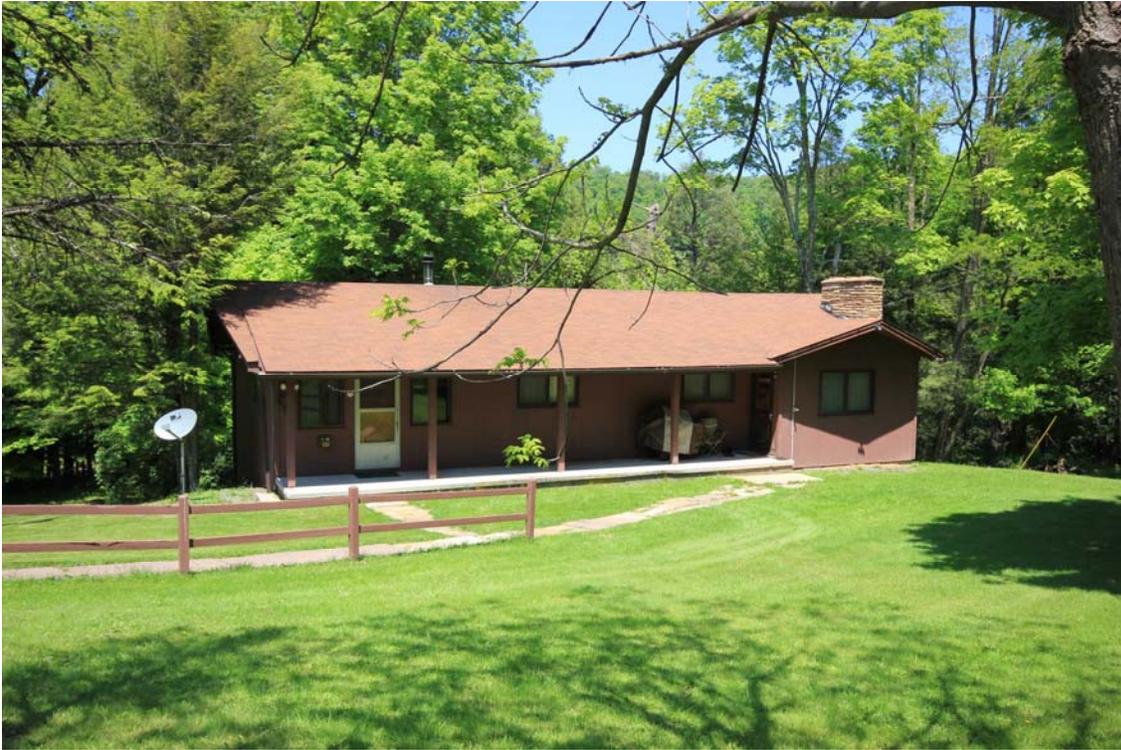
13 - Cathedral State Park: Caretaker's residence (non-contributing) on former site of Brookside Hotel, looking northeast from park entrance.

### **8. Caretaker's Residence** **ca. 1960** **Photo 13** **Non-contributing building**

The park caretaker's residence is a one-story frame ranch-style house with a gabled roof. The exterior is covered in wide vertical wood panels painted brown. The rightmost bay of the house is a forward-angled gable containing a two-pane horizontal sliding window. A concrete porch with a shed-type roof supported by wood posts extends from the bay across the rest of the front façade. The front entrance is on the left portion of the front façade and is flanked by two horizontal sliding windows. Two more sliding windows are spaced across the front elevation. A cut stone chimney is located on the east end of the house. The house is located a short distance north of U.S. Route 50, on the site of the original Brookside Hotel. The building was built after the period of significance and is thus considered non-contributing.

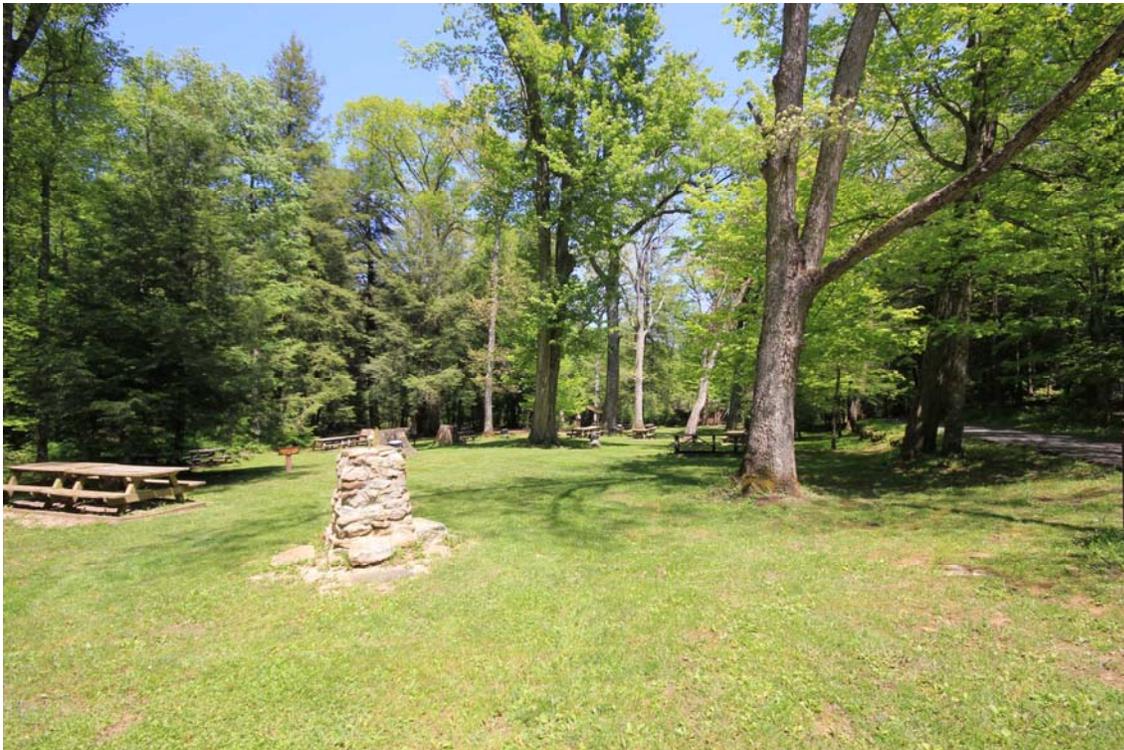
14 - Cathedral State Park: Picnic area looking east.

### **10. Picnic Area** **ca. 1955** **Photo 14** **Non-contributing site**

The picnic area is contained within a clearing of approximately 1 acre adjacent to the parking lot and caretaker's residence near the eastern boundary of the park. The picnic area includes a small frame gabled restroom building, playground equipment, a wood gabled pavilion, several permanent metal grills and a

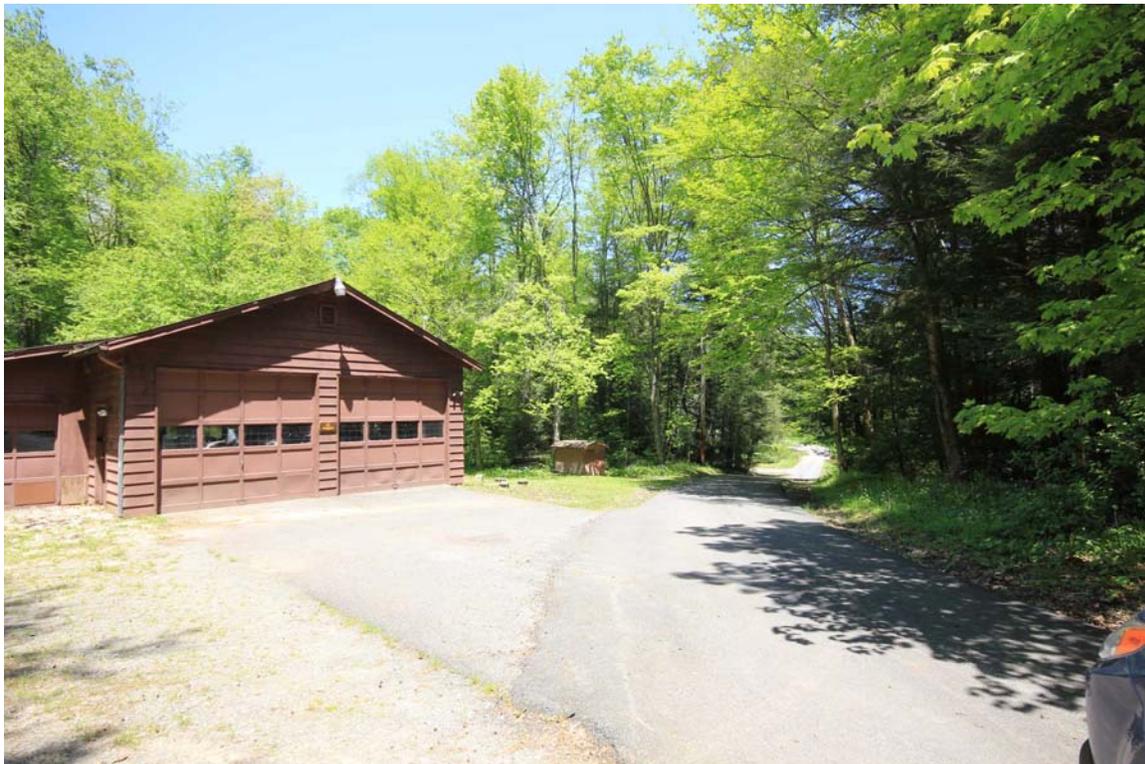
16 - Cathedral State Park: Park garage (non-contributing) on left, looking northwest down road leading to Brookside Farm.

### **9. Garage** **ca. 1960** **Photo 16** **Non-contributing building**

The maintenance garage for the park is located on the paved road leading to Brookside Farm on the easternmost boundary of the park. It is a one-story front-gabled building with two garage bays and brown aluminum siding. The building has a one-bay addition on the west side with a shed roof and one garage bay. The building was built after the period of significance and is thus considered non-contributing.

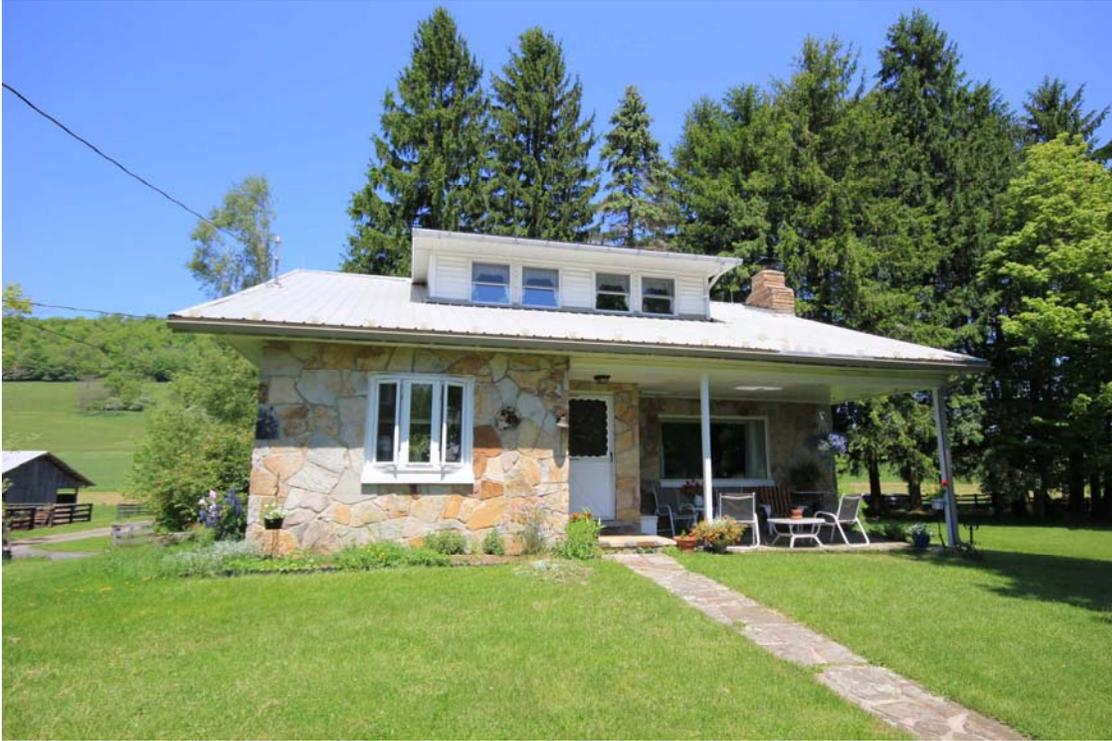
19 - Brookside Farm: House (non-contributing) looking north.

**11. House**                                      **ca. 1900**                                      **Photo 19**                                      **Non-contributing building**

The house at Brookside Farm is a one-story frame building with a gabled roof and shed-type dormer. It has a rectangular plan with a rear gabled extension. A sub-grade garage is located under the extension. The exterior of the house is covered in field stone veneer. The front porch is recessed beneath the main roof on the right side of the house and the front entrance is centrally located. There is a large picture window on the right side of the front façade and a three-panel projecting bay window on the left side. Windows are generally replacement unit and vary from double-hung sashes to casements. The house was originally built as a two-story residence, but was altered to 1½ stories in 1948. The stone veneer was also added at that time. Thus, this building is non-contributing due to lack of historic integrity.

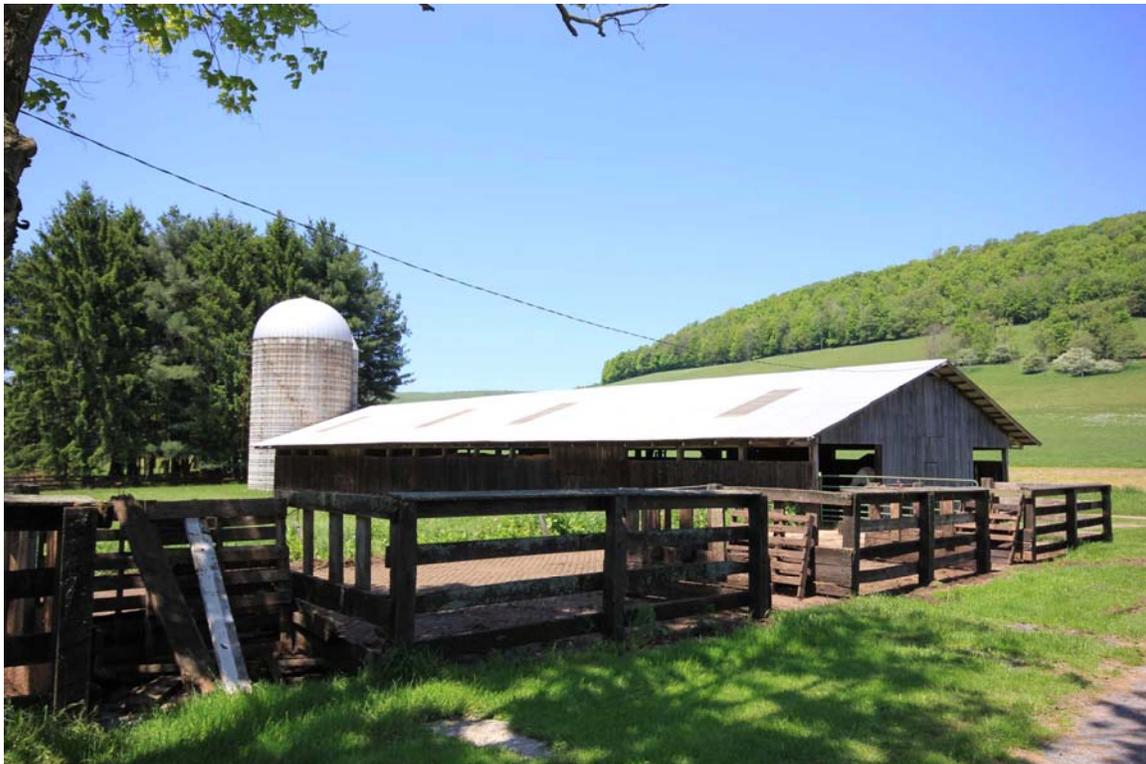
20 - Brookside Farm: Barn (non-contributing) looking north.

**12. Barn**    **1975**    **Photo 20**    **Non-contributing building**

This barn is a long one-story wood building with a gabled roof. It has a clerestory opening just below roof level along the length of the building and two wide openings on the east end. A round-top silo concrete silo is located at the west end of the barn. The siding consists of vertical boards and the roof is metal. This building is outside of the period of significance for the historic district and is thus considered non-contributing.

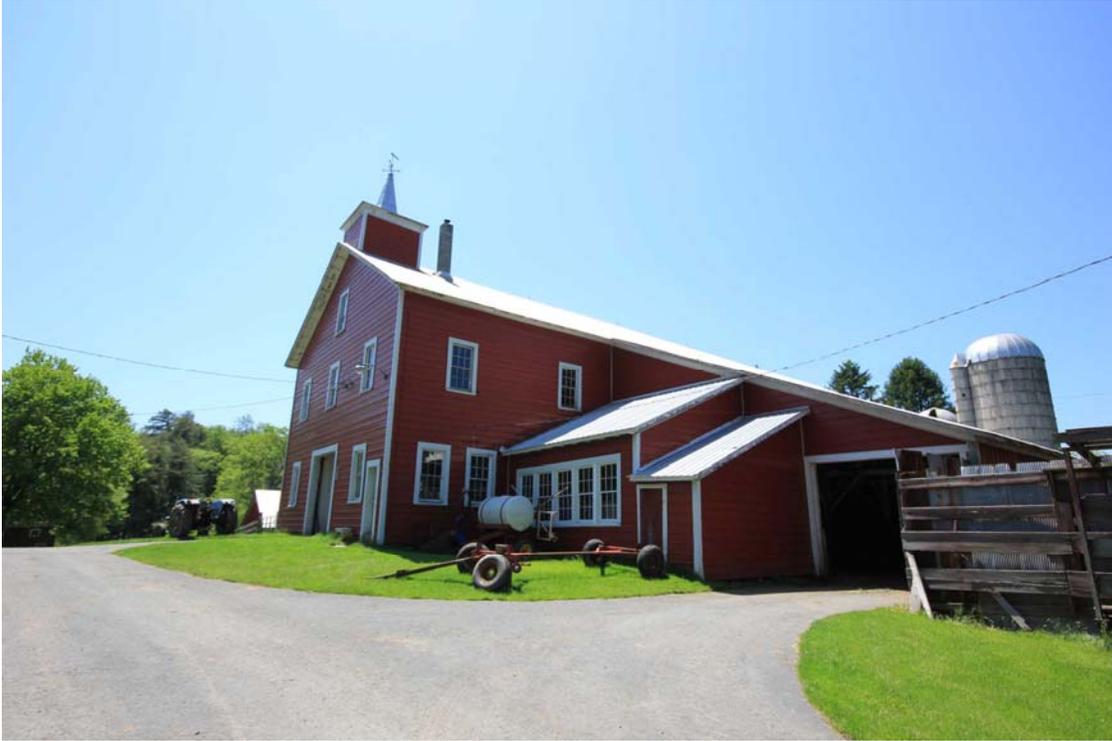
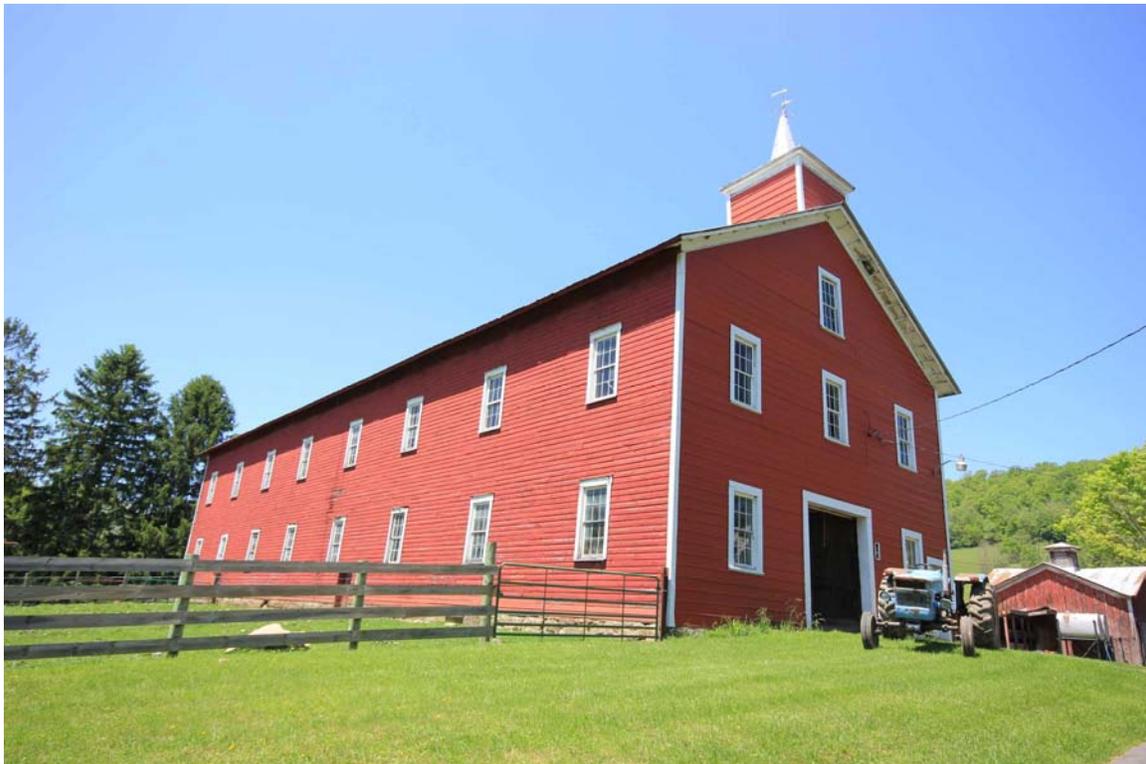
21 - Brookside Farm: Livery Barn looking southwest.

22 - Brookside Farm: Livery Barn looking north.

**14. Livery Barn**    **ca. 1895, 1907**    **Photos 21-23**    **Contributing building**

The livery barn is a large 2-story heavy-timber frame building with a gabled roof and stone foundation. It is 3 bays wide and 8 bays long with plan dimensions of 40'x120'. Each bay on the south and east elevations contains one six-over-six wood sash window on the ground and second levels, with the exception of the center ground floor bay on the east elevation, which contains a large barn door opening. An additional sash window is placed at the attic level on the east elevation. A large cupola with a hipped roof and additional steep spire is located at east end of the roof over the primary entrance. The exterior of the building is covered

in red German clapboard siding. On the north side of the building, beginning at the third bay and extending to the west end, is a 40'x100' shed addition formed by extending the roofline down to the one-story level. Two more additions extend from the front of this section, to the right of the main two-story barn; one has a shed-type roof and contains a bank of five (5) six-over-six sash windows, and the other is a shorter and narrower addition with a shed type roof and a doorway. The construction of these additions are noted in a 1907 from Leander McBride to his nephew Douglas McBride.

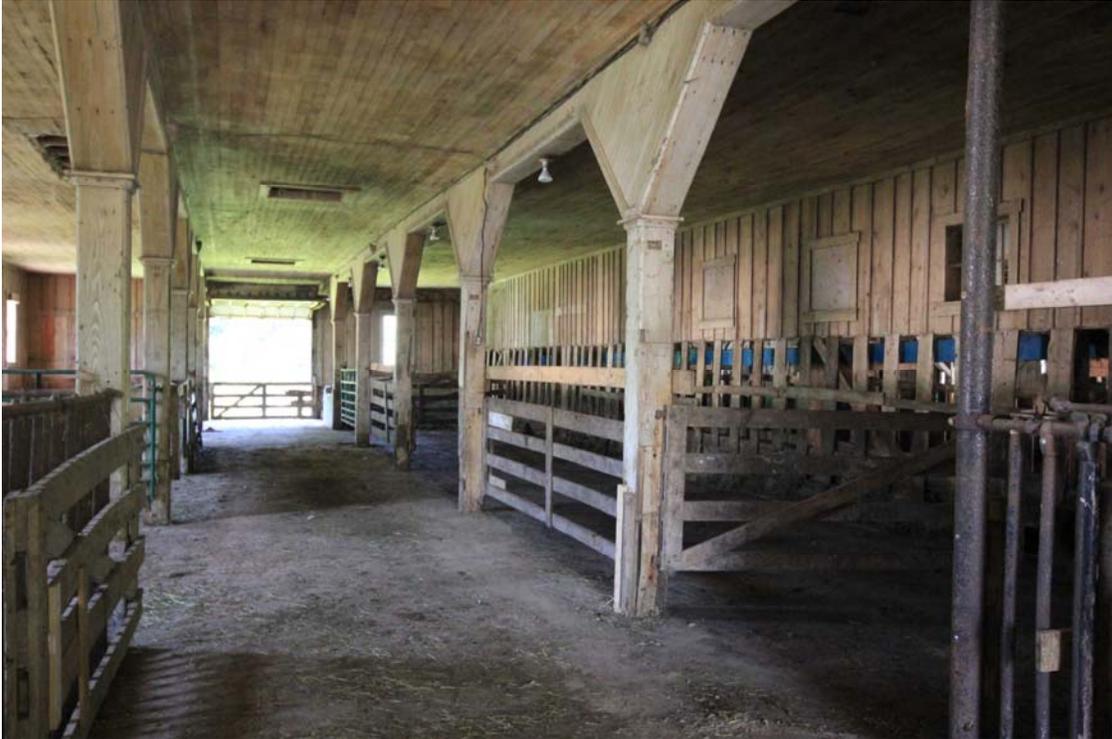
23 - Brookside Farm: Livery Barn interior, looking northwest on ground floor from main entrance.

The interior of the barn consists of a central passage along the length of the barn with animal pens on either side. The ground floor level has a maple tongue-and-groove ceiling and wormy chestnut board-and-batten walls. The upper floor is a 1½ story loft with two granary rooms on the east end and two finished rooms with chestnut paneled walls, said to be used to house farmhands, on the west end.

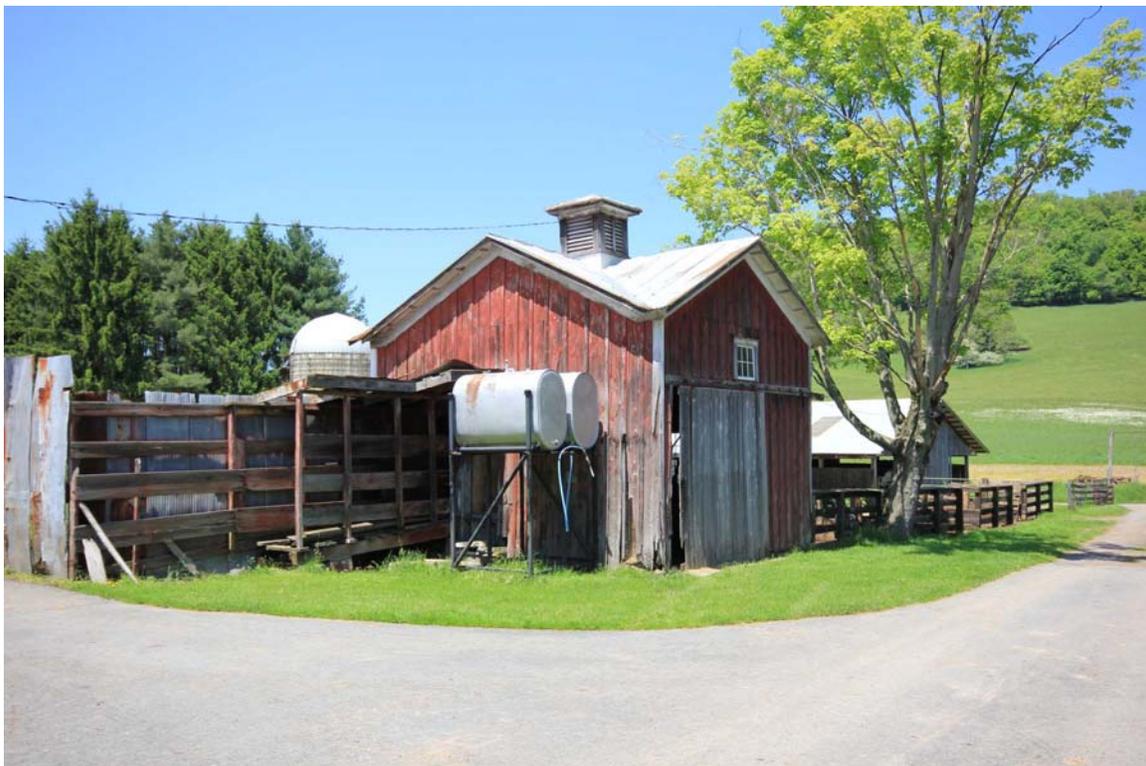
24 - Brookside Farm: Icehouse looking north.

**13. Icehouse**    **ca. 1895**    **Photo 24**    **Contributing building**

The icehouse is located next to the livery barn across the road from the house. It is a small one-story frame building with dimensions of approximately 20'x20'. It has a cross-gabled roof and a vented cupola with a hipped roof. The exterior consists of board-and-batten siding. The entrance is located on the left half of the east elevation and has a sliding barn door. A small three-over-three wood window is centrally located above the door.

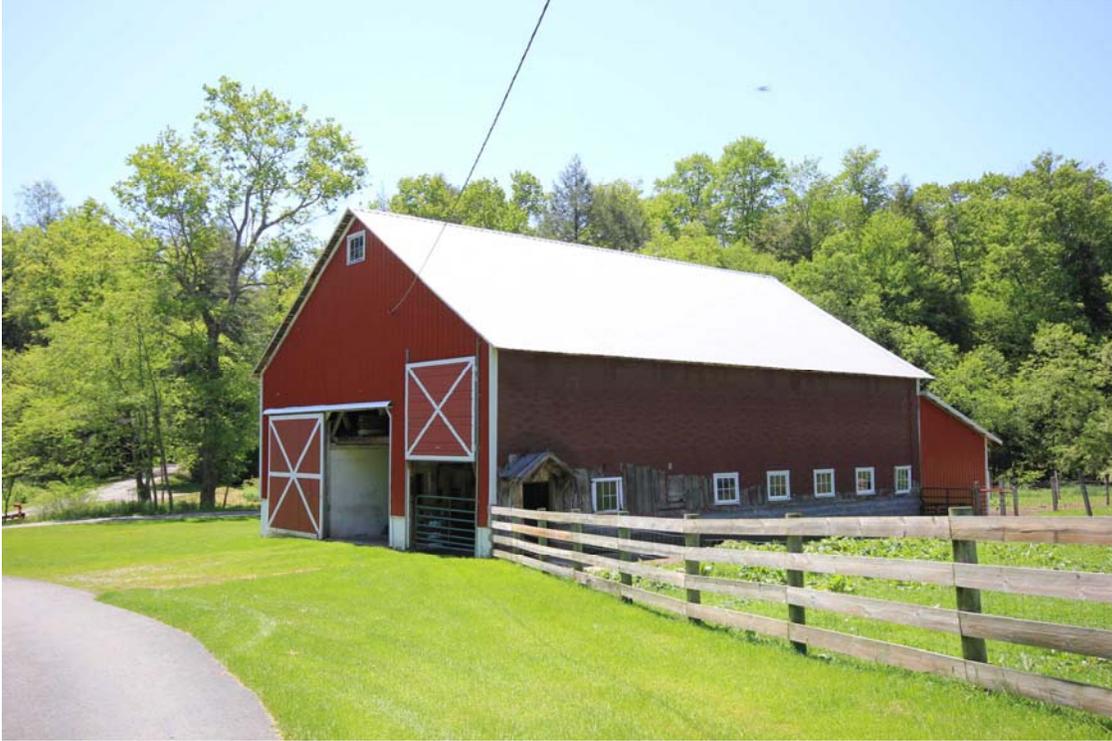
25 - Brookside Farm: Dairy Barn looking southwest.

### **15. Dairy Barn**                      **1905**                      **Photo 25**                      **Contributing building**

The Dairy Barn is located a short distance south of the Livery Barn. It is a timber-framed gabled building 3 bays wide and 8 bays long with plan dimensions of approximately 40'x60'. The front (east) elevation contains a large sliding barn door on the left and a smaller vertically-sliding barn door on the right. There is one 6-pane wood window in each bay at the ground floor level on the north and south façades, with the exception of the leftmost bay on the north façade, which contains a doorway covered by a cantilevered gabled roof. There is a one-story 40'x16' metal addition 40x16 with a shed roof extending from the rear (west) elevation. The exterior consists of asbestos faux brick siding on the north wall and, vertical metal siding on the other walls. The barn originally had board-and batten siding and a wood shake roof. The construction of the barn is noted in a 1905 letter from Harriett McBride.

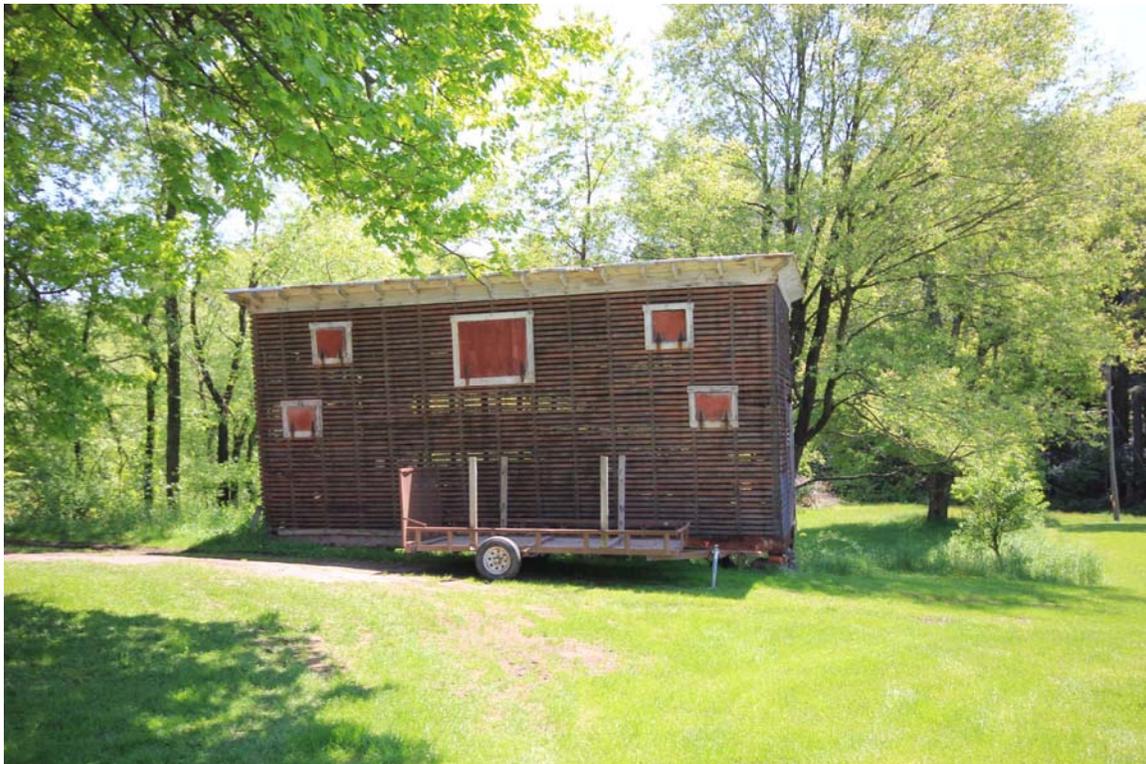
26 - Brookside Farm: Corn Crib looking south.

### **16. Corn Crib**                      **ca. 1895**                      **Photo 26**                      **Contributing structure**

The corn crib is located across the road from the dairy barn along an old road/pathway connecting several farm structures parallel to Rhine Creek. The corn crib has a U-shaped plan and is approximately 25'x4' with 6' sections extending from the back towards the creek. It consists of wood frame and horizontal wooden slats spaced to accommodate air circulation in corn. The structure has a shed roof and a stacked stone pier foundation. It has a centrally-placed top-hinged square opening and four smaller similar openings on its north side and a doorway on its west side.

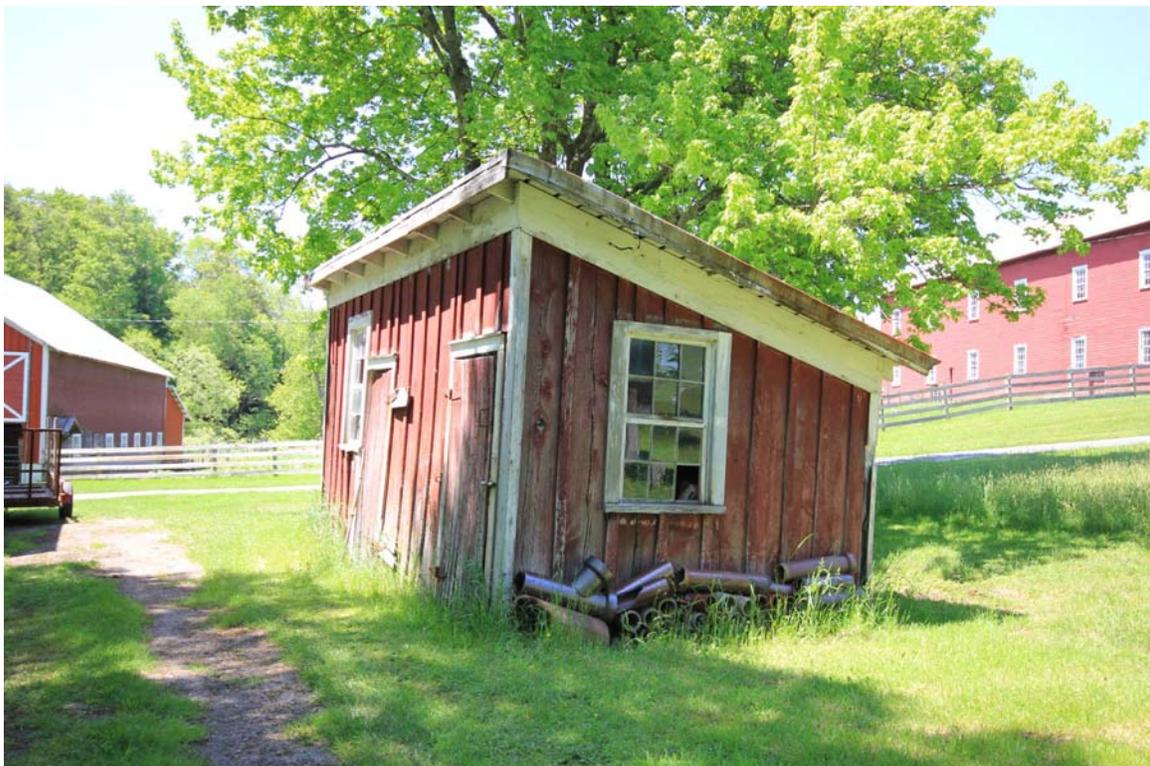
28 - Brookside Farm: Storage Shed looking northwest.

### **17. Storage Shed**                      **ca. 1895**                      **Photo 28**                      **Contributing**

This one-story frame building is located across the path from the corncrib and has dimensions of approximately 12'x8' and a shed roof. It has one six-over-six wood sash window on the left side of its front (south) façade, one door in the center and another door on the right. It has two additional sashes on the east and west elevations. The exterior is covered in board-and-batten siding. The interior is divided into two pens with a half-height wood partition.

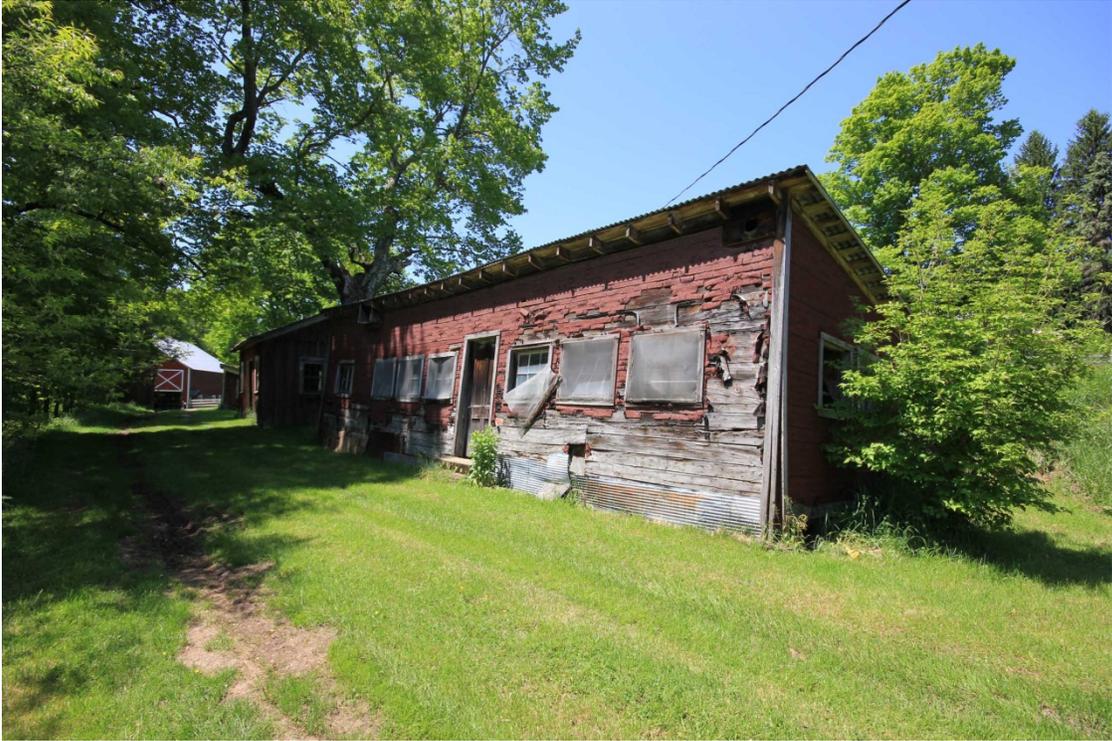
29 - Brookside Farm: Chicken Coop looking northwest.

The chicken coop is a long, one-story wood frame structure with a shed roof and deteriorated brick-pattern asbestos siding. It's plan dimensions are approximately 30'x16'. It is located next to the gabled shed and faces Rhine Creek. It is eight bays wide and two bays deep. The structure has a doorway in the center bay on the front façade and another in the right bay of the west façade. Other bays on the front and east facades contain six-pane fixed wood windows. The structure was built after the period of significance and is thus considered non-contributing.
