United States Department of the Interior  
National Park ServiceNational Register of Historic Places  
Registration Form

historic name Buffalo Church

street & number Intersection of County Routes 28 and 14 over 12☐ not for publicationcity, town Palestine☒ vicinitystate West Virginiacode WVcounty Wirtcode 105zip code 26160

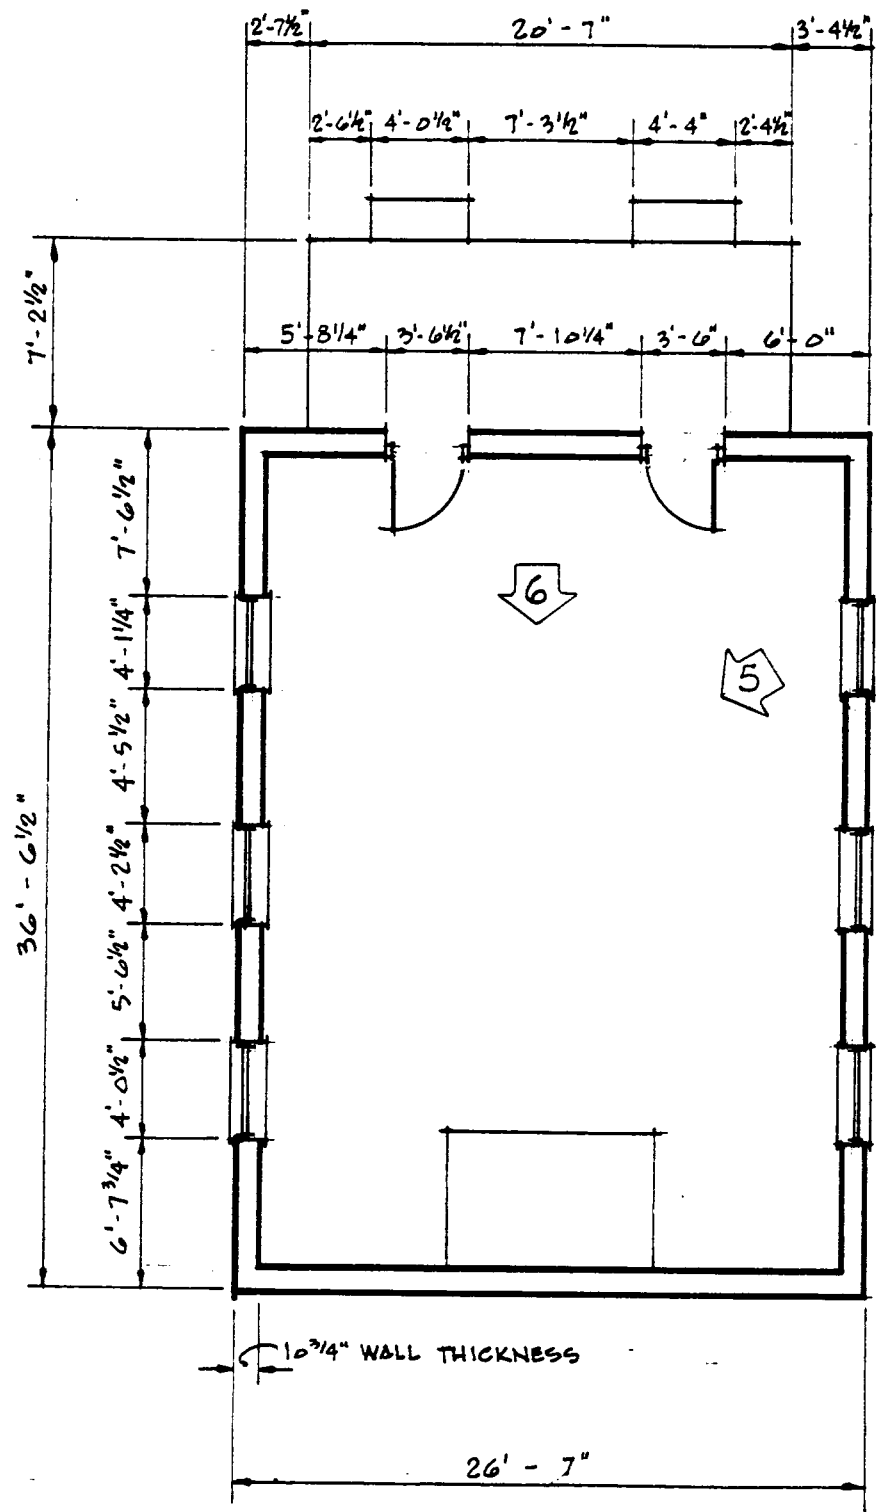
FLOOR PLAN

1/8" = 1'-0"

There are two entrance doors in the north elevation of the building and three bays of 2-over-2 single-hung windows along each side. There are no openings in the south end. The roof design is a common gable with a metal covering. There is a small square bell tower with metal roof and rectangular louvered openings in each side of the tower.

The original foundation consisted of stone piers placed at each corner of the building, with two intermediate piers along each side and center piers at each end. At this time there is a concrete block infill between piers, except for an access panel in the west foundation. Except for a concrete and masonry entrance stoop and steps, and vinyl siding material on the bell tower (which is soon to be removed), the building presents essentially the same appearance as in late 1909, when the weatherboarding was first applied. The original entrance stoop was constructed of wood boards over log joists. A hewn log step was built for approach to each door.

The interior of the church has most of its original flooring, pulpit platform and pews. There are wall brackets along each side wall between windows to support oil lanterns and two iron hooks hung from the ceiling which also support oil lanterns. To this day there is no electrical service to the site, and no central heating system. It remains in its original primitive condition. Recent restoration work has been very carefully done and has retained all original fabric of integrity. The building is in exceptional condition.
