HISTORIC PROPERTIES INVENTORY FORM

1. NAME(S), historic/common: R. Wild House / Case House

2. LOCATION, street/road: 710 Ann St. (S corner of 8th & Ann Sts)

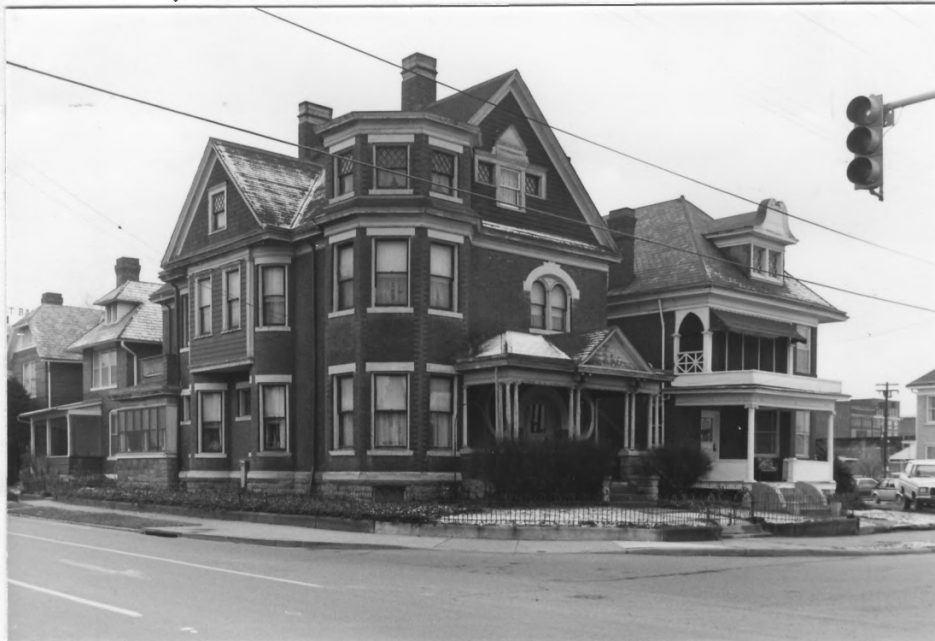
7. PLAN (include approx. dimensions):

42' x 90'

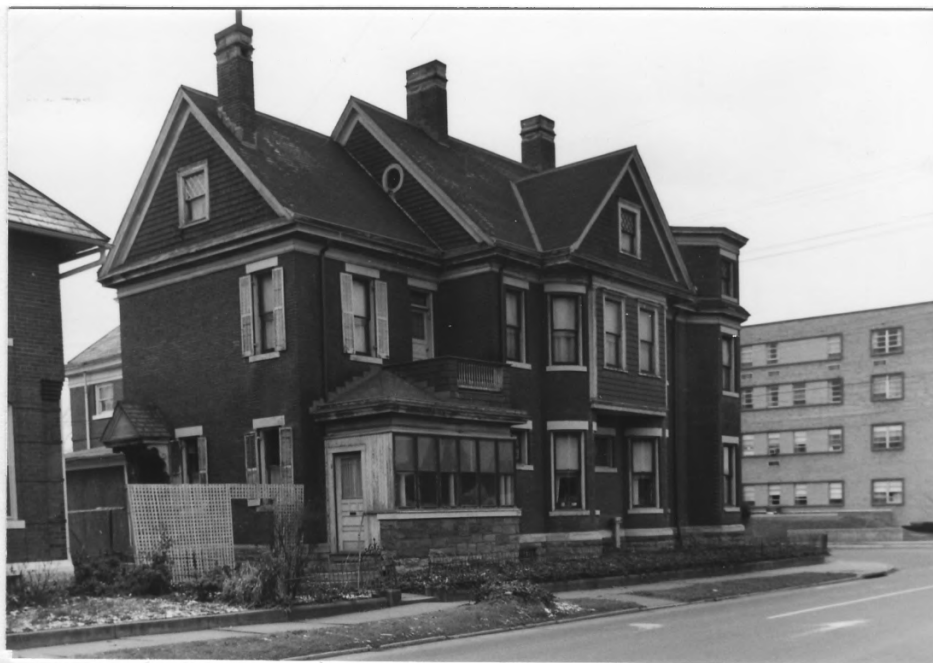
8112-R3-F13

This 2½ story Queen Anne house on a corner lot has a characteristically picturesque plan and silhouette. Its multigabled roof is pierced by 3 tall chimneys; the gable ends are shingled and contain various window configurations, mostly d/s (diamond panes/1). A 3 story polygonal tower, now flat roofed, dominates the N corner. Most of the 1st and 2nd story windows are d/s (1/1); on the NE side they are curved to conform to 2 rounded projecting bays. The porch across the NW side is 3 bays with a hip and intersecting gable roof on paired, slender wooden columns. The balustrade below is stone. The doorway is contained in a broad rounded arch and is flanked by 2 elliptical stained glass windows; above the doorway is a pair of arched windows set in a similar arch. A one story enclosed porch is at the E corner.
