National Register of Historic Places Registration Form

Gum Farmstead Historic District
Name of Property

Lewis County, WV
County and State

Other: I-house

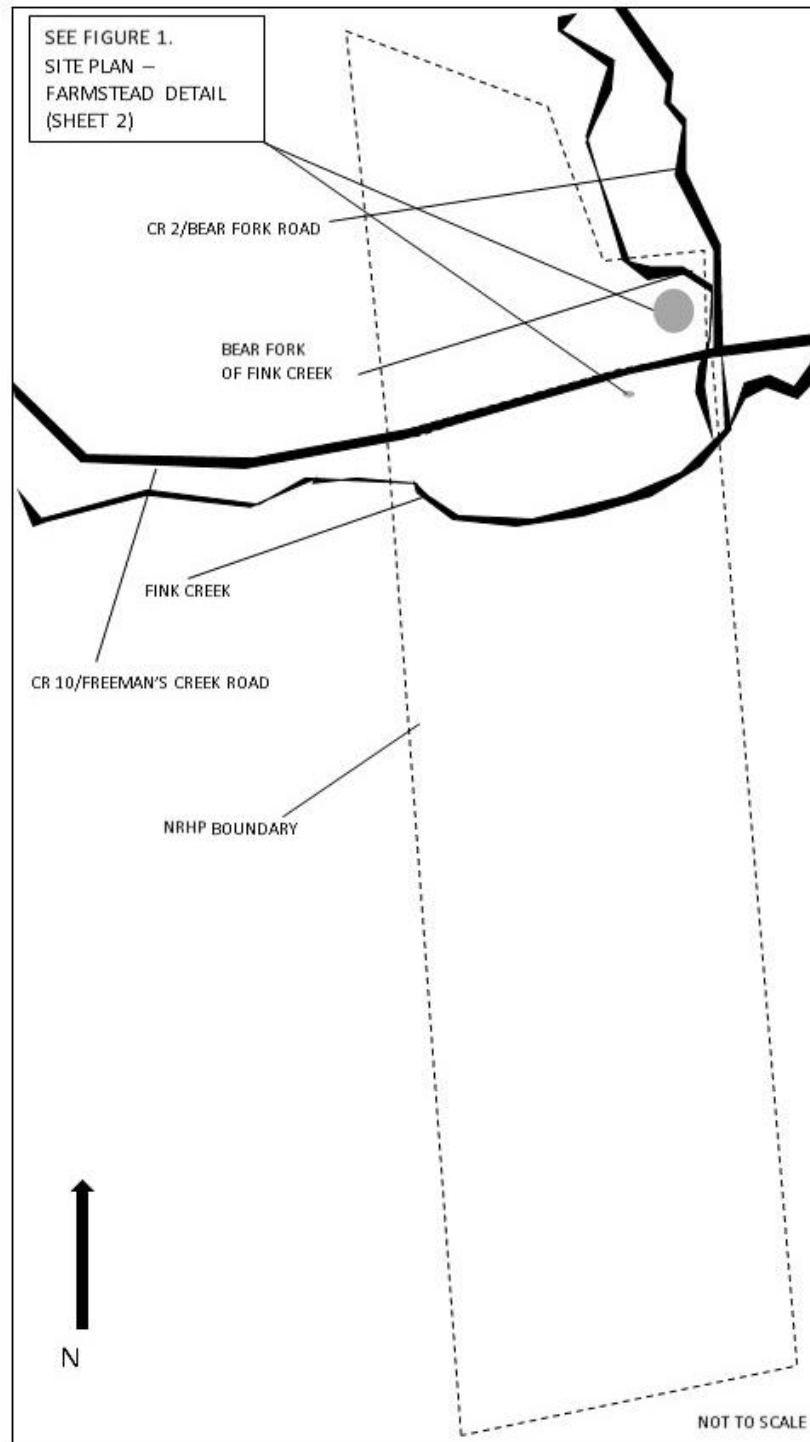
FIGURE 1. SITE PLAN – OVERVIEW
GUM FARMSTEAD HISTORIC DISTRICT
CAMDEN, LEWIS COUNTY, WEST VIRGINIA

This nomination includes four contributing resources (Resources A-D) five non-contributing resources (Resource E-I), and one contributing site, the locations of which are depicted in Figure 1 - Sheets 2 and 3 and descriptions for which are provided below.

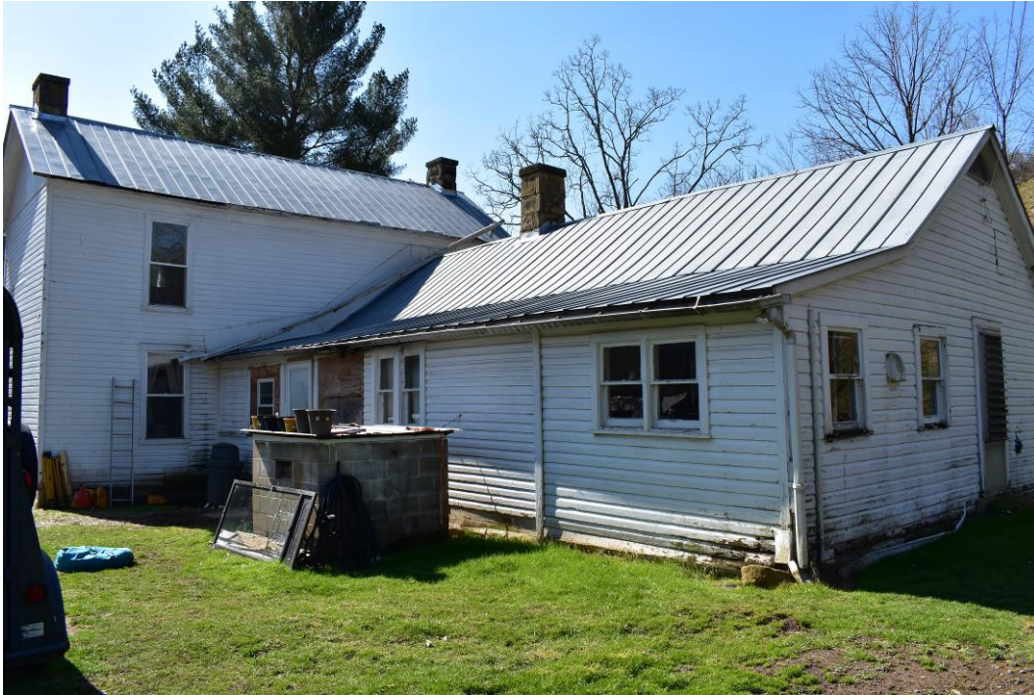
Photo 5

The west elevation of the rear element has an entrance left of center (**Photo 5**). It is fitted with a fully-glazed replacement door and is accessed by a set of concrete stairs. Areas of the upper wall flanking this door are clad in unpainted plywood. There is a wide rectangular window opening fitted with a vinyl replacement window left of the door, a pair of small narrow windows fitted with wood sashes near the center of the elevation, and a pair of smaller wood sash windows near its north end. A metal cover creates an informal breezeway by connecting its roof eave to the roof of a low root cellar building just to the west of the house (**Photo 4**). The asymmetrical north elevation has a screened vent in the gable end and two small wood sash windows left of center (**Photo 6**). An entrance below the gable is fitted with a metal screen door with plastic jalousie window and is accessed via a low set of concrete steps.

The west elevation of the rear element has an entrance left of center fitted with a replacement door and areas of the upper wall flanking this door are clad in unpainted plywood instead of the original drop siding.

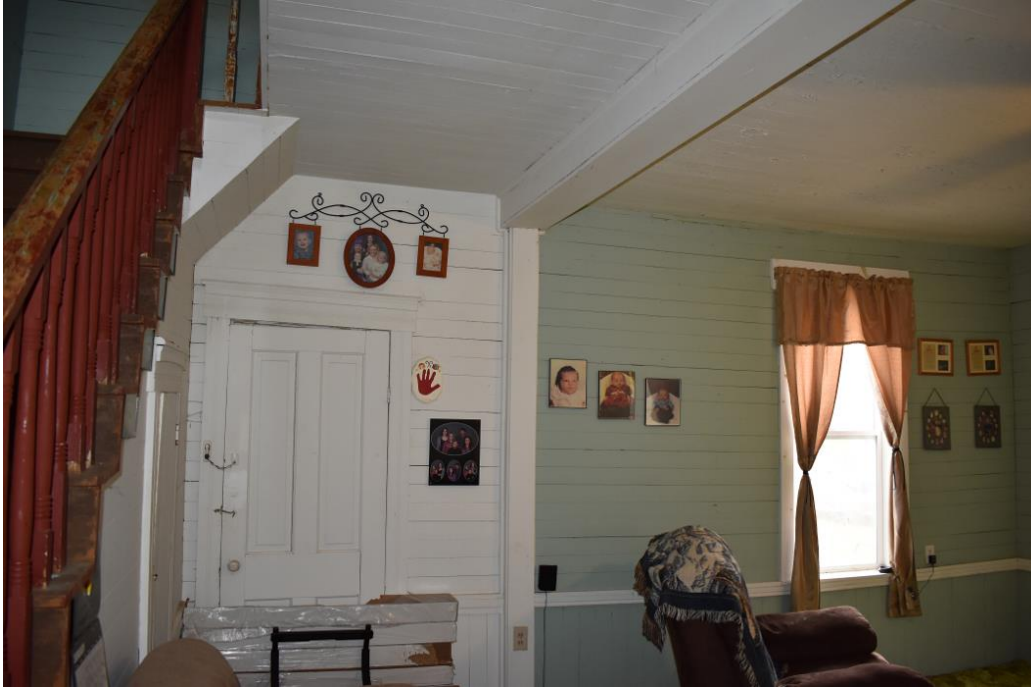
Photo 7

The first floor of the house is formally entered through a single wood paneled door as described previously (See **Figure 2-Sheet 1**). Upon entering the front door, one is in what was originally a vestibule flanked by cased openings topped with movable transoms and decorative surrounds (with cornices) to the east and west leading to the hall (or multipurpose room) and parlor, respectively. However, the wall leading to the parlor was removed circa 1948, so today one stands in an open room comprising the original parlor and vestibule upon entry (**Photo 7**) and only the cased opening leading to the hall remains (**Photo 8**). The surround's cornice board is composed of individual pieces of wood trim to form its design. A single wood paneled door located immediately north of the entry door (adjacent to what would have been the parlor's interior west wall) (**Photo 7**) leads to the back porch that was enclosed circa 1948.

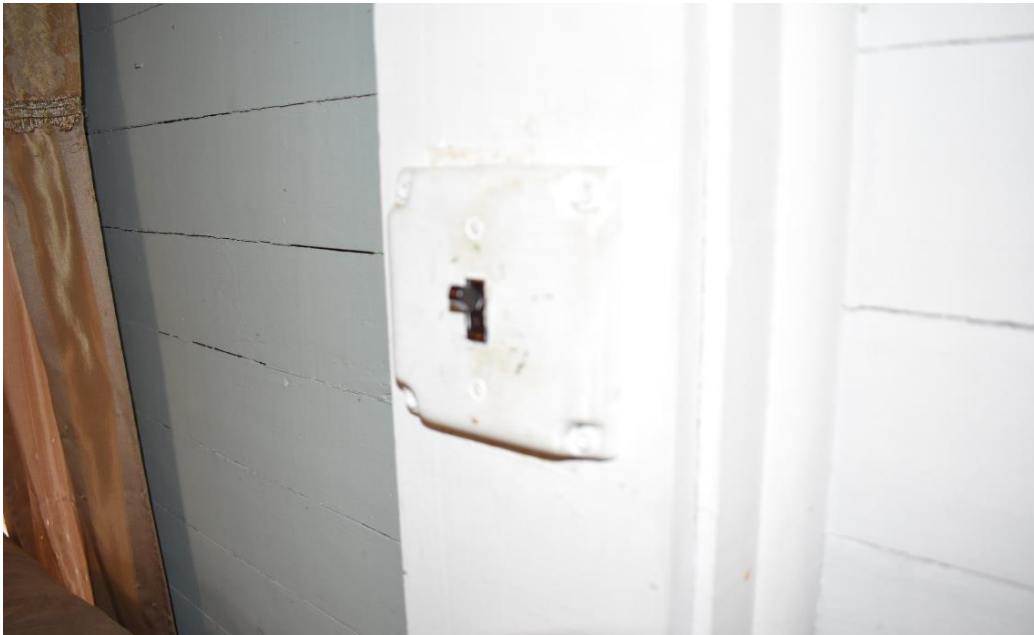
Photo 14

Both the hall (on the west end of the first floor) and parlor (on the east side) feature fireplaces centered on the exterior wall flanked by closets on each side accessed by single wood paneled doors with original cast-iron painted rim-lock sets and decorative glass door handles (**Photo 11**). The mantle has been removed in the parlor and the room's fireplace has been modified to hold a gas wall heater. The mantle in the hall (multipurpose room) is composed of individual pieces of wood to form its design. The rooms' walls and ceilings are the original painted tongue-and-groove; the original hardwood floors remain under modern carpet. Each room has two windows facing (south) out onto the front porch. The parlor also features a window on its north (rear) wall. These five windows all have simple wood surrounds. The house's transition from gas to electric is evident in these two rooms through the intact gas light fixtures (**Photo 12**), a visible cord entering the exterior wall (**Photo 13**), and a switch plate located where a wall once stood (to hide the wires) (**Photo 14**).

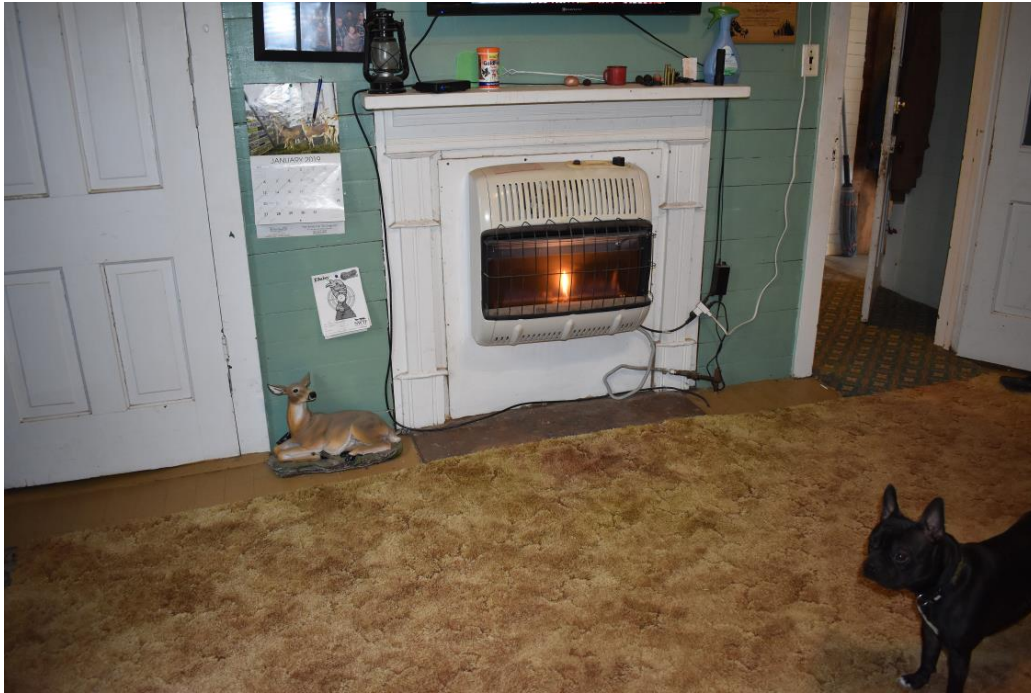
Photo 15

a single wood paneled closet door on the left and a single wood paneled door with a simple wood surround on the right leading to the original kitchen (**Photo 15**). Like the mantle in the hall, the bedroom's mantle is composed of individual wood trim components to form its overall design. The fireplace has been modified to hold a gas wall heater. The room's walls and ceilings are the original painted tongue-and-groove; the original hardwood floors remain under modern carpet. On the west wall is a window with a simple wood surround.

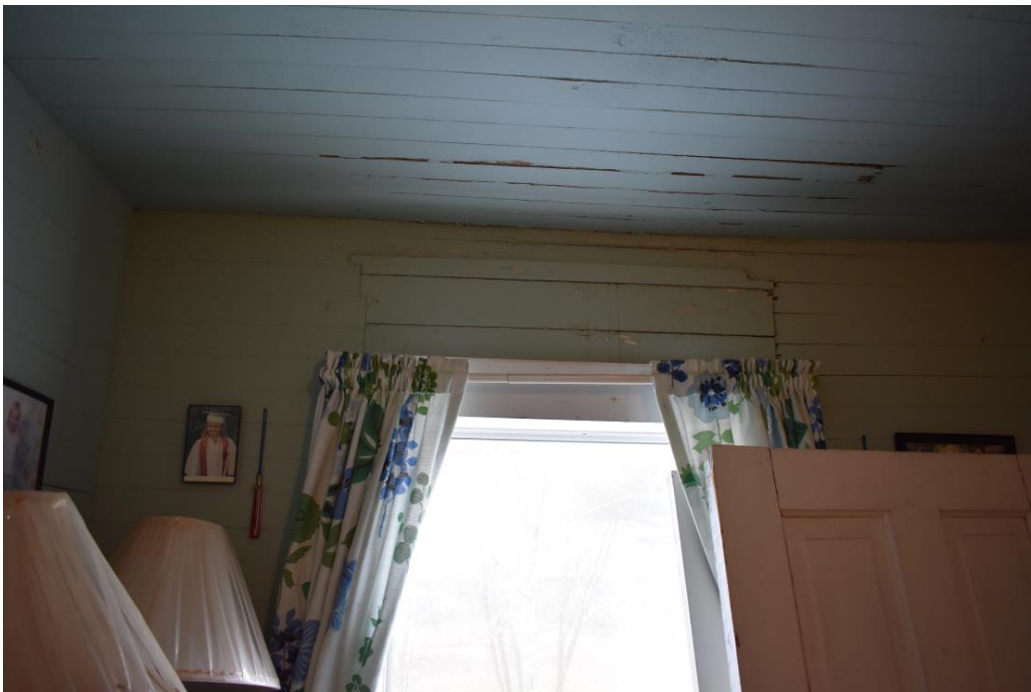
Photo 20

At the end of the hall there is a window with a simple wood surround. This window is the centrally-located (or middle) window within the farmhouse's second-story fenestration in the façade. There is evidence of patching in the south wall's tongue-and-groove above the window in the shape of cornice board where a door once led to a second-story porch (no longer extant) (**Photo 20**).

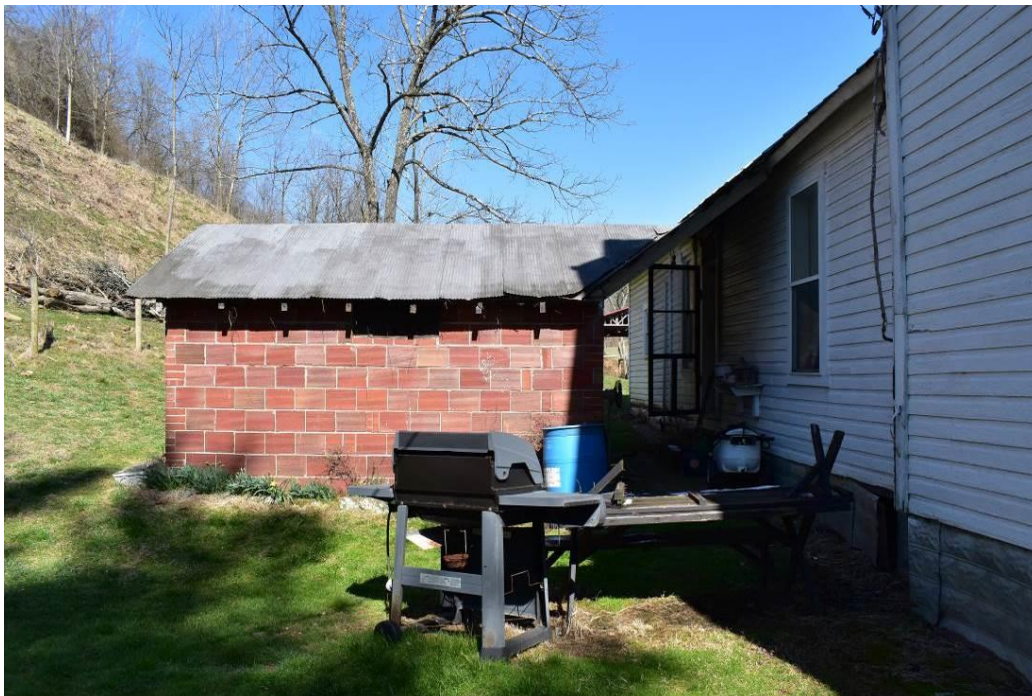
Photo 24

Adjacent to the farmhouse's west elevation is a front gable root cellar measuring roughly 15 feet long by 14 feet wide (**Photo 24**). The circa-1920, one-story cellar is constructed of structural terra cotta block. The structure's front gable roof is covered in corrugated metal; rafter tails are exposed. A shed roof covers the space between the cellar door and the farmhouse kitchen's exterior door and connects the two buildings. The structure's attic story is clad in vertical wood boards and access to the attic is provided by a small wooden hinged door on the west elevation's gable end (**Photo 25**). Main level access is provided by a solid wooden door on the structure's east elevation directly across from an exterior door leading to the original farmhouse kitchen (**Photo 26**). The shed roof connection between the root cellar and the farmhouse's kitchen is covered in corrugated metal. This structure exhibits characteristics typical of root cellars, the first being that it is in the farmhouse's orbit, in this instance, incorporated into the fabric of the farmhouse. Also, while root cellars range in size, like this cellar, they were commonly large enough for an adult to stand erect. Further, this cellar is floored in concrete, which is typical of this structure type and features storage bins for produce (**Photo 27**) and shelves for canned goods (**Photo 28**).

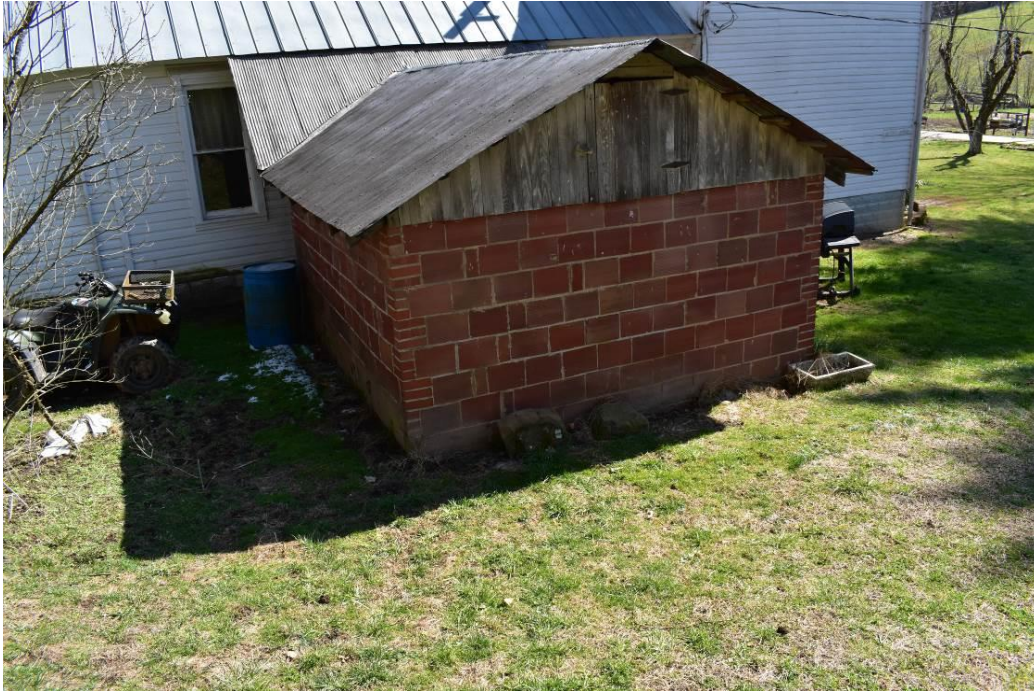
Photo 25

A number of exterior and interior alterations have been made to the District's primary resource, the farmhouse (Resource A), since its construction in 1902. The second-story's five window openings are fitted with replacement double-hung vinyl sashes (in the same location as the original wood windows) and exterior wall cladding on either side of the central window is plain boards rather than the original drop siding. Further, the removal of the residence's original upper story porch likely resulted in the loss of millwork such as window surrounds with corner brackets similar to those on the west elevation (**Photo 25**).

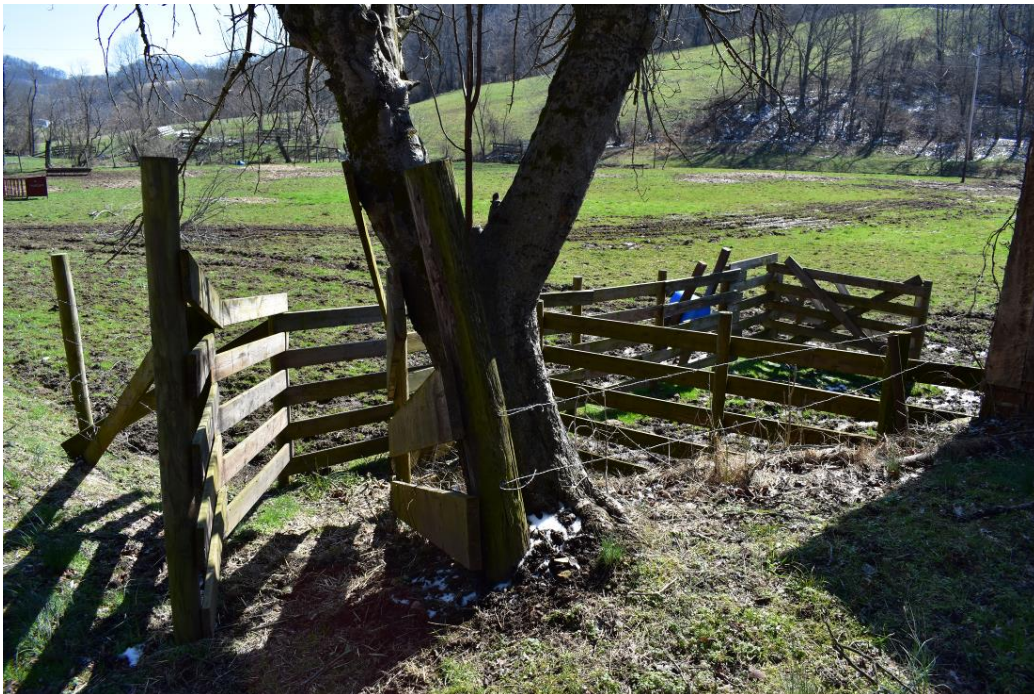
Photo 32

As noted previously, the circa-2013 wooden loading chute is located adjacent to Resource C along County Route 10 (**Photo 32**). The circa-1970 chicken house and circa-1960 feed house with shed addition are clustered directly south of Resource D (**Photo 38**). The chicken house is a timber frame structure measuring roughly 8.5 feet wide by 18 feet long. The structure's exterior walls are clad in vertical wood boards and its front gable roof is covered in standing seam metal. The timber frame feed

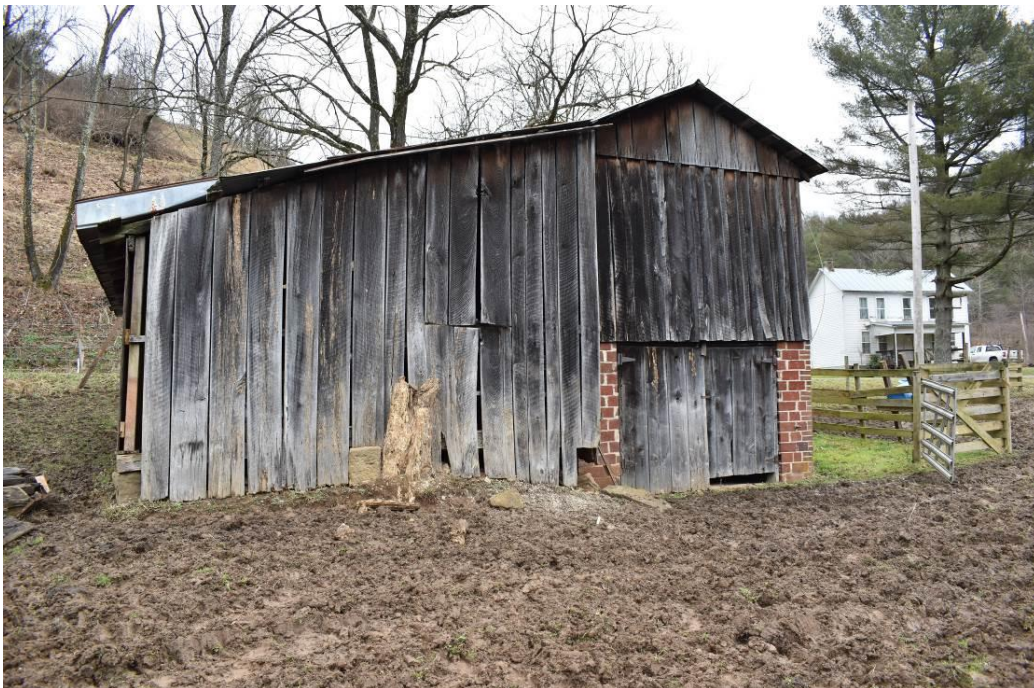
Photo 34

Located on the opposite side of County Route 10 directly adjacent to the road, approximately 155 feet southwest of the farmhouse, stands a small variation of a gable-entry bank barn (also known as a gable front bank barn) (**Photo 29**). The circa-1940 timber frame gable-entry bank barn is banked on its gable end (rather than the eaves side) and a shed-roofed timber frame addition, constructed on cut stone piers, is appended to the barn's west elevation (eaves side) (**Photo 30**); the barn's total dimensions are roughly 30 feet by 22 feet. The barn's lower story is constructed of structural terra cotta block and features a square window opening on the eave's sides (**Photo 31**). The barn's upper story is clad in vertical wood boards. The building's gable and shed roofs are covered in standing seam metal. A non-contributing, circa-2013 loading chute runs along County Route 10 directly off the barn's east elevation (**Photo 32**). Historically, double wagon gable-end doors on the upper level provided easy access to tractor/machinery storage space via an earthen ramp; however, the current doors appear to have been repurposed from another building (**Photo 33**). Access on the lower level was through another gable-end door, on the opposite end (**Photo 34**).

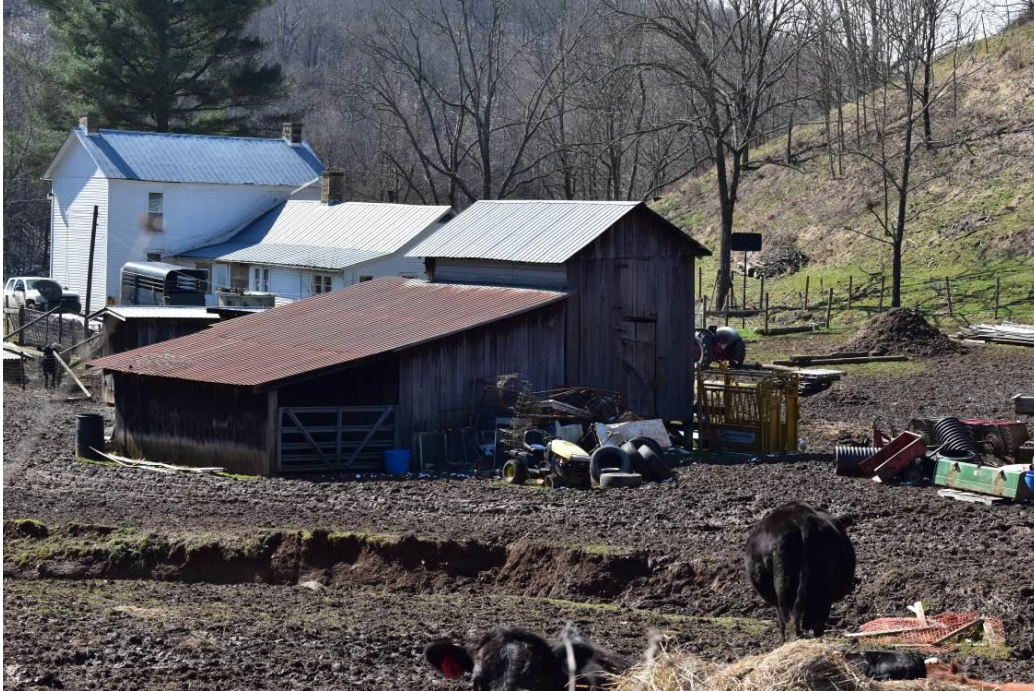
Photo 35

Approximately 118 feet northeast of the farmhouse (Resource A) stands a circa-1910 front gable, timber frame granary raised on wood piers (**Photo 35**). The granary measures roughly 14 feet wide by 19 feet long. The granary's exterior is clad in vertical wood boards. The structure's front-gabled roof is covered in standing seam metal. The structure exhibits the following typical characteristics of granaries: wood construction; tight boarding, no windows; gable end pass doors and entry doors (**Photo 36**); interior bins, partitioned from one another; and an interior walkway. Also, the granary is elevated off the ground, as a means of deterring rodents.

Grain growing continued at the same levels in the early-twentieth century, as in prior periods, so granaries also continued in use (Noble 1984:39; Noble 1995:130). The farmstead's granary (Resource D) was devoted to storing threshed grain. Grown for animal feed, small grains were a valuable and highly vulnerable component of livestock raising. As such, the granary is significant as secure storage for small grains was a priority for the Gum Farmstead. While the date of construction for the granary is noted as circa 1910, it is possible that the granary was constructed soon after 1911, a date in the agricultural history of the United States that was marked by the failure of the hay crop. Farmers, unable to "winter their cattle," shipped them to markets where they entered competition with many more than the usual numbers of stock. By the fall of 1911, livestock raisers in Lewis County were faced with the choice of selling their cattle at ruinous prices or having them underfed the following winter. To secure the greatest possible food value from their crops, several farmers in different sections of the county decided to build granaries and silos (Smith 1920:410).

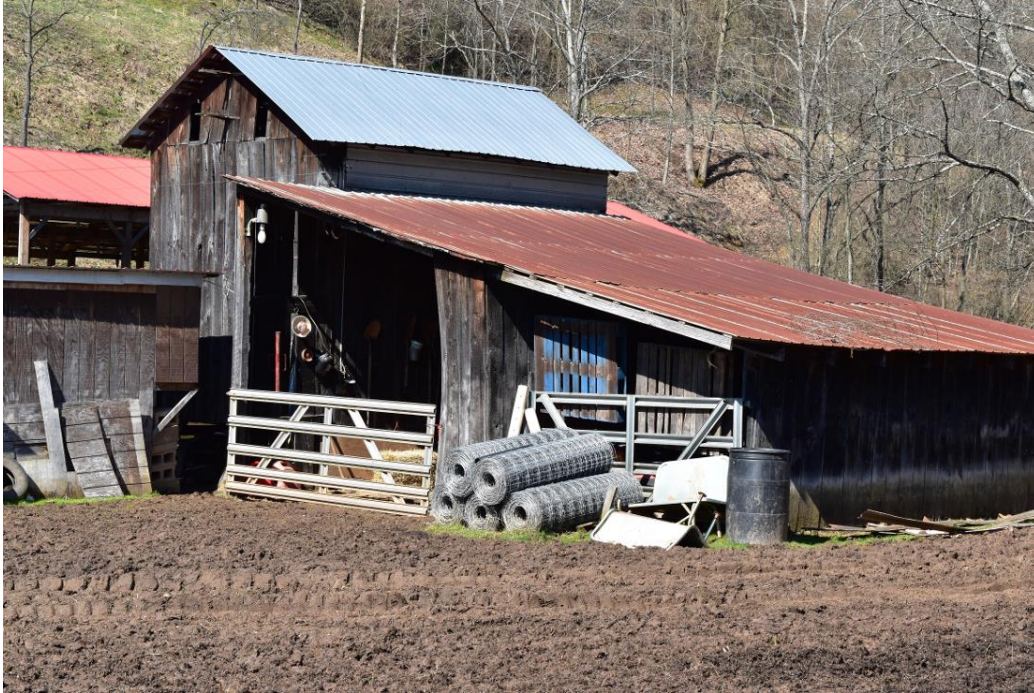
Photo 37

A shed-roofed machine shed addition measuring roughly 20 feet wide by 25 feet long was appended to the granary's east elevation (eaves side) circa 1935 (**Photo 37**). The addition's exterior is clad in vertical wood boards and its shed roof is also covered in standing seam metal.

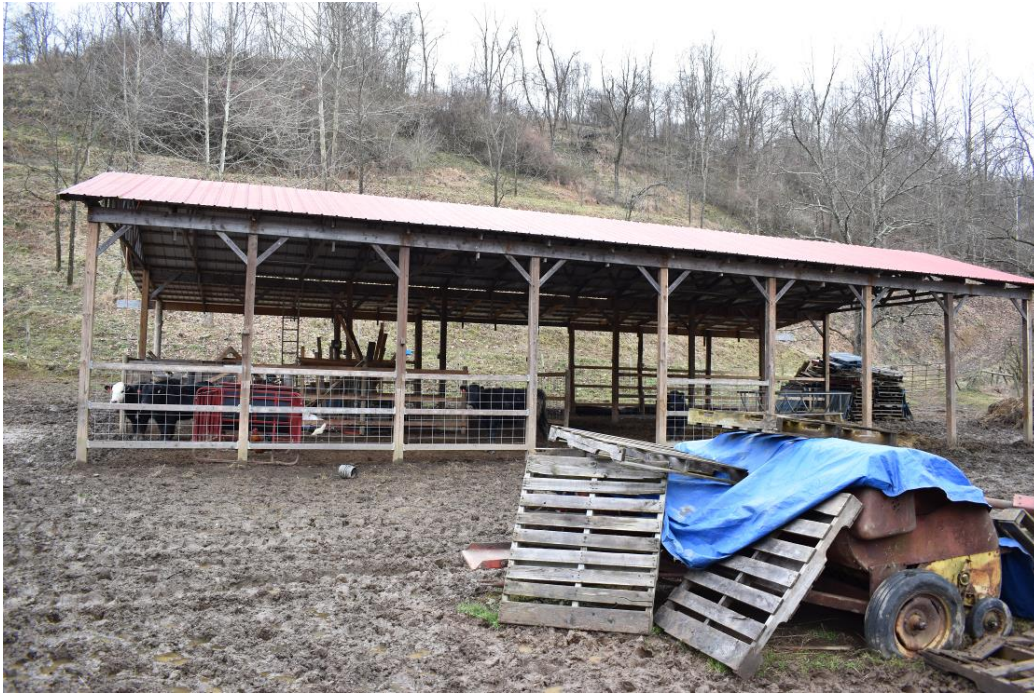
Photo 39

The circa-2013 pole barn is located approximately 120 feet north of Resource A (**Photo 39**) and measures roughly 45 feet wide by 70 feet long. The structure's framing system is built of wood roof trusses connected to vertical sidewall posts. The barn's gable roof is covered in standing seam metal. The structure lacks exterior cladding.
