United States Department of the Interior National Park Service  
NATIONAL REGISTER OF HISTORIC PLACES REGISTRATION  
FORM

historic name: Speck, Peter House

street & number: 1149 Ben Speck Road

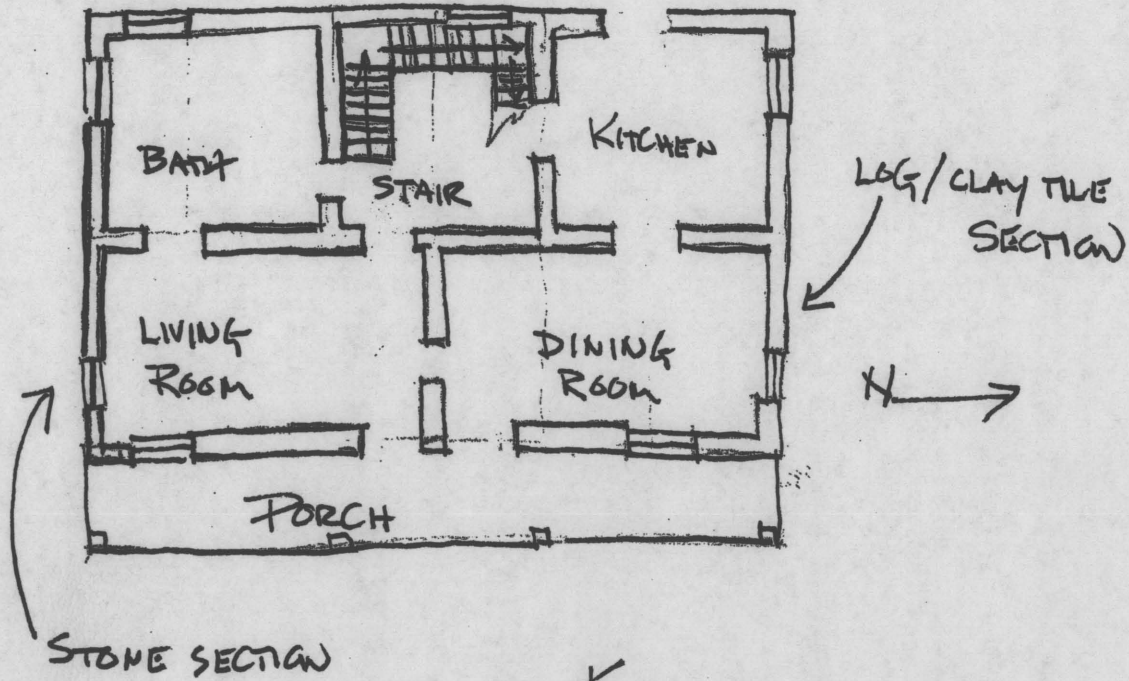
FIRST FLOOR PLAN  
 PETER SPECK HOUSE  
 BERKELEY, WV  
 6/2002  
 NOT TO SCALE

The log half features two rooms on each floor in addition to a rear stair hall that is shared with the stone half of the house. The first-floor north room is now used as a dining room.

The stone half features two rooms on each floor in addition to a rear stair hall that is shared with the log half of the house. The first-floor north room is now used as a living room. This room features modern wood floors laid over the original wide pine floors. Woodwork trim includes a molded baseboard and a chairrail. On the east wall is a fireplace mantel consisting of fluted pilasters and a frieze with bull's eye corner blocks. The molded mantel shelf extends nearly eight inches on each side. The original hearth and opening have been bricked over and a metal wood stove added. To the right of the fireplace is a built-in open cabinet with five shelves, with a double-door cabinet below. A six-panel door with porcelain handle leads to the present bathroom. This room features the original pine floors. The fireplace (now sealed) in this room has a mantel consisting of fluted pilasters and bull's eye corner blocks.

The stair hall is probably the most unusual feature of this house and was built ca. 1815 to join the log and stone halves of the house. Unlike most stair halls from this period, it is located at the rear, rather than to the front or to the side. The stair hall is accessed on the first floor from three grained wooden doors with metal box locks and porcelain knobs. There is a small closet set below the stairs, also with a six-panel grained wooden door. The open staircase rises in two stages and features a turned mahogany newel post, turned posts at each landing, a round handrail, and two plain balusters per stair tread. A small molded baseboard runs along the stair wall.

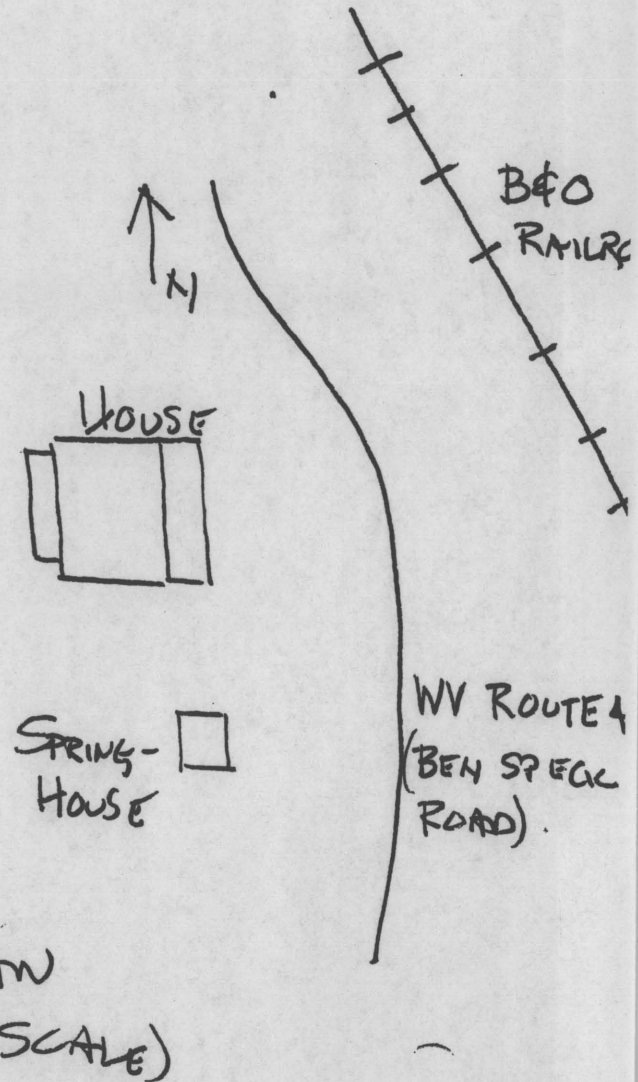
SITE PLAN  
 (NOT TO SCALE)

The boundaries of the Peter Speck House property are drawn to include the ca. 1814-1815 log-and-stone main house and the nearby ca. 1815 stone spring house. The two bank barns and shed located across Ben Speck Road on the north are no longer part of the current owner's property.

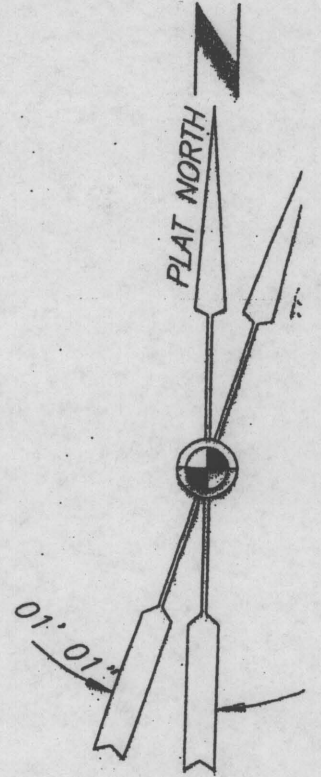
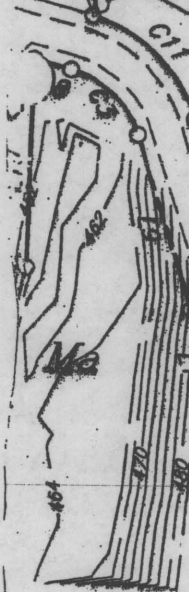
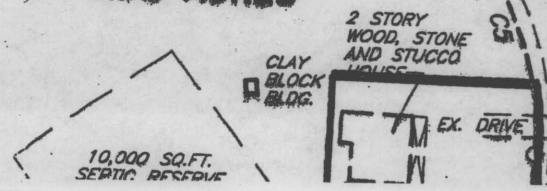
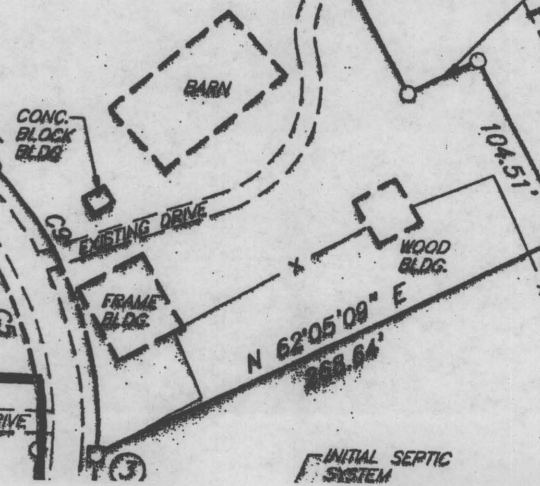
N 19°17'30" E 161.17'  
S 27°54'51" E 146.90'  
N 21°18'07" E 31.62'  
N 59°01'16" E 42.14'  
N 62°05'09" E 29.00'

PART OF  
REMAINING LANDS  
P/O WB. 61 PG. 417  
3.27 ACRES

The boundary of the Peter Speck House property is shown as the solid black line on the accompanying tax map (Berkeley County tax assessor's map number 12, parcel 53).
