National Register of Historic Places Continuation Sheet

Spring Valley Farm, NE of Union on U.S. Rt. 219
Monroe County, W.V.
Spring Valley Farm Boundary Increase
National Register Listing Date: 12/30/74. # 74002017

BOUNDARY INCREASE

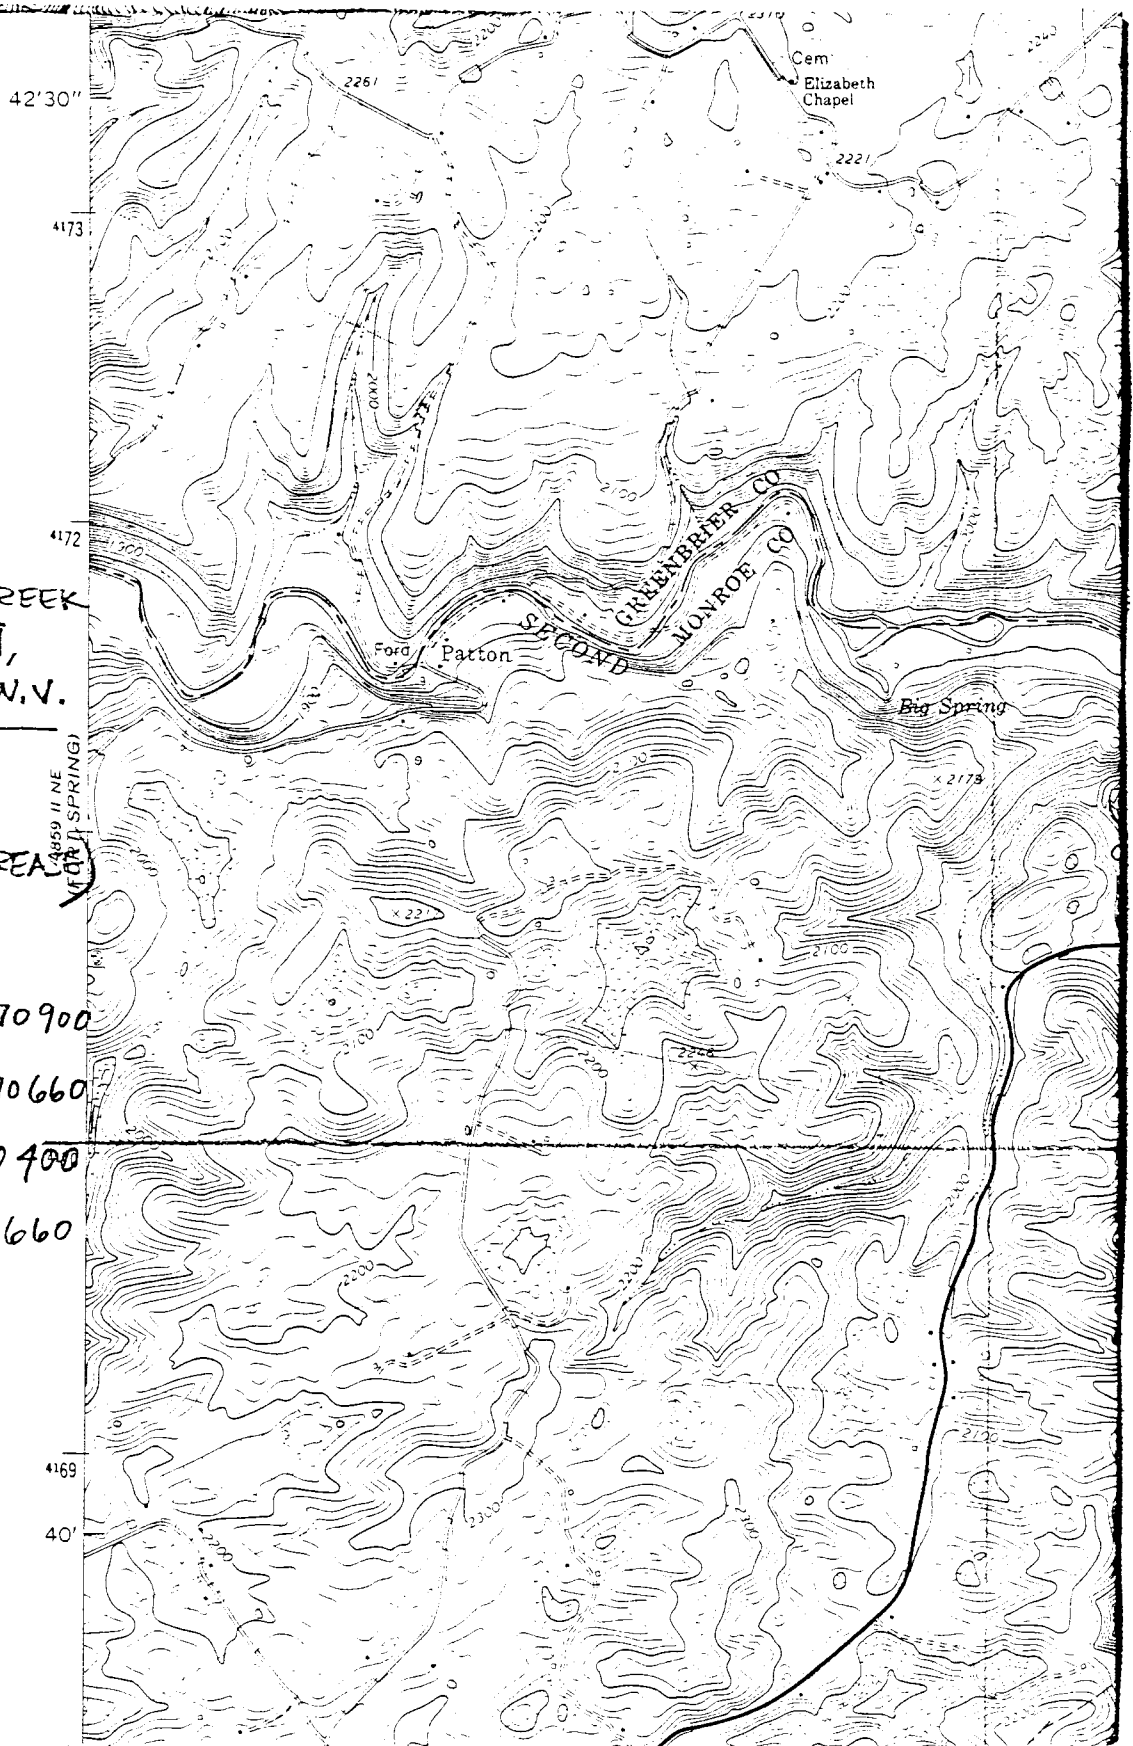
Section 10, p. 1
UTM

Spring Valley Farm
U.S. Rt. 219 at Second Creek
Monroe County, W.V.

1. 17/547780/4170900
2. 17/548080/4170660
3. 17/547940/4170400
4. 17/547600/4170660

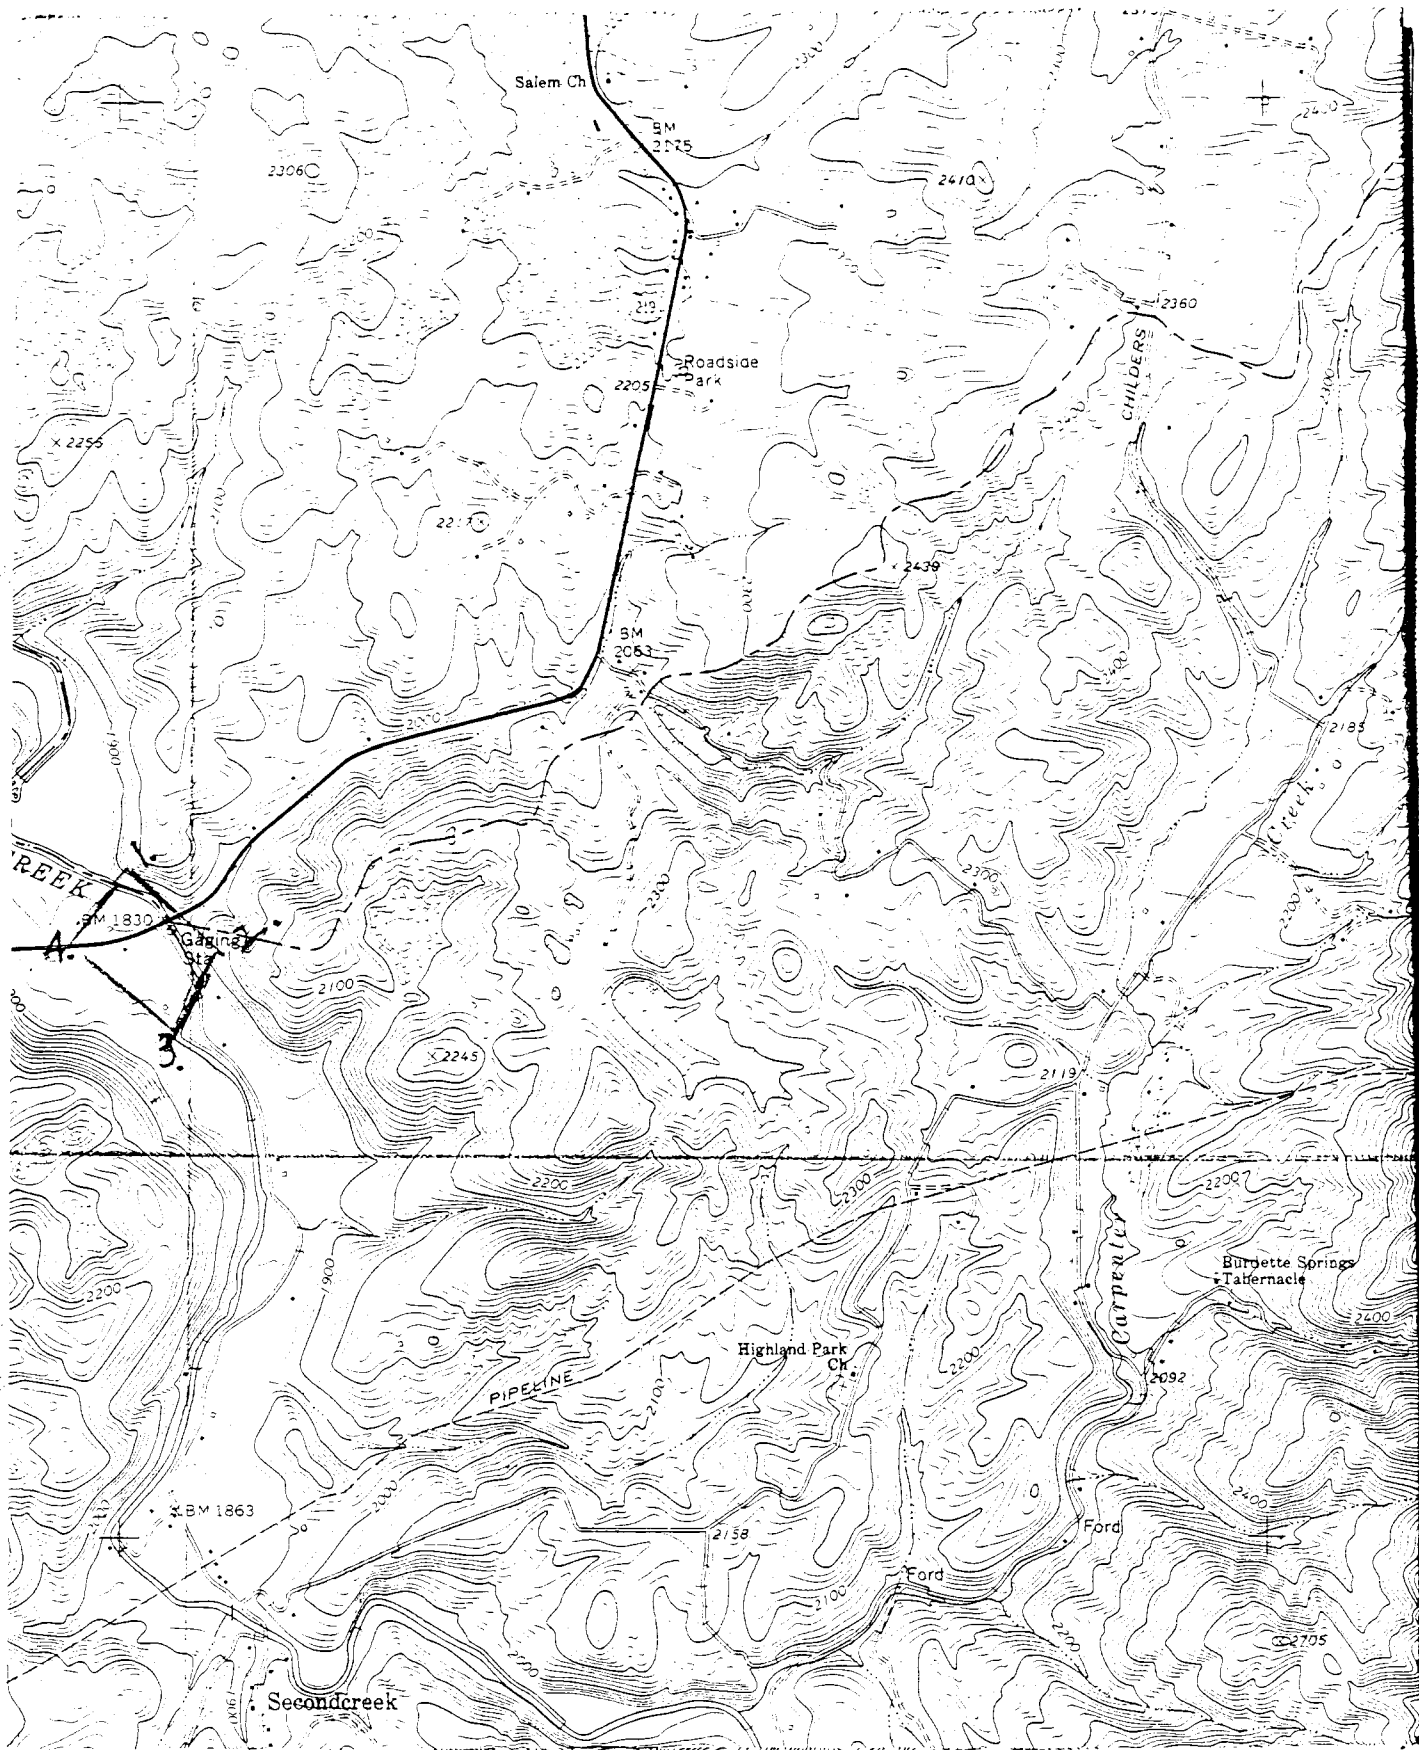
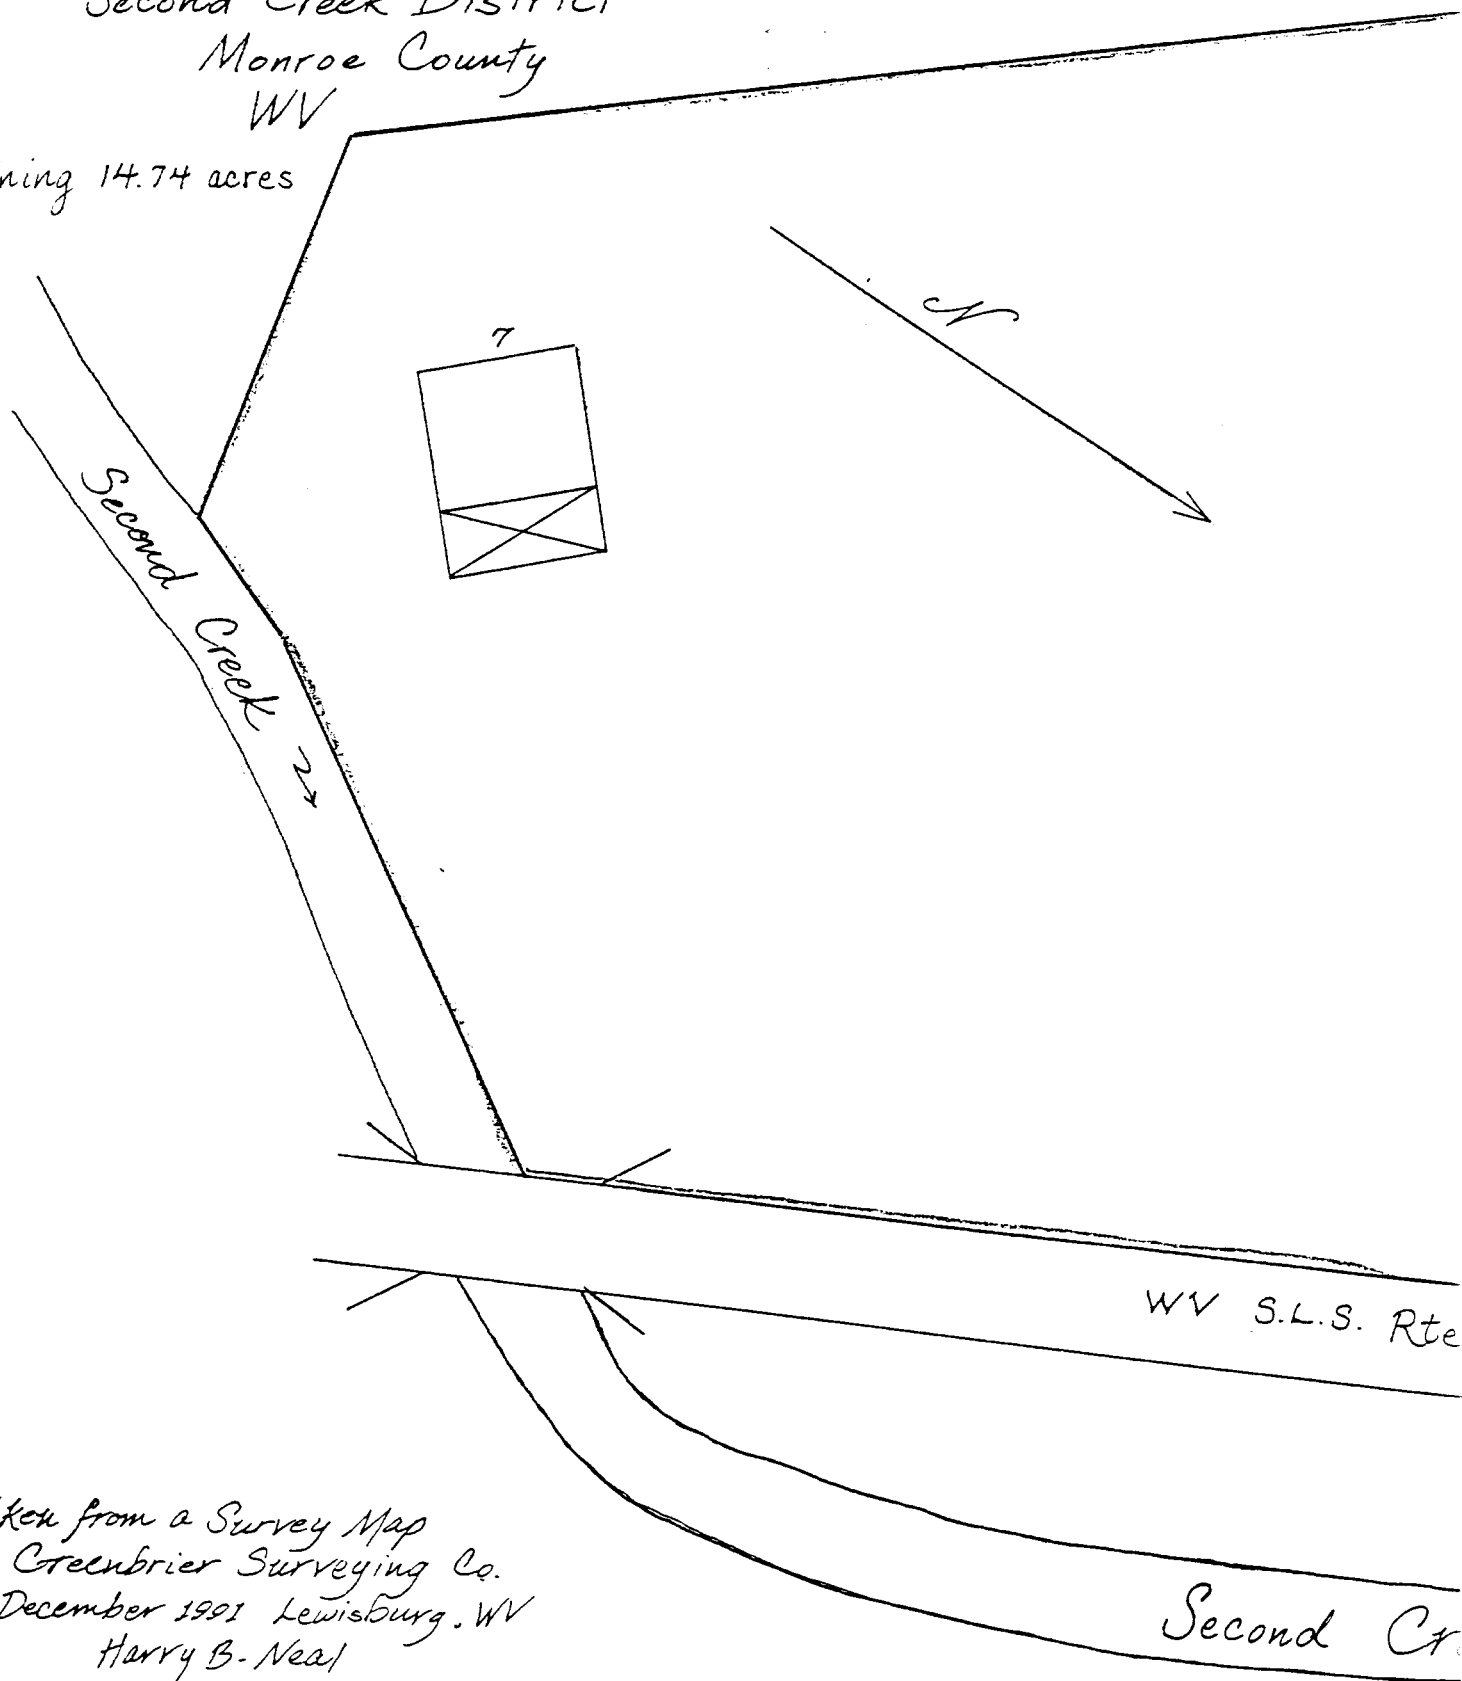
Boundary Increase Sketch Map

Spring Valley Farm

Second Creek District

Monroe County

WV

containing 14.74 acres

The boundary increase for Spring Valley Farm is roughly a rectangle containing 14.74 acres. The long sides of the rectangle face approximately east and west and the short ends are the north and south boundaries. The southeastern boundary is County Road 219/1 and the northeastern boundary is the waters of Second Creek. U. S. Rt. 219 traverses the nominated property in its east-west direction dividing it into a north one-quarter portion and a south three-quarter portion. The northeast and south-east corners are rounded by Second Creek as it flows to the Greenbrier River. (see sketch map for Spring Valley Farm boundary increase.)

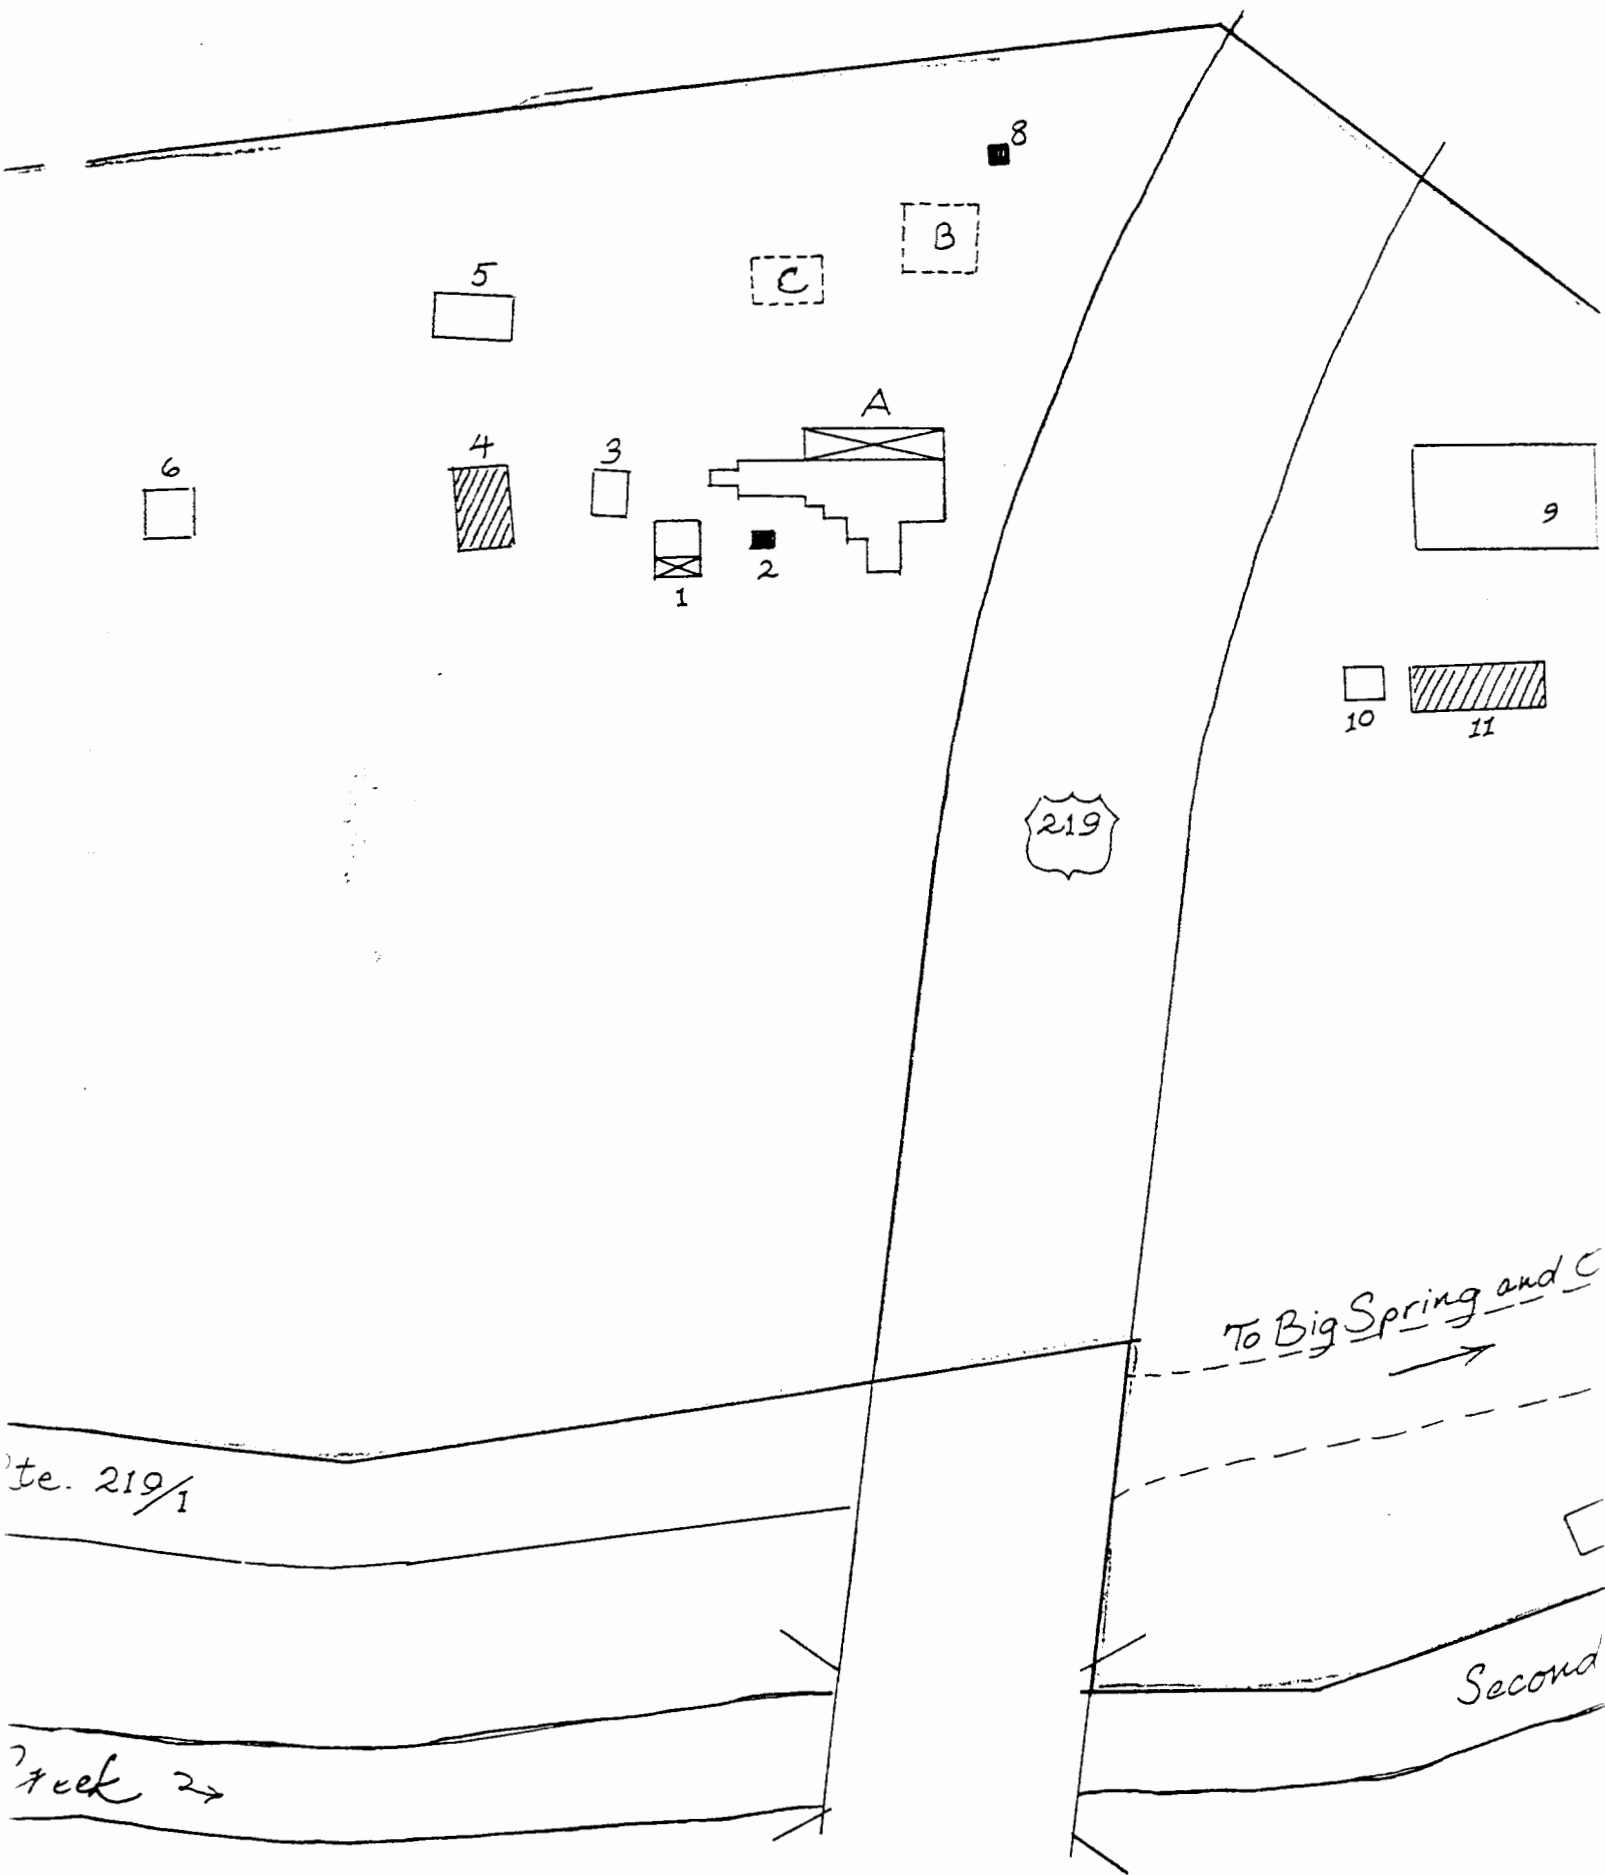
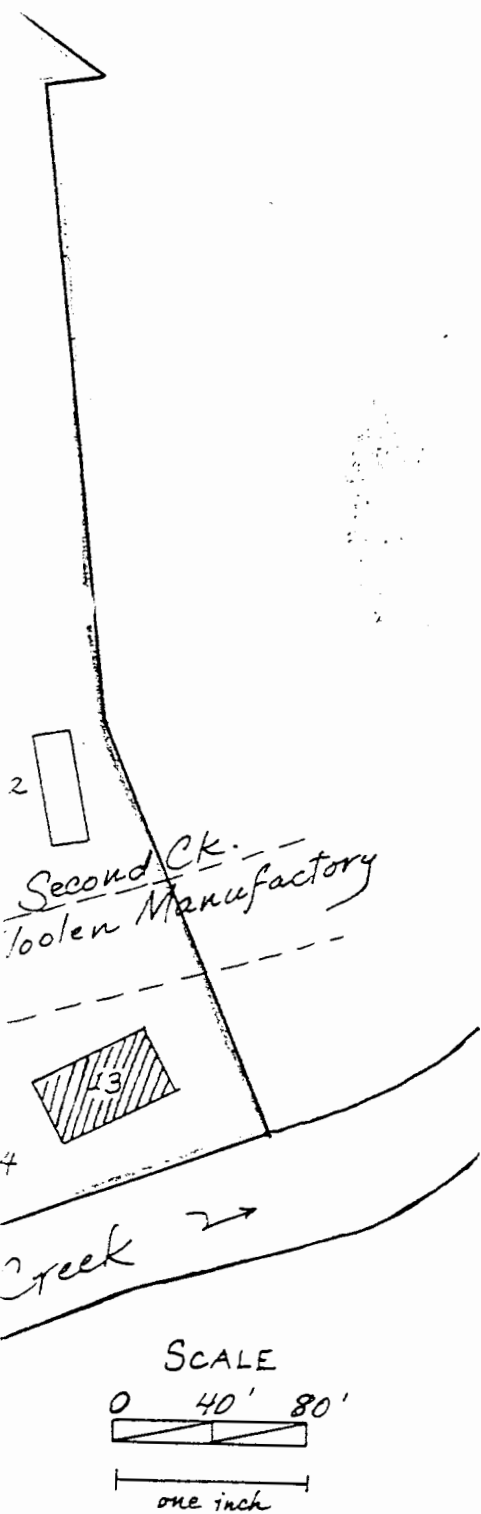
Taken from a Survey Map
by Greenbrier Surveying Co.
December 1901 Lewisburg, WV
Harry B. Neal

A Spring Valley Farmhouse

B Second Creek Fort site

C Knox House site

1. Shop ~ Root Cellar
2. 1834 well
3. Smoke House - Meat House
4. Garage
5. Granary
6. Old Stable
7. Cattle Barn
8. Second Creek Fort well
9. Horse Barn
10. Old Garage
11. Machine Shed
12. Machine Shed
13. Concrete Block Building
14. Old Log Building

8. Second Creek Fort Well. In the northwest corner of the yard is a well dug by hand ca. 1780. It is 24 feet deep and is lined with stone. The well is covered by a wooden platform. This well was the source of water for the Second Creek Fort (a fortified house) which stood just southeast of the well and the 1793 Knox House which was somewhat south of the fort site. (see sketch map, C & B) Contributing Structure.
