HISTORIC PROPERTIES INVENTORY FORM

1. NAME(S), historic/common: Rectory, Trinity Episcopal Church
2. LOCATION, street/road: 430 Juliana St. (S corner of Juliana & 5th Sts)
TAX MAP-LOT # 92-33 city/town: Parkersburg, WV 26101
(incorporated/unincorporated)
3. USE/FUNCTION, present: church offices
original: rectory
4. OWNER/ADDRESS, present: Trinity Episcopal Church
address above
original: same as above

Rectory, Trinity Episcopal Church
430 Juliana St. (S corner of Juliana & 5th Sts)
92-33

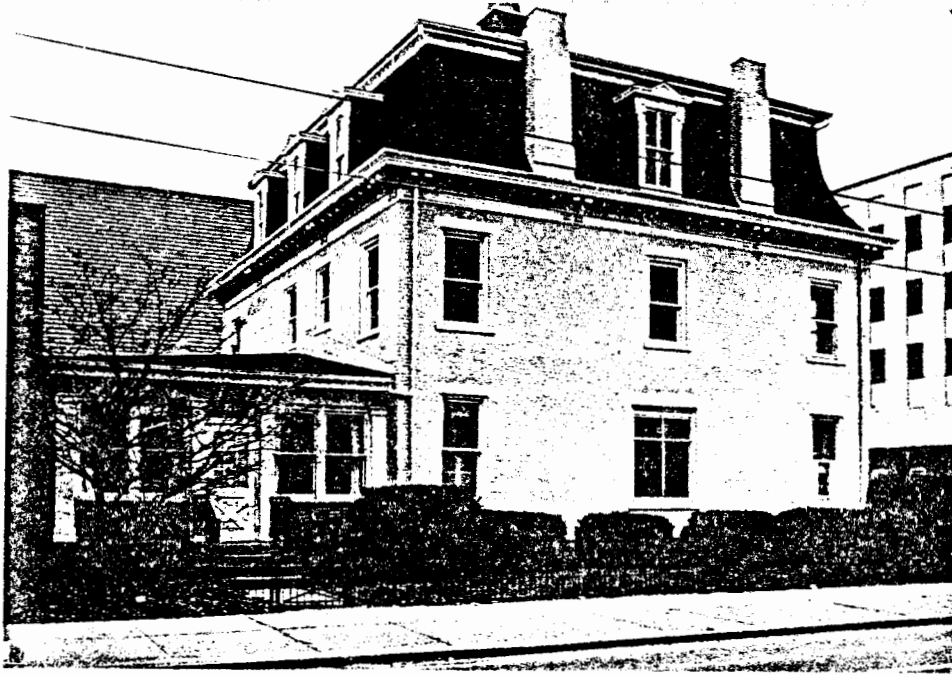
5. PHOTO/SKETCH OF: 8112-R2-F5,7

The Rectory is a freestanding building, joined by small wings to the church building. It is roughly 5 bays square, of 2 stories plus a concave mansard. The mansard is pierced by 3 dormers on the NW (front) facade and a dormer flanked by 2 chimneys on the NE (5th St.) facade; its cornice is bracketed, with larger, paired brackets between the bays. The 2nd story windows (3 on NE, 5 on NW originally) are d/s; on the NW, those in the outer 2 bays are joined by a picture window. The 1st story windows are also d/s. The central doorway on the NW has a transom and sidelights and is sheltered by a concave hood on wrought iron supports.
