HISTORIC PROPERTIES INVENTORY FORM

1. NAME(S), historic/common: Union Trust & Deposit Co. /
Union Trust National Bank
2. LOCATION, street/road: 700 Market St.
TAX MAP- LOT #
91-4 city/town: Parkersburg, WV 26101
(incorporated/unincorporated)
3. USE/FUNCTION, present: bank

Union Trust & Deposit Co. / Union Trust National Bank
700 Market St.
91-4

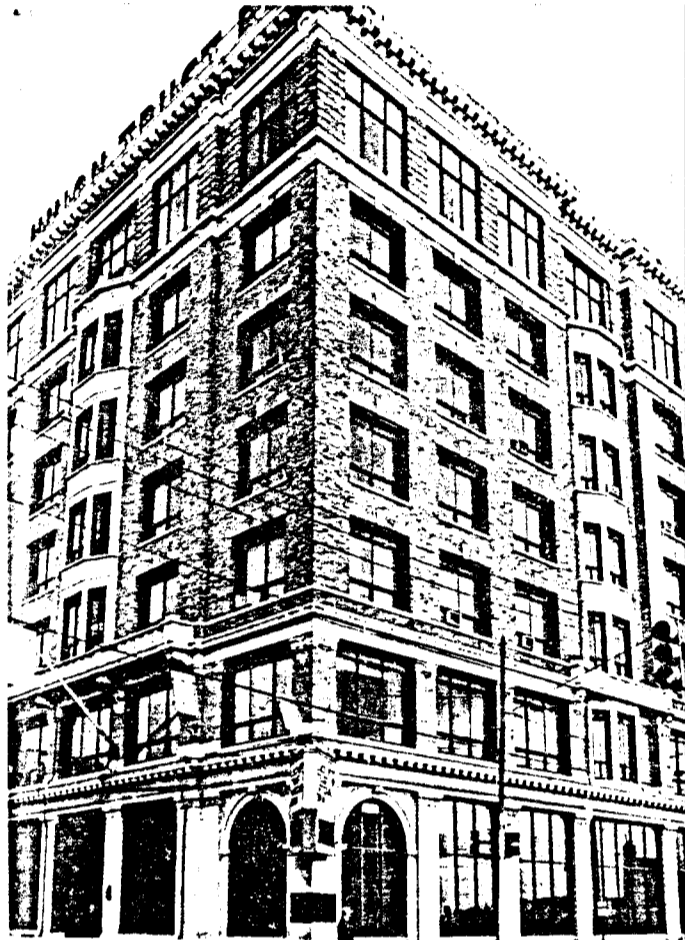
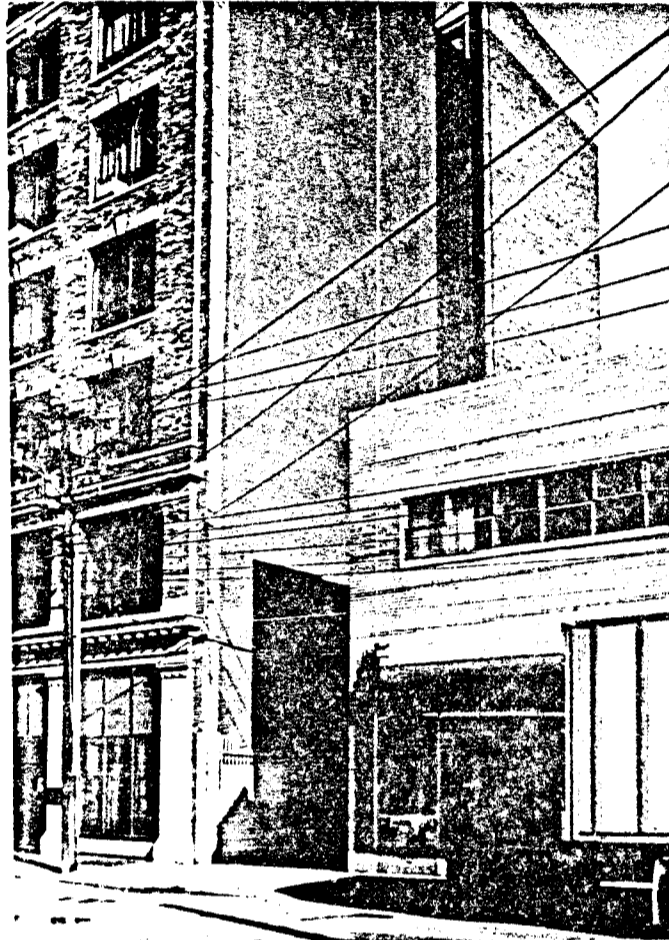
This is a solidly constructed 7 story, 5 by 7 bay building in a U-shape with the Classical columnar design of base, shaft, and capital. The base is a smooth dressed stone pilaster and window system with corner arches and a modillion cornice; the capital is a metal modillion and dentiled cornice with cartouches below and acroterions above. The shaft consists of wide window apertures with brick relieving arches and stone keystones and sills, containing replacement windows. The central bay (NW) is a projecting 3 sided bay. Above the 2nd story, whose window apertures are larger, is a balconet on consoles. The 1st story apertures, also with replacement windows, are arched at the corners. On the 2 less exposed facades (SE & NE) the fenestration is a simple system of paired d/s (1/1) with stone lintels and sills.
