National Register of Historic Places Registration Form

Historic name: Citizens National Bank of Belington

Street & number: 5 Crim Avenue

City or town: Belington State: WV County: Barbour

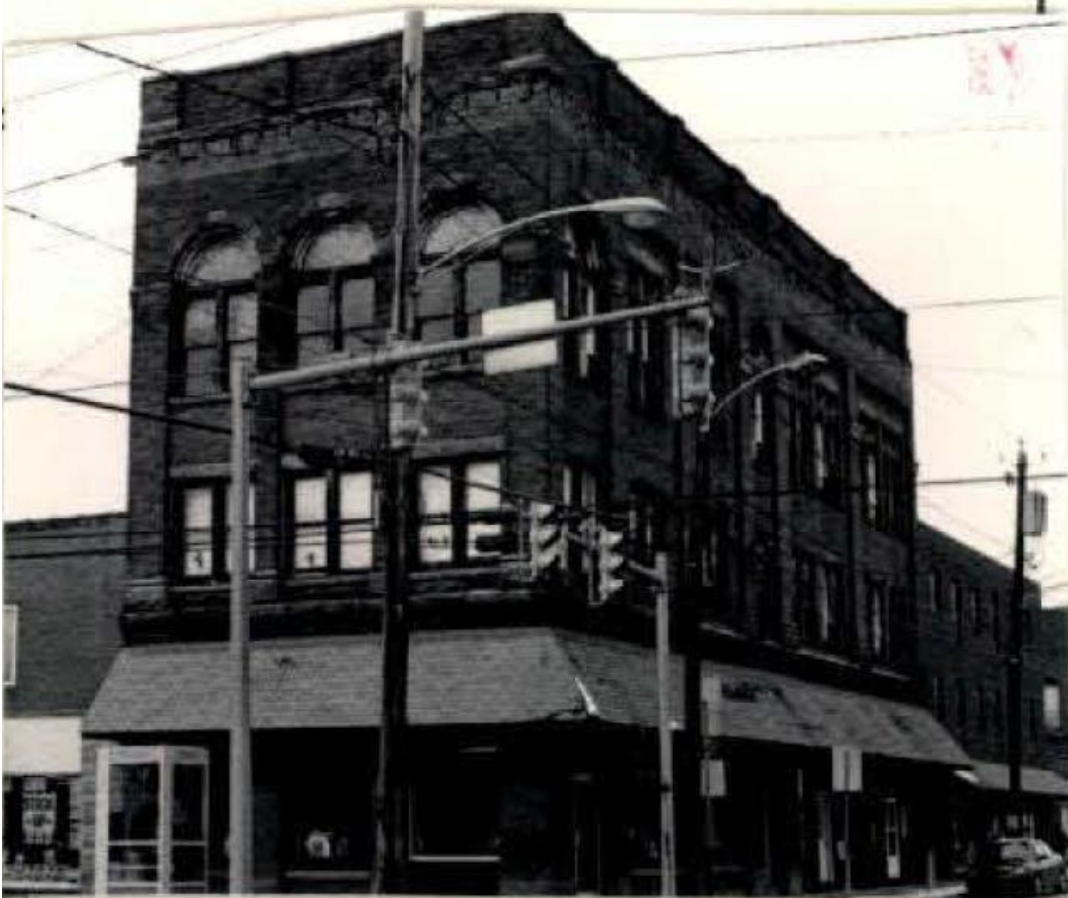
12. Historic photo, southeast corner and facades, 1995.

The building's exterior retains an overall high degree of integrity. The footprint, bay configuration, and fenestration pattern remain unaltered. The masonry remains unpainted and in generally good condition. All historic window sashes and frames have been retained on the upper levels. While the commercial windows have been replaced, they have been installed within the same penetration dimensions using same large display-style units. The two most notable alterations are the renovations to the second and third storefronts previously described, and the installation of the current projecting metal cornice in place of the original one. Historic photographs c1995 show no projecting metal cornice present, meaning the original was lost by

that time and that the current one and new corbels were added in the last 30 years. However, the use of pressed tin tile gives a historically sympathetic feeling to the alteration and does not drastically detract from the overall character of the building.

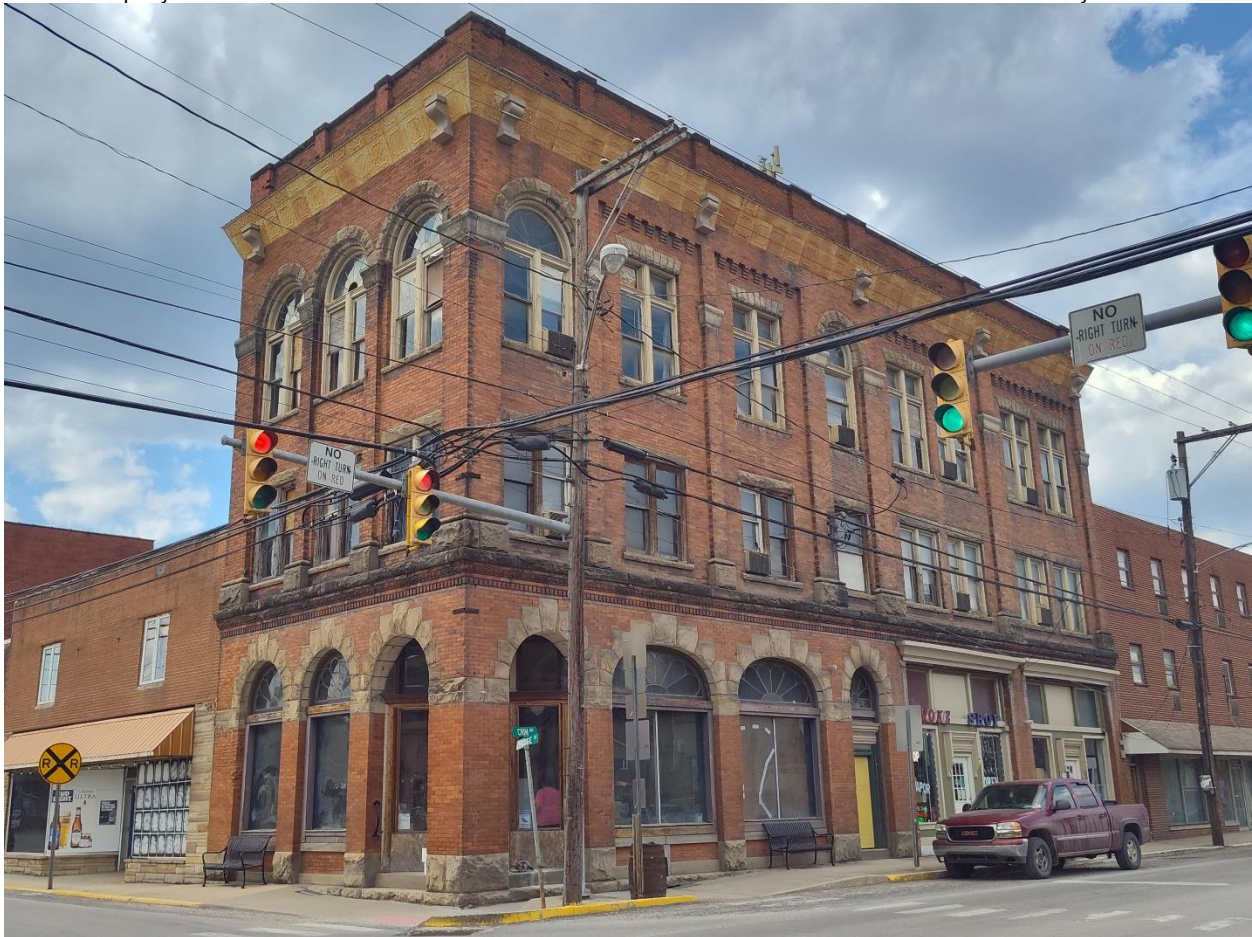
Photograph 1. View: southeast corner and facades, facing northwest
WV_BarbourCo_CitizensNatlBankofBelington_0001

The former Citizens National Bank is a 3-story, red brick, Romanesque Revival-style, commercial structure with two primary street-facing facades. The south elevation is three bays wide. Each bay features a grand stone block arch on brick pillars at ground level, a paired 1-over-1 doublehung wooden window with flat stone lintel and sill at second level, and a paired 1-over-1 doublehung wooden window with leaded fanlight transom under rusticated stone arch at third level. The upper bays are recessed and divided between brick pilasters with rusticated stone bases and caps. At ground level, the two western bays feature nearly full-length display windows in wood frames and leaded fanlight transoms. The eastern arch is open to a recessed corner entry with commercial storefront featuring a single-lite wooden door, large sidelites, and transoms in wooden frame. The upper transom row is divided by decorative Corinthian-style mullions and is separated from the lower storefront by a metal cornice. While the historic door and storefront configuration have been retained, it appears to have had its finishing trim removed leaving the internal framing exposed on the exterior. An elaborate belt course with rusticated stone over dentiled and egg-and-dart brick molding spans the south and east elevations. A non-original projecting metal cornice of pressed tin tiles and scrolled nonstructural corbels also spans these elevations.

The east elevation is six bays wide. The southern most bay mimics the south elevation with open arch at ground level and arched third floor window. The second and third bays each feature a slightly wider display window with fanlight and stone block arch at ground level, paired 1-over-1 doublehung wooden window with flat stone lintel and sill at second level, and a paired 1-over-1 doublehung wooden window with square transoms and flat stone lintel with keystone at third level. The upper bays are again recessed and divided by pilasters as previously described, but with a row of stacked brick corbels along the top edge of bays two, three, five, and six instead of stone arches. The fourth bay is narrower and corresponds to the interior stairwell, featuring a door at ground level and single 1-over-1 windows on upper levels. The fifth and sixth bays have additional storefronts at ground level corresponding to the second and third commercial spaces. These have been remodeled with modern materials. Each storefront features a 9-lite steel door under Italianate hood, display windows and 3-lite transom row in wood frames, projecting molded cornice, and beadboard-style wall paneling.

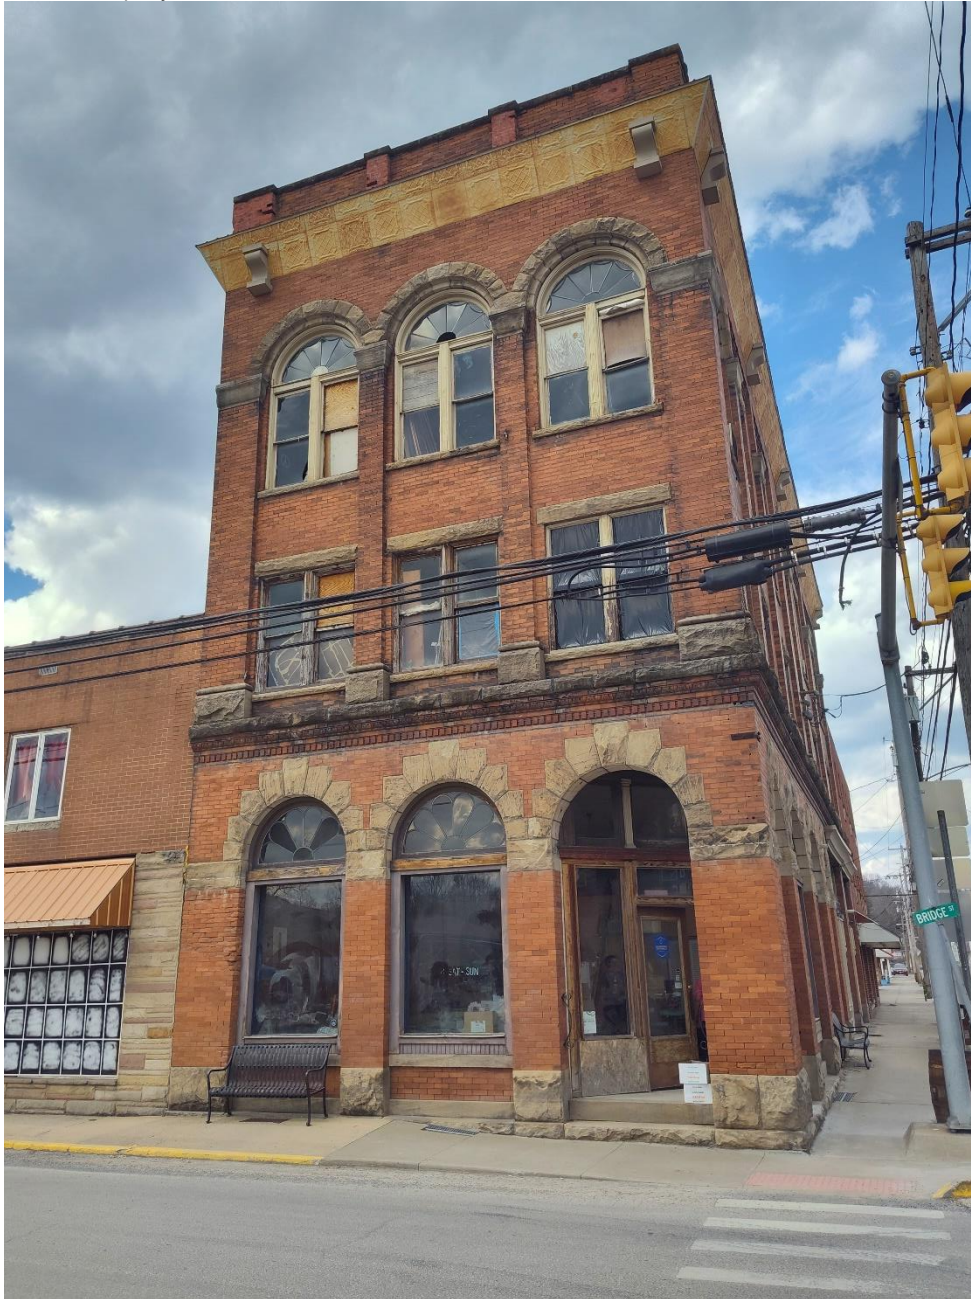
Photograph 2. View: south facade, facing north
WV_BarbourCo_CitizensNatlBankofBelington_0002

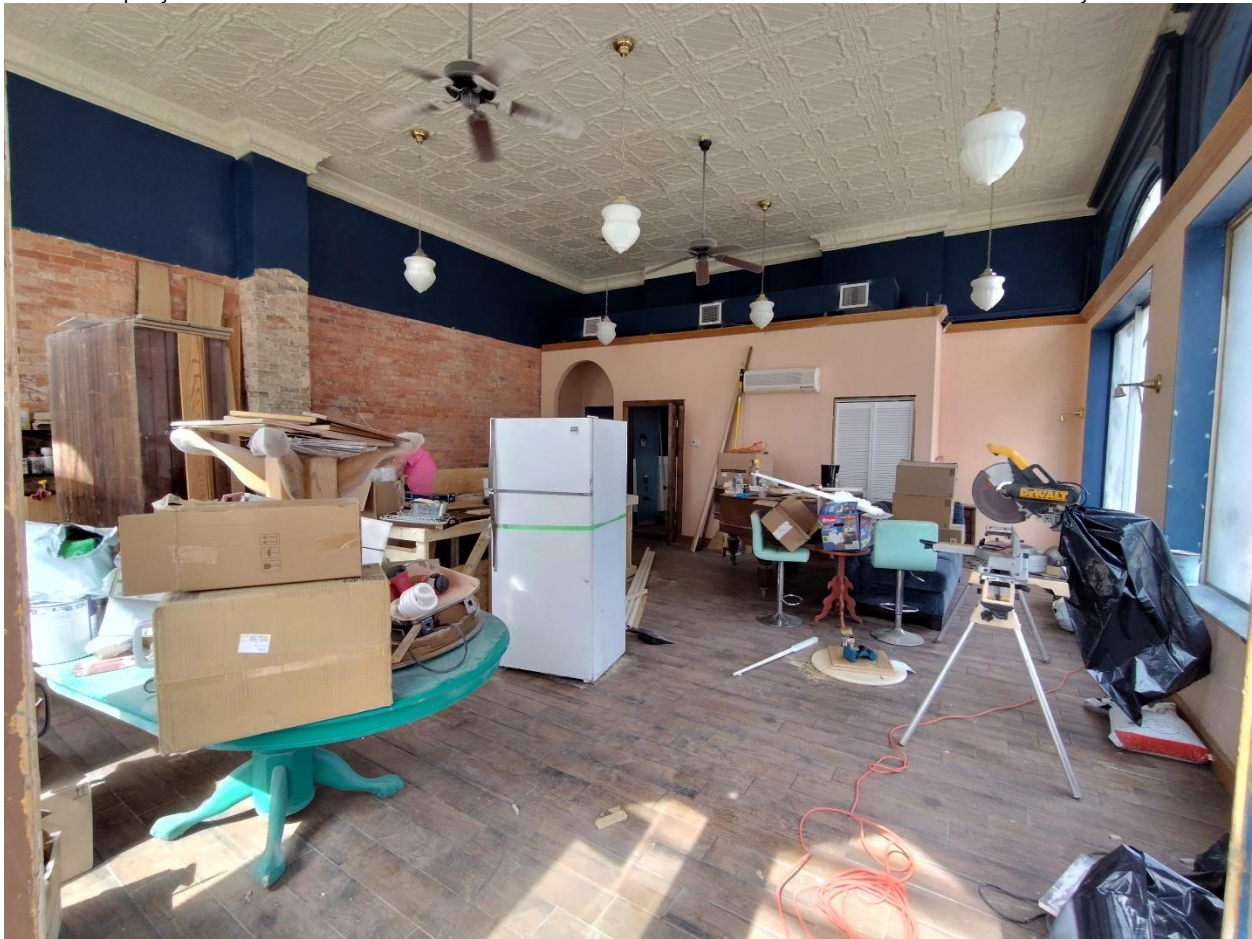
Photograph 7. View: first floor interior, facing northwest
WV_BarbourCo_CitizensNatlBankofBelington_0007

The interior of the building includes three floors and a full basement, each covering approximately 2000 sq. ft. The primary commercial space is a single large room featuring a 15ft. ceiling with pressed tin tiles, modern schoolhouse pendant light fixtures, plaster and exposed brick walls, newly framed bathroom and mechanical closet at rear, and woodgrain-pattern ceramic tile flooring. An arched doorway on the rear/north wall leads to the central stairwell with plaster walls, pressed tin ceiling, and wooden baseboard trim. The stairs are dark stained wood with coffered paneling, wooden balustrade, and decorative newel posts. The second and third commercial spaces are nearly identical, featuring pressed tin ceilings, modern schoolhouse pendant lights, plaster walls with modern peg board shelving, carpet flooring, and modified columns inside the storefront door denoting configuration of original recessed entrance.
